# EFFECT OF SLOW-MOVING LANDSLIDES ON CHURCHES IN THE LIGURIA REGION: A GEOTECHNICAL APPROACH

**Keywords:** Slow-moving landslide, Historic masonry churches, Damage assessment.

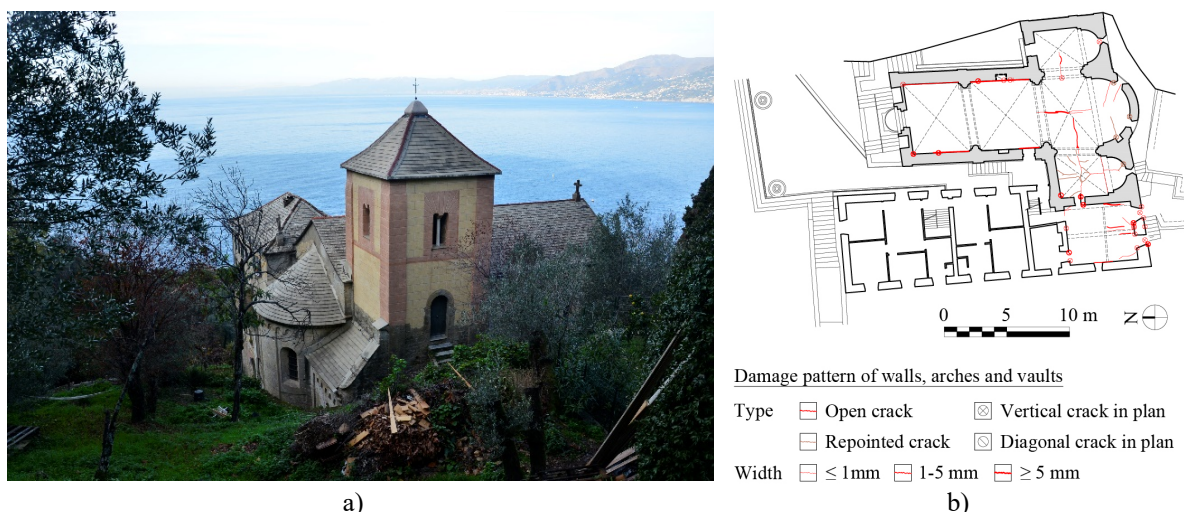
The crack pattern surveyed in San Nicolò church and the Fishermen’s house during on-site inspections is reported in Figure 1b.

**Figure 1:** San Nicolò di Capodimonte church: a) exterior view, b) damage pattern.

The church presents slight to moderate damage. Few thin (width up to 1 mm) and medium (width between 1 mm and 5 mm) vertical cracks can be observed in the longitudinal walls as well as in apse wall above the windows. The vaults of the transept present cracks oriented parallel and perpendicular to the longitudinal axis of the church. Regarding the Fishermen's house, the authors were given access only to the building portion adjacent to the church. Extensive and severe damage was found in this area. In particular, large (width equal or larger than 5 mm) vertical cracks developing from the level of the ground were observed in the external wall continuous with the wall of the church apse.

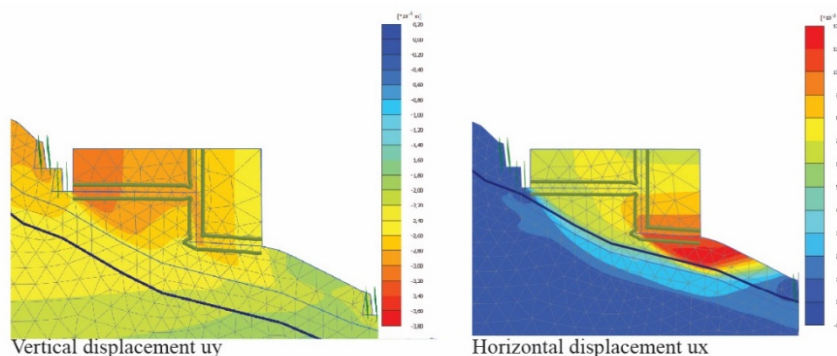
Figure 3 shows the trend of vertical and horizontal displacements for section E under the

Fishermen’s House and under the church. It can be noticed that, while vertical displacements exhibit a uniform distribution under the entire complex, horizontal displacements are larger under the Fishermen’s House than under the church. These results can explain the crack pattern observed in both buildings. Firstly, the vertical cracks observed in the apse wall as well as in the external wall of the Fishermen’s house can be attributed to the occurrence of horizontal displacements. The latter may have caused also the cracks in the vaults oriented parallel to the longitudinal axis of the church (Figure 1b). Secondly, the more severe damage observed in the Fishermen’s house can be explained by the larger horizontal displacements obtained under this building. Regarding the cracks in the vaults oriented perpendicular to the longitudinal axis of the church, they may be associated to a local subsidence occurring under the apse of the church. This phenomenon may have been triggered by the significant concentration of rainwater in the area of the apse due to the presence of the ditch mentioned above.

**Figure 3:** Vertical and horizontal displacements obtained in section E.

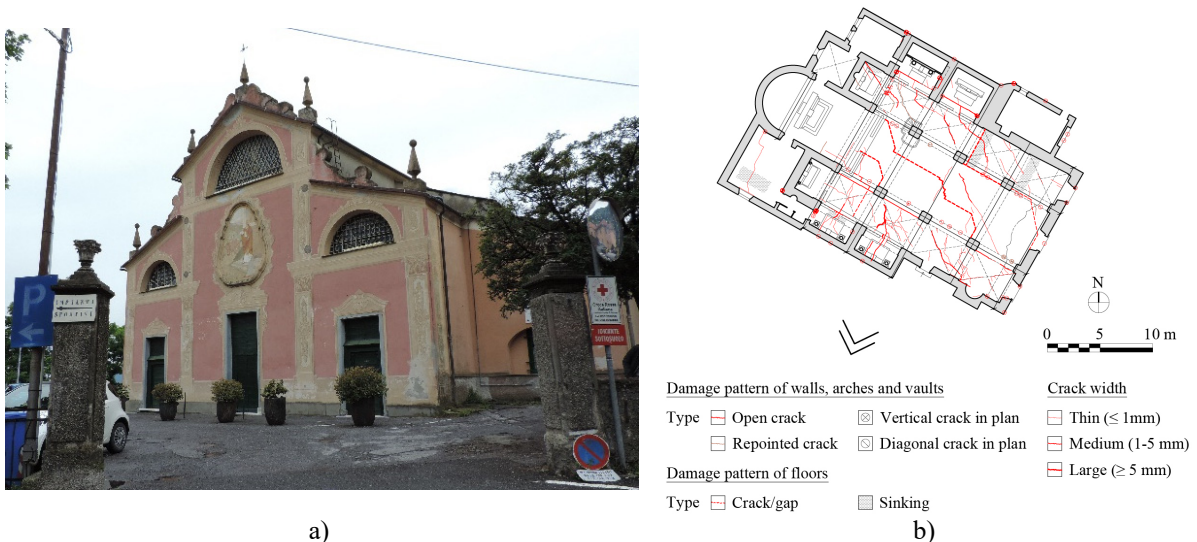
The crack pattern observed in Sant’Olcese church during on-site inspections performed by [1] is reported in Figure 5b.

**Figure 5 – Sant’Olcese church:** a) exterior view, b) damage pattern (the direction of the landslide acting in the area is indicated with an arrow).

The church presents extensive and heavy damage, in particular in floors and vaults. Damage in the floor appears in the form of parallel gaps among tiles (ranging from 2 to 5 mm in width) and localized sinking. Extensive damage can be observed in the vaults with diagonal shear cracks widespread throughout the building. It can be observed that these cracks, which exhibit the same orientation in all the vaults, reflect the gaps observed in the floor, both being oriented almost perpendicular to the landslide direction (indicated with an arrow in Figure 5b). Finally, walls are affected by few minor vertical cracks.

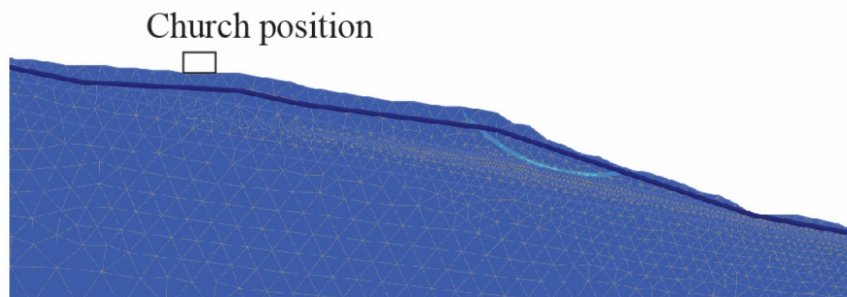
Both horizontal and vertical patterns of displacement were evaluated. The results show only very small displacements (less than 1mm) in the section under the church while an area of instability downhill of the church was identified (Figure 7). However, the latter is too far away from the building to influence its behavior.

The results of numerical analyses do not appear to be in good agreement with the crack pattern observed in the church. In fact, the heavy damage exhibited by the building as well as the occurrence of parallel cracks in vaults and floors oriented perpendicular to the landslide direction clearly indicates that the church has been subjected to slope movements. The absence of significant soil displacements obtained from numerical analyses can be attributed to the fact that the lack of detailed geotechnical data did not allow for an accurate modeling of the soil. The latter could be achieved by performing new in-situ tests and boreholes, especially in the area downhill of the church, in order to obtain a detailed stratigraphy and fully characterize soil parameters.

**Figure 7:** Shear strain concentration in area downhill of the church.

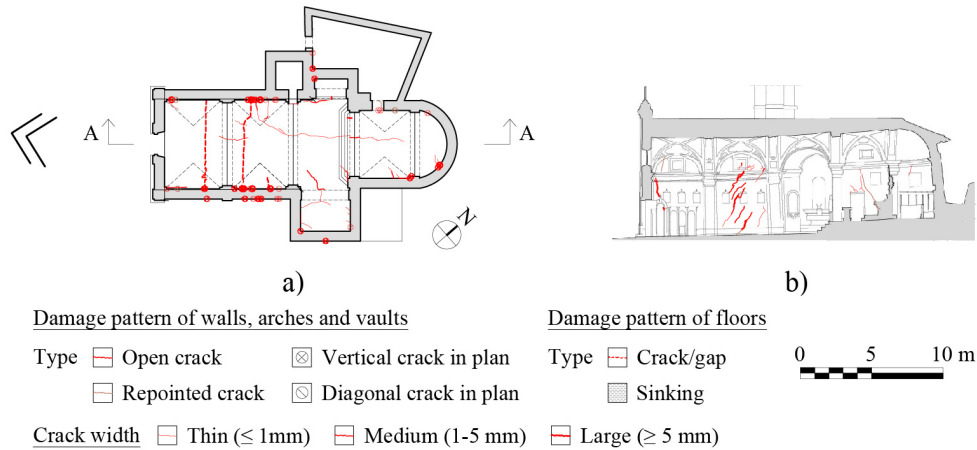
Figure 8a-b presents the crack pattern of San Carlo church in plan and elevation. The building exhibits extensive and severe cracking as well as large deformations. The floor presents two large parallel gaps (the largest one with a width of 18 mm) crossing the entire floor and propagating between longitudinal walls (Figure 8a). These gaps continue up into the walls with a diagonal orientation. Regarding cracking of walls, the most important damage is observed in the second bay behind the façade where series of severe diagonal cracks propagating from the level of the ground and developing upwards towards the apse are observed in both the longitudinal walls (Figure 8b). As for arches and vaults, they exhibit only few and

slight damage. In particular, a thin longitudinal crack is present in the barrel vault at mid-span. Thanks to the deformation survey performed in [15], the presence of large deformations can be observed (Figure 8b). In particular, a significant rotation of the apse towards the interior of the church can be detected. Furthermore, it can be observed that the left part of the church, where the bell-tower is located, experienced a larger settlement with respect to the right one [15].

**Figure 8:** Damage survey of San Carlo church in Cassingheno: a) plan, b) section AA. (The direction of the landslide acting in the area is indicated with an arrow).

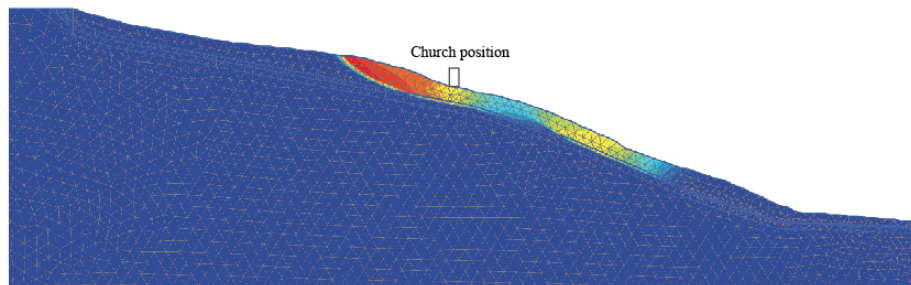
The results show that the church is located in an area of potential instability (Figure 10) and is subjected to horizontal and vertical displacements of the same order of magnitude.

Regarding horizontal displacement, a maximum value of about 20 mm is obtained under the church when analyzing the slope section along landslide direction. This displacement value is in good agreement with the horizontal displacement recorded by the inclinometers and reflects the width of the gaps of the floors. These latter can be, indeed, attributed to the significant horizontal movement experienced by the church in the direction of the landslide. As for vertical displacements, they may explain the rotation of the apse towards the interior of the church.

The presence of severe cracks localized in the second bay of the church as well the settlement experienced by the left part of the church with respect to the right one can be attributed to the occurrence of differential settlement in this area. These displacements could have been responsible for the structural instability of the bell tower, which was strengthened in 1988. It is evident that such local phenomena cannot be captured when modeling the behavior of the entire slope.

**Figure 10:** Total displacements  $|u|$ .
