SEISMIC DAMAGE MECHANISMS FOR CHURCHES AND DAMAGE SEQUENCE: CONSIDERATIONS FROM A CASE STUDY

4.1 The church of San Bartolomeo at Quistello

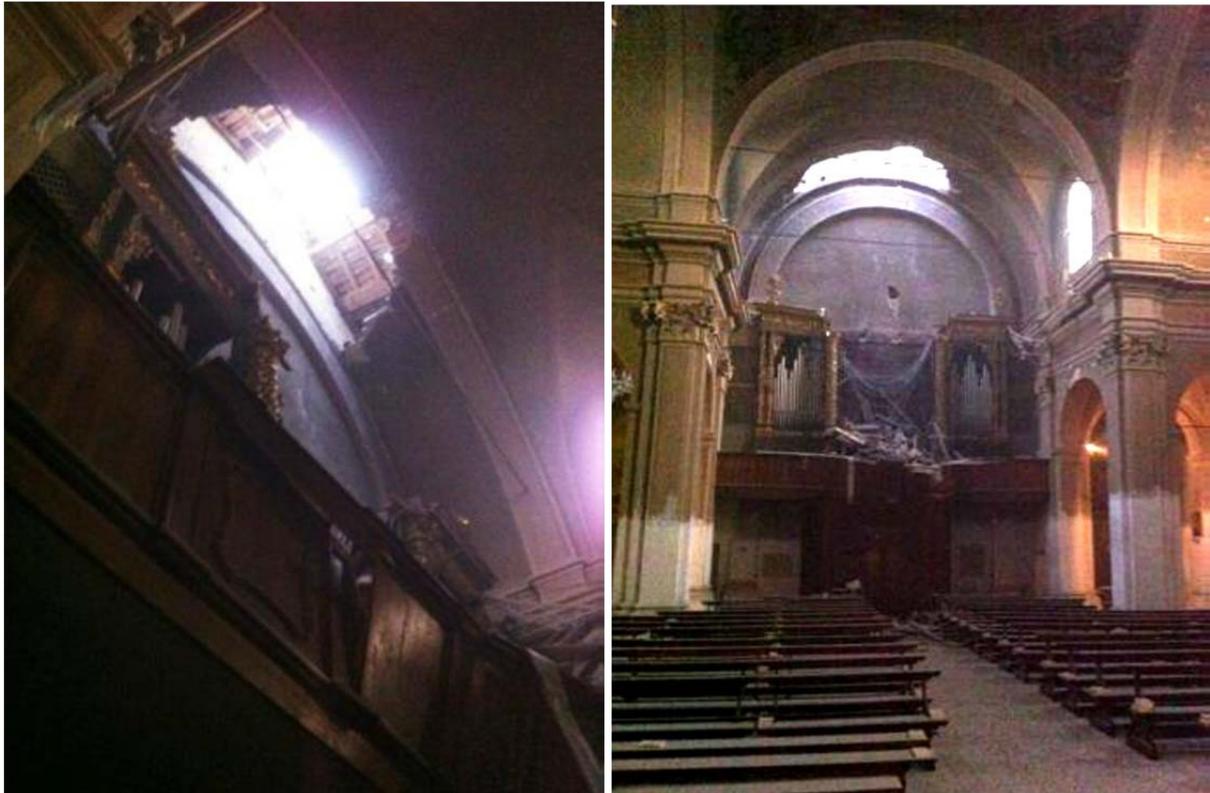
During the earthquakes of 2012, the many seismic shocks that occurred from the 20th and particularly on 29th of May heavily damaged the church that reported collapses of the vaults and wide cracks on many bearing walls of the central nave, as well as the collapse of the roof behind the façade. The event of the 20th of May caused out of plane, overturning cracks on the façade in the proximity of the gable and the overturning toward the interior of the marble element supporting the cross, at the top of the façade, that collapsed into the roof. The fall of such non-structural element caused damage to the roof behind the façade and to the counter-façade vault underneath. This kind of damage was observed in other churches in the area.

The second important shock of the 29th of May, at 9:00 a.m., deteriorated further the situation. Many of the vaults collapsed, causing additional damage to decorations and other art elements below. The damaged vault behind the façade fell, entailing the collapse of the organ, see fig. 5.

Figure 5: Collapse of the vault behind the façade

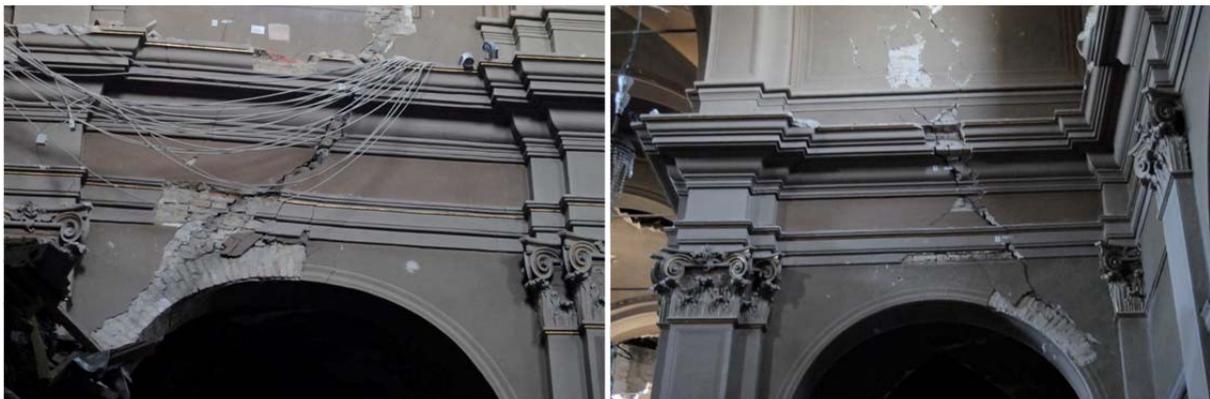
Other elements and parts of the church were also severely damaged. Important cracks opened in the entablature above the arches along the central nave as well as in those between the chapels. In many cases they reached the vaults above, as in fig. 6. The apse developed numerous inclined cracks, which are frequently found in such element: a situation that has been listed in the abacus of typical mechanisms.

Figure 6: Cracks in the arches along the nave and transversal to it.

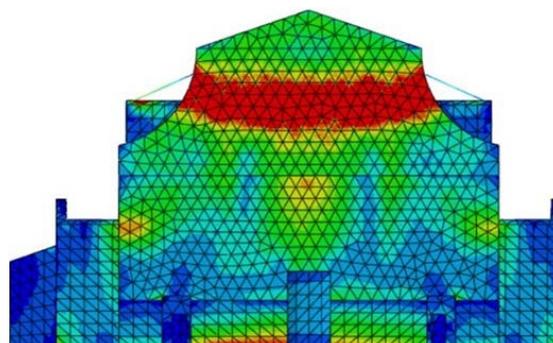
The aim of a *response spectrum analysis* was to find the general distribution of stresses and the most solicited elements, until damage would become significant. Once more, the façade top appeared to concentrate the highest stress levels clearly showing out-of-plane bending, as in fig. 11. Vaults and arches, especially those close to the façade, also appeared in critical conditions.

In order to clarify the behavior of the façade, a *limit equilibrium analysis* modeling the overturning of the gable was performed with non-linear kinematic approach. The acceleration activating the mechanism resulted lower than the peak ground acceleration and the spectral acceleration occurred during the earthquake, once more indicating failure of this element.

Figure 11: tensile stress distributions, where blue is null and red the maximum value

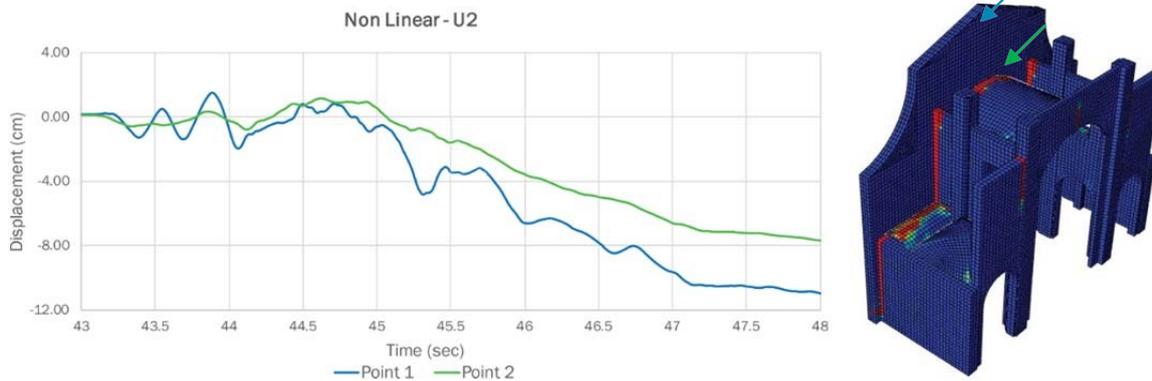
Figure 13: development of displacements at the vertex (blue, dark line) and at the connection of façade and vault (green, light line), see arrows, and model in damaged conditions along the red line

Results may be summarized making reference to fig. 13. An initial oscillation occurs at the top, until the connection of the façade with the back part deteriorates; at this time, the entire façade is weakly restrained and a trend toward a full façade rotation sets in.

Meanwhile, larger displacements occur at the vault, now separated from the façade, bringing to its collapse. A switch from an initial gable mechanism to a façade overtopping one has avoided further development of the first; damage in the second has also developed partially. The situation could not be described without a time history analysis, but the reference to codified damage mechanisms has helped in pointing out this particular situation.
