# USING THE ULTRASONIC TOMOGRAPHY METHOD TO STUDY THE CONDITION OF WOODEN BEAMS FROM HISTORICAL BUILDINGS

M. ZIELIŃSKA<sup>1\*</sup>, M. RUCKA<sup>2</sup>

**Keywords:** Historical Structure, Wood, Monitoring, Non-Destructive Inspection

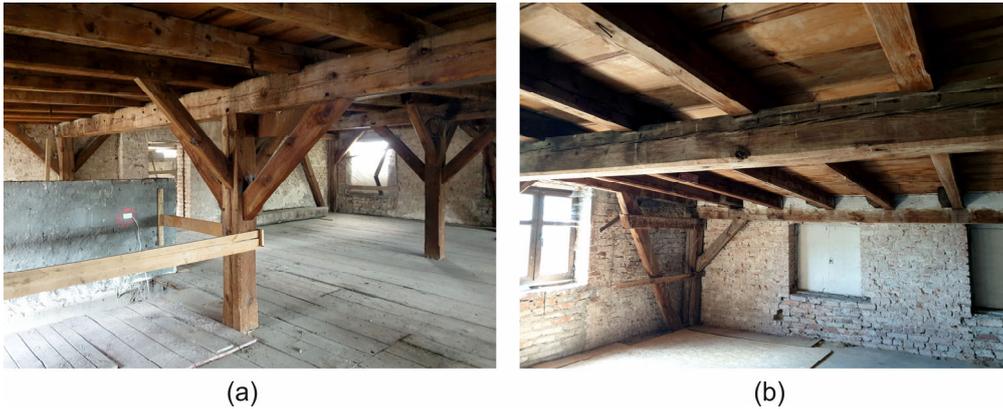
The tests were conducted on wooden beams taken from the historical Monastery of Congregation of the Sisters of St. Catherine located in Orneta, in the northern part of Poland (Figure 2). The beams were the elements of a roof framework, which due to its poor technical condition underwent the restoration works.

**Figure 2:** Photographs of the roof framework from the Monastery of Congregation of the Sisters of St. Catherine in Orneta (Poland).

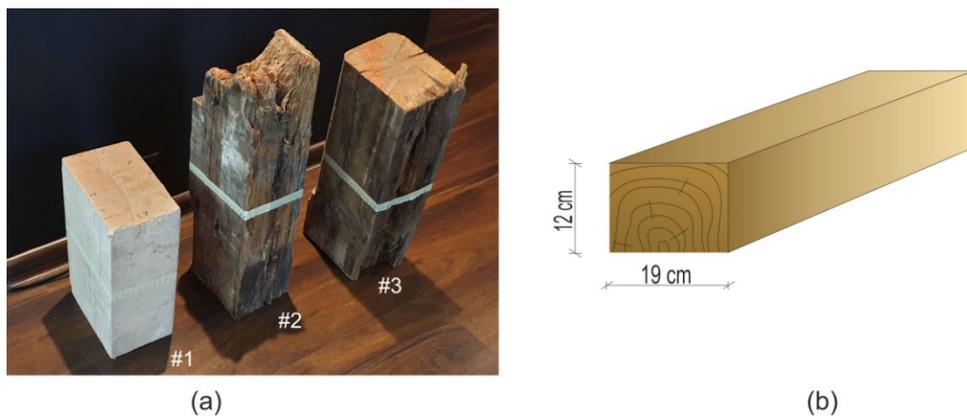
The ultrasonic tomography was conducted on three beams (Figure 3a). The beam cross-section had the dimensions equal to 19 cm x 12 cm (Figure 3b). For the purpose of the study, the beams of significant (#3) and partial destruction (#2) were implemented. Both beams were waste materials from a roof framework (they were replaced due to their bad technical condition by the new wooden beams). The measurements were also taken for a new beam (#1) in order to compare the results. This material replaced the deteriorated wood or wood damaged by the insects.

**Figure 3:** Laboratory models of wooden beams.

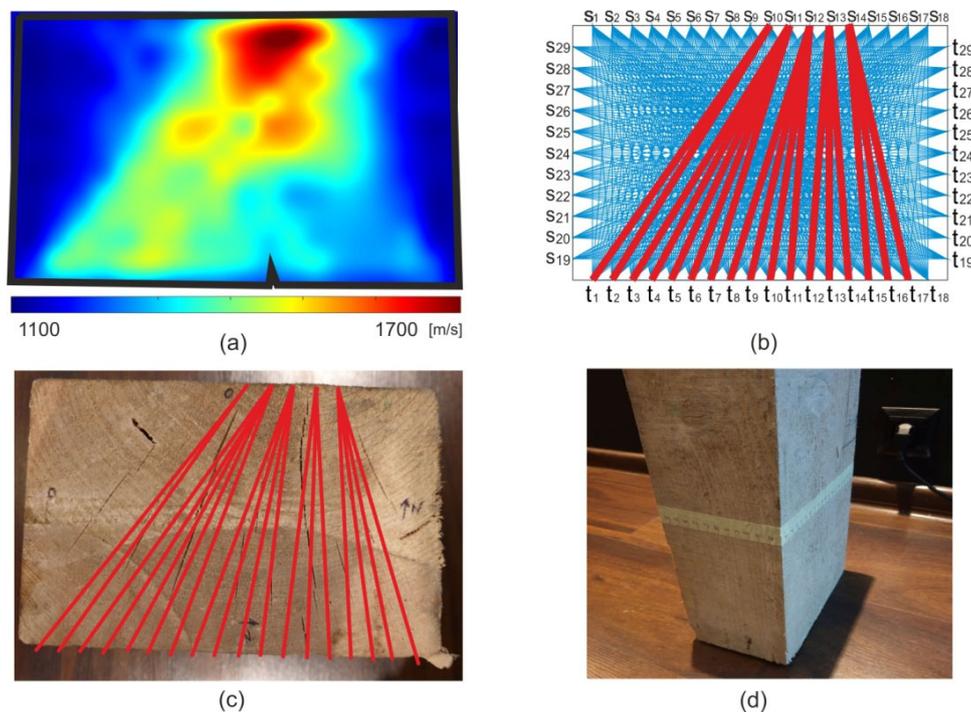
The first laboratory model (#1) was a new beam. This material was used to replace the wood damaged by insects. The edges were straight and the beam did not have any significant damages or cracks. The internal structure was recreated based on the collected transfer time signals (Figure 6a). A significantly higher velocity was observed in the upper part of the map. This place indicates the location of the cross section's core. The signals collected from the transmitters  $t_1 - t_{18}$  showed major differences between the waveforms' velocities. They ranged from 650 to 1550 m/s. For each of the transmitters  $t_1 - t_{18}$  a waveform with the highest wave propagation velocity was chosen. The waveforms were marked in red in Figure 6b. It was observed that the intersection of the waveforms indicates the exact location of the wooden element's core. (Figure 6c). The wave propagation velocities from the transmitters  $t_{19} - t_{29}$  did not indicate equally high differences between each other (900 – 1150 m/s).

**Figure 6:** Results obtained for beam #1: (a) ultrasound tomography image, (b) ray paths with the fastest paths marked for  $t_1-t_{18}$  transmitters, (c) top view of the beam, (d) side view of the beam.

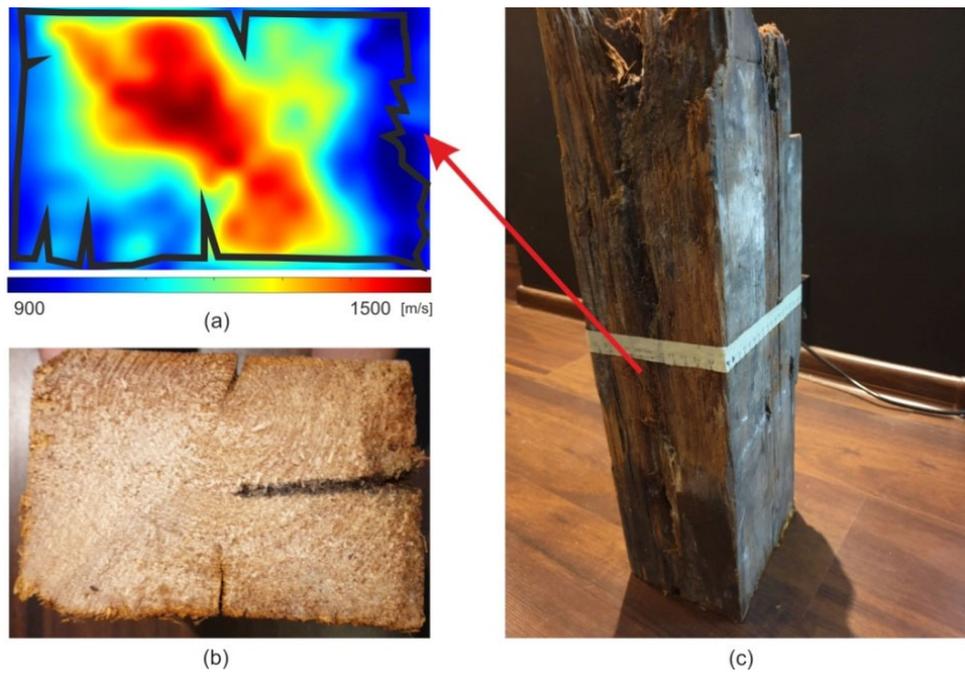
Beam #2 was taken from the historical roof framework. One of its sides included a major wood fibrosis (Figure 7c). The remaining three contained cracks. The ultrasonic tomography image clearly shows the places where the beam is damaged (Figure 7a). The edge with the wood fibrosis showed the reduced wave transfer velocity. A similar effect was observed in places where the cracks were located. Furthermore, an increased velocity may be spotted at the location of the cross-sections core, similarly to the reference beam (#1).

**Figure 7:** Results obtained for beam #2: (a) ultrasound tomography image, (b) top view of the beam, (c) side view of the beam.

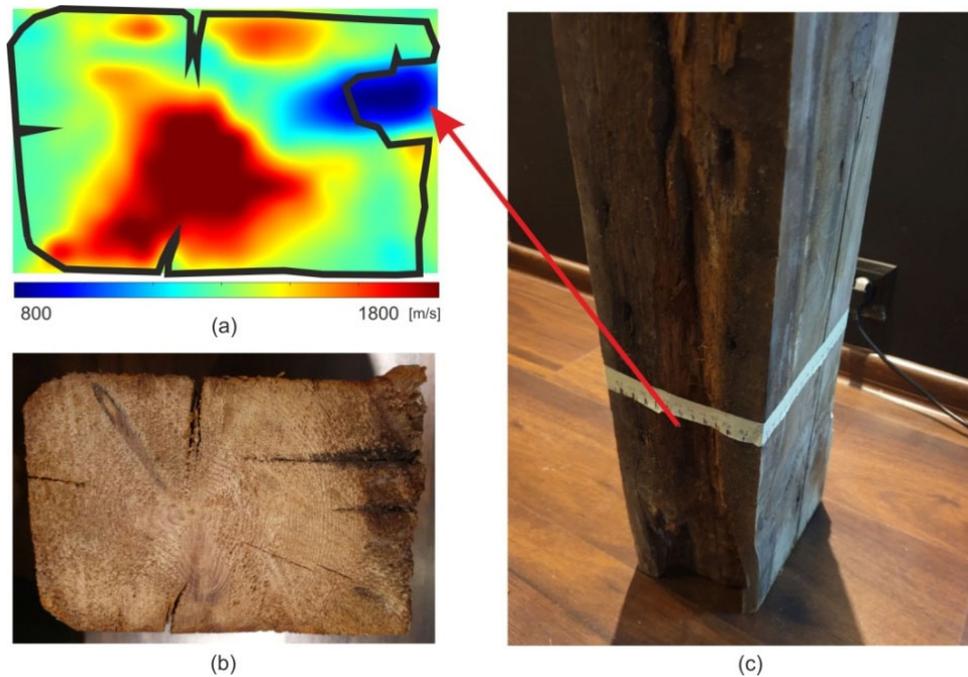
**Figure 8:** Results obtained for beam #3: (a) ultrasound tomography image, (b) top view of the beam, (c) side view of the beam.

The beam #3 had the highest level of degradation. One of the sides included a significant cavity caused by insects (Figure 8c). This place is marked in blue on the ultrasonic tomography map (Figure 8a). The remaining sides included cracks. The biggest crack was marked on the tomographic image. Similarly to beam #1 and #2 the greatest concentration of the wave propagation velocity determined the location of the wood cross section's core.
