FROM THE CURE OF THE SIMPLE STRUCTURAL ANALYSIS TO THE CONTROL OF THE FINAL TECHNOLOGICAL QUALITY – THE CONSERVATION OF “SANTA MARIA DEGLI ANGELI” ORPHANAGE IN CASTELGRANDE (POTENZA, ITALY)

FRANCESCO P.R. MARINO^{1*}, GIANLUCA AULETTA¹, FABRIZIO
BALDANTONI¹, FELICE C. PONZO¹ AND FILIBERTO LEMBO¹

¹ Università della Basilicata - School of Engineering (SI-Unibas)
Campus Macchia Romana, 85100 Potenza, Italy
e-mail: francesco.marino@unibas.it*, gianluca.auletta@tiscali.it, fbba6@hotmail.it
felice.ponzo@unibas.it, filiberto.lembo@unibas.it (*corresponding author)

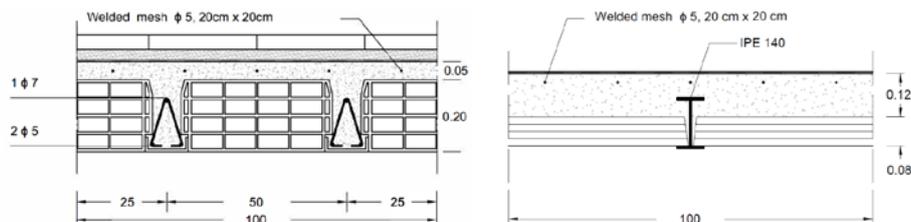
Figures 4 and 5: Details of the “Bausta type” floor (left) and of the new pitched roof that replaced the original wooden roof (right), realised in the consolidation intervention

On closer inspection, there are blatant design errors: the floor in Fig. 4 shows an insufficient concrete cover to ensure its durability, even if it divides internal environments [9]; and that of Fig. 5, in the presence of IPE profiles without any protection, is destined to corrode quickly by differential aeration [9]. The same mistake was repeated for the roofing of the Church, where the heavy roof was built, when light wooden trusses could have been chosen. It is therefore appropriate to remove these heavy floors, leaving only the perimeter curbs in place, which would otherwise be problematic to remove without destroying the upper cornices of the buildings, subject to a specific protection rule. Light reticular wooden trusses can be placed in their place. In this regard, the Authors have devised and developed [16][17][18] a particular thermo-hygrometric conditioning method for a species of hardwood widespread in Basilicata, the *Quercus cerris* (*Turkish Oak*), which allows the production of laminated wood beams with exceptional static performances [17] (Fig. 8). In this regard, even if the latest Standard UNI EN 14080:2013 only reports strength classes from GL 20h to GL 32h, remark that the reference to the resistance class GL 36h "refers to laminated wood obtained from specific hardwood species based on some provisions of the current European standard" and following the results of the tests carried out on the *Quercus Cerris* laminated wood specimens typed as a number and size of the lamellas and glue used [16].

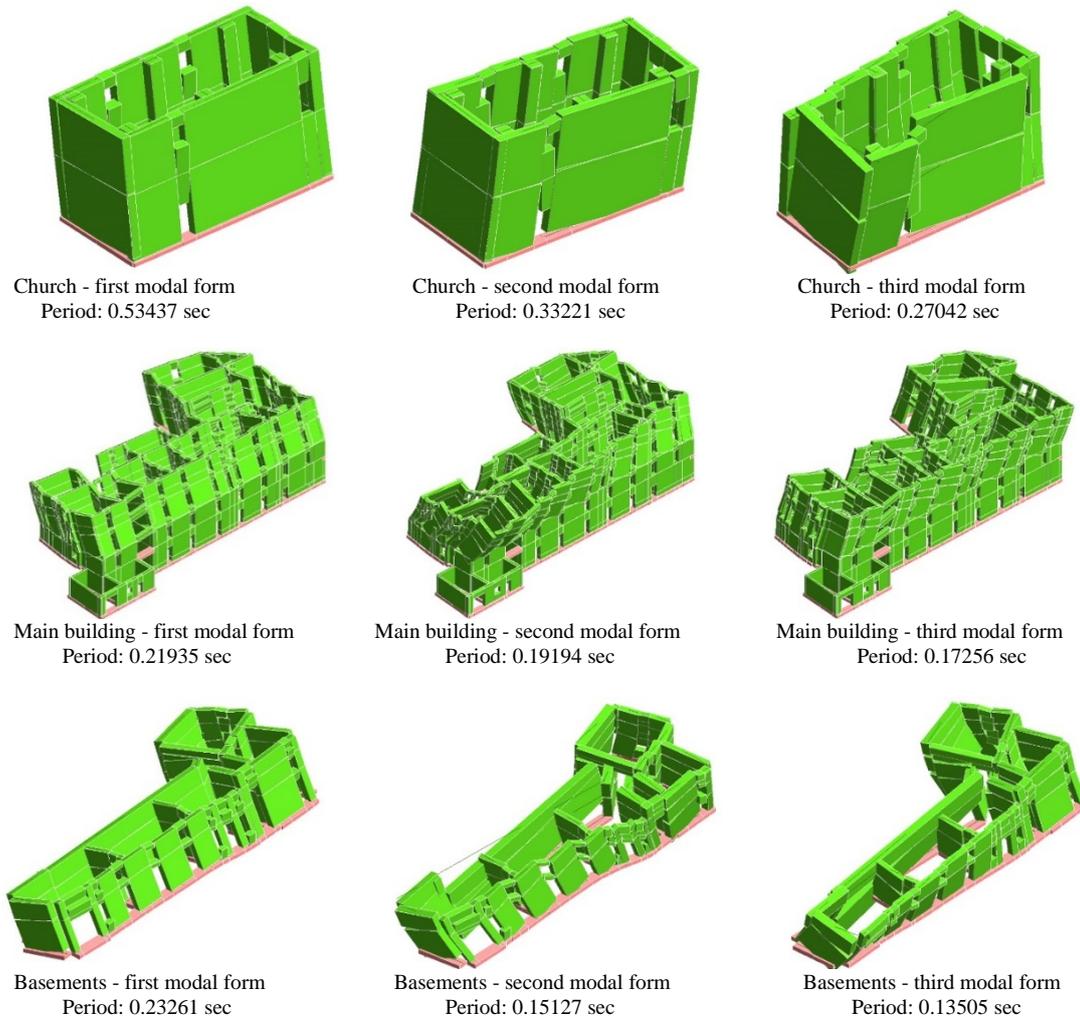
Figure 6: Modal form and periods of Church, main building and basements

inclination between 15 and 30 degrees). The PGA acceleration corresponding to the SLV (life safeguard limit) is equal to 0.31g, considering a nominal life of 50 years and a class of use III. The seismic vulnerability indexes are respectively 0.51 for the church, 0.55 for the main body and 0.52 for the basement: all slightly greater than 0.5, a value which in any case can be considered acceptable for the type of destination of the structure. Therefore, the interventions carried out have raised the safety level of the entire building complex. Finally, as regards the analysis of the local mechanisms of collapse out of the plane, conducted using the limit analysis method, there were no significant critical issues, as the structures have both covering curbs and metal anchoring bars in the hammer's walls and chains in the arches of the Church.

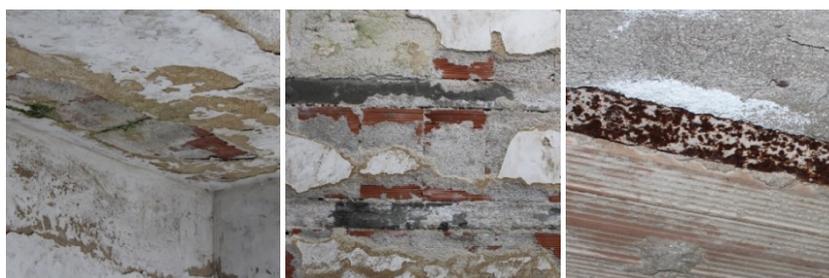
Through the analysis, it became clear that the intervention carried out well could have been softer, more rational, and even cheaper, if he had renounced to place the two heavy floors on the top of the main building, the one above the third level and the other the sloping roof slab: they increase significantly, and in the least suitable position, the masses that undergo seismic acceleration. In relation to the conditions of severe exposure to atmospheric agents in which these elements have been found in these thirty years (with the penetration of rainwater through the badly placed bituminous membrane) (Fig. 7) both are severely corroded.

Figure 7: Accelerated degradation of structures due to the design errors illustrated in the text

The relative pitched floor is provided in the same wood, insulated and ventilated and covered with double-roof tiles as well as the original one (see below, Fig. 10). Other interventions are necessary to drain the surface waters at the boundary and under the buildings and limit the phenomena of capillary rise, favoring the evaporation of the water contained in the ground through cavities and floors permeable to steam (see below, Fig. 11).
