COLLAPSE OF THE ARECIBO OBSERVATORY IN PUERTO RICO: REFLECTIONS FROM A STRUCTURAL ENGINEERING PERSPECTIVE¹

Juan C. Morales² and Luis E. Suárez³

Keywords: Arecibo Observatory, collapse, fatigue, corrosion, socket

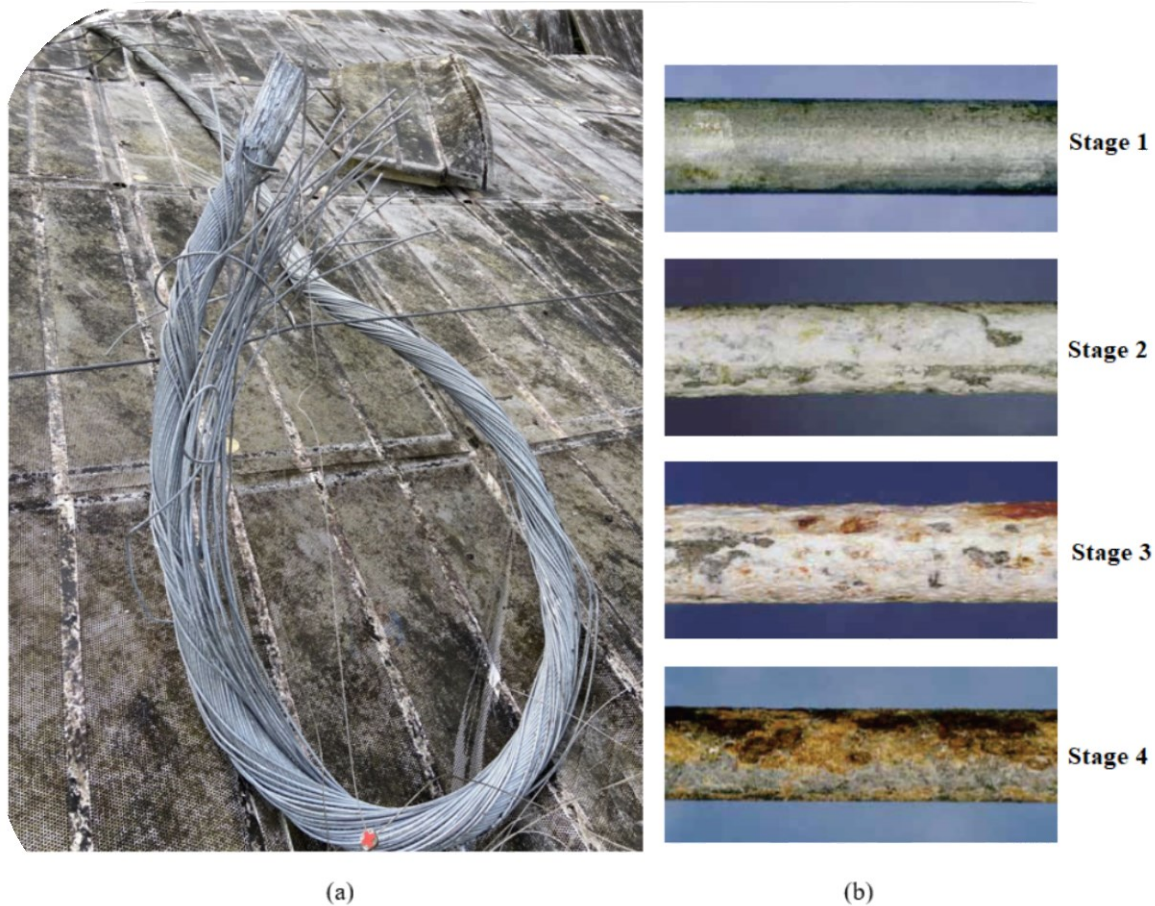
Figure 2(a) shows a photograph of the 3.25-inch diameter cable as it lay on the dish after the failure. It shows that the cable was fabricated by wrapping a large number of small-diameter galvanized wires in a single strand to the

desired cable diameter. The wires appear in very good condition in terms of corrosion. There are some regions of whitish corrosion products of the protective zinc coat that seem to classify between Stages 1 and 2 of the Hopwood and Havens classification system for corrosion of galvanized wire, shown in Figure 2(b). There are no brownish discoloration zones that would indicate corrosion of the steel inside the zinc coat. These would have classified as Stage 3 or 4 of corrosion of the wires, but none are detected from the photograph.

Figure 2(a) also shows the cylindrical-shaped end of the cable near the top of the photograph. The length of the cylindrical end is approximately three times the cable diameter. It seems mostly intact and free of corrosion. The wires on the end appear to have been unwound and separated during the brooming process (addressed in the next section). Based on its cylindrical shape, the cable clearly appears to have failed by slipping out of its socket anchorage, as reported. However, there are also several unattached wires surrounding the broomed end which will be addressed later.

Figure 2: (a) Photograph of the auxiliary cable after failure. Taken from Wall (2020). (b) Photographs of the four stages of galvanized wire corrosion based on the Hopwood and Havens classification system. Taken from Chavel and Leshko (2012).

Judging from Figure 2(a), the end of the cable that went into the socket appears to be only 3.0 times the cable diameter, i.e., it appears to be shorter than the basket size of the socket.

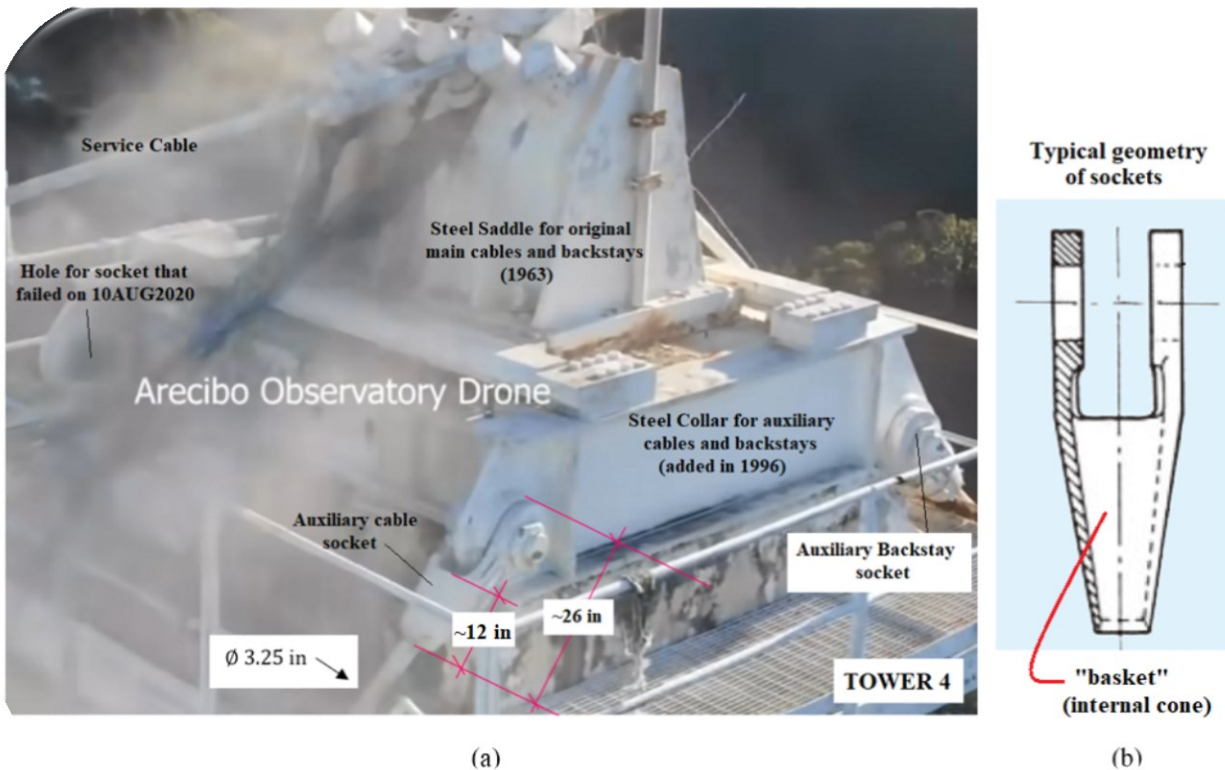
Figure 3(a) shows a photograph of the top of tower 4 at the instant that the remaining three main cables failed. It shows the socket of the remaining auxiliary cable below the word “Drone” and includes approximate dimensions that were scaled off using the 3.25-inch diameter cable as the basis. It was presumably identical to the socket involved in the failure; whose anchor hole is seen on the left of the photo. The failed socket had been removed and lowered for forensic analysis. The auxiliary cable entered the socket at the lower-left end, the load was transferred to the socket

in the ~12 in conical section, and the clevis joint transferred the load to the collar. Slippage occurred from the ~12-inch conical section of the socket. Figure 3(b) shows that typical sockets are also conical on the inside and this internal conical volume is called the “basket” of the socket.

The federal specification RR-S-550 Rev. D (1980) specifies a basket whose length is 3.7 times the cable diameter, for the case of the largest diameter cable that they specify (2.625 inch). The updated specification (RR-S-550 Rev. F, 2018) still specifies the same ratio of basket length to cable diameter. If the 3.7 ratio was maintained for the 3.25-inch diameter auxiliary cable, then the basket length would be calculated at 12 inches which agrees with the scaled-off dimension shown in Figure 3(a).

Figure 3: (a) Photograph of the top of tower 4 during final collapse. Taken from the NSF video (2020a). It shows the location of the sockets and their approximate dimensions (scaled off). (b) Typical geometry of a socket that shows its internal conical shaped basket. Taken from Tokyo (2020).

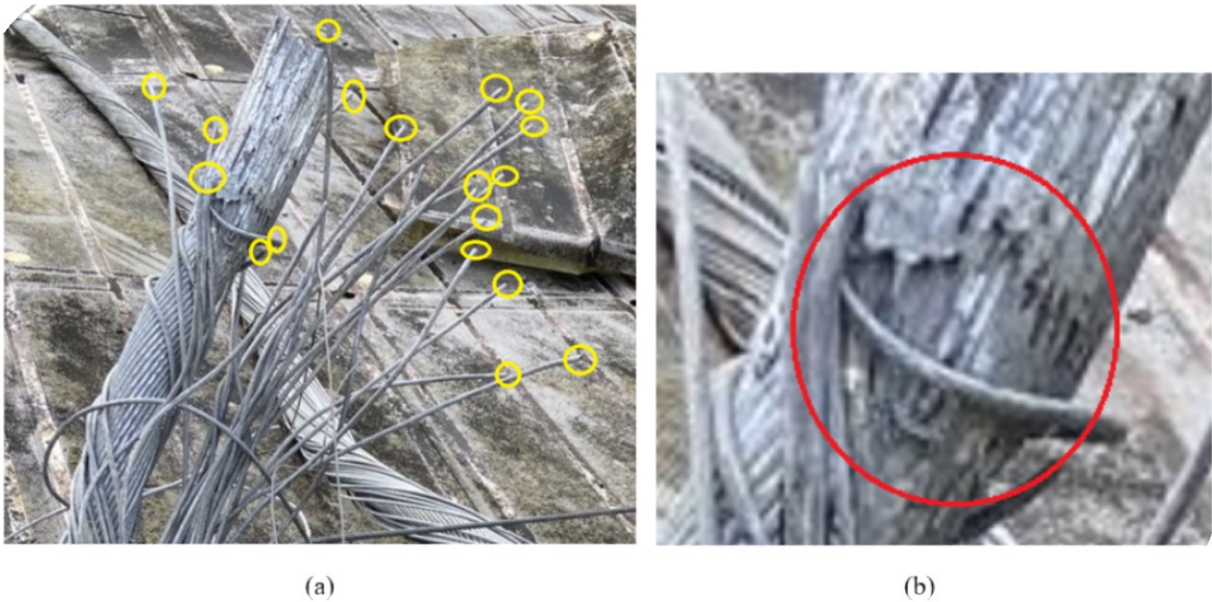
Figure 5(a) zooms in on the broomed end shown in Figure 2(a) and shows approximately 20 detached wires surrounding the broomed end (circled in yellow). Metcalf and Matanzo (1980) observed that 100% of the wire fatigue failures were located either inside or at the base of the socket. These detached wires would therefore be at the predicted location for fatigue failures. If fatigue were the cause, the wire breaks would have taken place before the failure on August 10, 2020 and would have been identifiable. It is unknown to the authors if wire breaks were present before failure. Thornton Tomasetti (2020) mentions “a few documented wire breaks on the original cables over the years”.

Another possible mechanism for these detached wires is that they became unbonded or that they broke off due to the impact of the fall from the tower (~500 ft). A forensic inspection of the fracture zones of the cables (the tips) with a Scanning Electron Microscope (SEM) would most probably be able to detect fatigue signatures such as crack initiation sites and “beach marks”.

Another interesting area to conduct a forensic inspection with a SEM is the circled zone in Figure 5(b) which zooms in at the bottom of the broomed end. Wire breaks appear to have occurred in this zone, either by fatigue, or by the impact of the fall.

Nevertheless, if fatigue had been the primary failure mechanism, then the cable should have failed, not by slipping from the socket, but by rupturing near the base of the socket. The fact that the broomed end seems almost intact (Figure 5(a)), points at slippage from the socket as the cause of failure, even if all of the 20 wires circled in yellow had failed by fatigue. Also, Metcalf and Matanzo (1980) observed that pull-out failures occurred only in cases of static loading. Therefore, it appears that the slip mechanism is mostly associated to the capacity of the socket assembly for static load resistance rather than a fatigue-cycling condition.

Figure 5. (a) Detail of the broomed end showing detached tables (yellow circles) that could have failed either by fatigue or by detachment/breakage due to the impact of the ~500 ft fall. (b) Detail of the bottom of the broomed end showing a potential zone where cables broke off (red circle). Taken from Wall (2020).

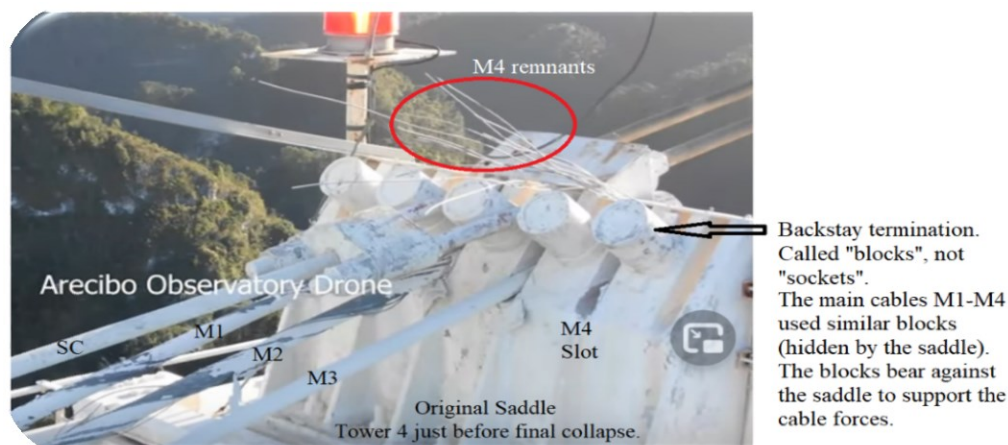
The second cable failed 88 days after the failure of the first cable. Following this second failure, the press release of the Arecibo Observatory (NAIC, 2020e) reported the following: “A main cable that supports the Arecibo Observatory broke Friday (November 6) at 7:39 p.m. Puerto Rico time. Unlike the auxiliary cable that failed at the same facility on August 10, this main cable did not slip out of its socket. It broke and fell onto the reflector dish below, causing additional damage to the dish and other nearby cables. Both cables were connected to the same support tower (tower 4)”. The cable is identified as M4 in Figure 1(b) and Figure 9.

Figure 9 shows a photograph of the original saddle of tower 4 just prior to the final collapse. The wires within a red oval are the remnants of the second cable that failed (identified as M4 in Figure 9). This was confirmed by NSF (2020b). The remnants of the cable establish that the cable ruptured, instead of slipping out from its termination. The fact that the rupture occurred near its anchorage point is consistent with the findings of Metcalf and Matanzo (1980) that 100% of the fatigue failures occur near or inside the termination. The cable ends are the most vulnerable because they are the weakened the most during fatigue loading caused by the oscillations (vibration) of the cable. Figure 1(b) shows the tuned mass dampers that were used in the main cables to mitigate the vibration effects.

Figure 9: Photo of main saddle on Tower 4 just prior to the final collapse. The cable identifiers are consistent with Figure 1(b). Taken from NSF (2020a).

The loss of paint on cables M1 and M2 offers a glimpse of the cables to evaluate their corrosion state. Figure 9 shows that the cables had a grayish color which is consistent with no corrosion issues, perhaps in the Stage 1 of corrosion based on Figure 2(b). In addition, the saddle and the blocks that terminate the backstays also appear free of corrosion.

The drone video (NSF, 2020a) shows that the sequence of cable failures took place in approximately 1 second. Cable M2 was the first to break, followed by M1, and finally M3. The order of failure is consistent with observations of Figure 9, based on the amount of paint removed from the cable by wire breakage prior to the collapse, i.e., M2 had the most paint removed (the most wire breaks) while M3 had no paint removed (no wire breaks). Once M2 failed, the level of overload, plus the dynamic effects of the sudden failure of M2, were simply too great to be supported by the remaining cables. The collapse had been predicted by Thornton Tomasetti (2020), as cited previously. The service cable SC broke approximately 6 seconds after M3 as a result of the cables of Tower 12 impacting the catwalk bridge during the pendulum swing of the platform, thus overloading the service cables that supported it.

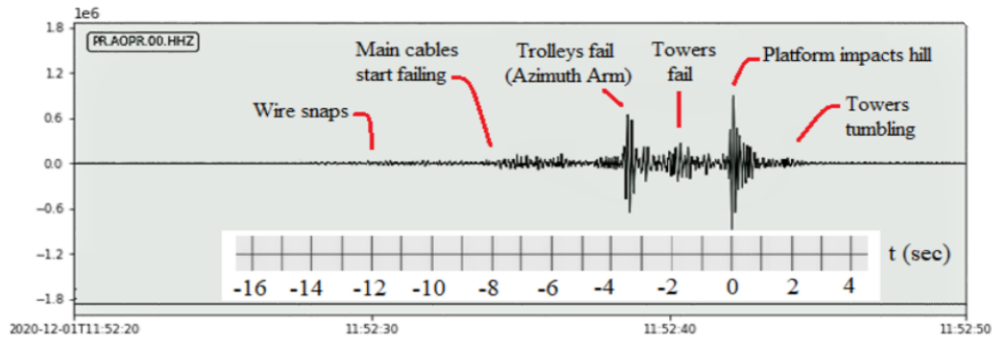
Figure 12 shows an accelerogram (z-axis, vertical) during the final collapse. The accelerometer is located at the site of the observatory near tower 12. It was installed and operated by the Puerto Rico Seismic Network (PRSN) of the University of Puerto Rico at Mayagüez (UPRM) and had been operational for approximately 10 years. The signal was retrieved and processed by Dr. Elizabeth Vanacore, seismologist of the PRSN and associate professor at the Department of Geology of UPRM.

A time scale was included as an inset to compare times versus the video footage (NSF, 2020a). The table that is presented below the accelerogram synchronizes times with the control room footage, the drone footage, and the time scale in the accelerogram. Both footages are available in NSF (2020a). The footage times are precise to the nearest second and there are some apparent discrepancies with the accelerogram time scale (1 second discrepancies) which are highlighted in red in the last column. The origin of the time scale ($t = 0$ s) was placed at the highest acceleration peak which, after synchronizing the events, most likely represents the instant at which the platform impacted the hill. This seems reasonable because the platform was massive (about 700 tons after shedding the dome and the Azimuth arm) and moving at a speed close to 80 mi/hr., as calculated in the previous section. Notes were placed within the accelerogram to indicate the most likely events, based on the table. The impact of the Azimuth arm and the dome are not noted because this instant was not captured by the cameras. However, it is estimated that they impacted the dish at just about the same time that the towers failed ($t = -2$ sec).

Figure 12: Accelerogram obtained during the collapse event. Provided by Elizabeth Vanacore of PRSN. The Control Room and Drone footage times were taken from the NSF video (NSF, 2020a).
