# Investigation of Pipelines Integrity Associated with Pump Modules Vibration for Pumping Station 9 of Alyeska Pipeline Service Company

October 2009

Prepared by  
John Jy-An Wang,  
Oak Ridge National Laboratory

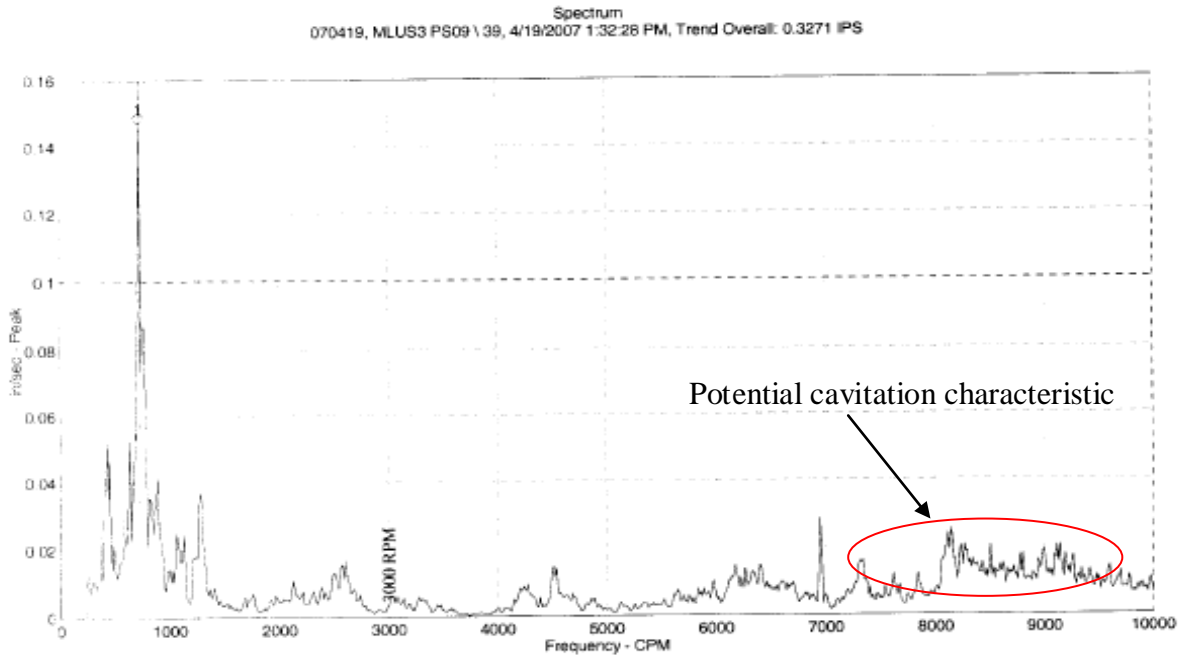
**Figure 1 Velocity spectrum from Module 2 data**

Nevertheless, the intensity of turbulent flow induced cavitation phenomena in a piping system will be increased when the horizontal piping is changed to vertical orientation, such as in the discharge and suction lines sections within the pump modules. The consequence of the increased cavitation event is the increasing vibration and the potential of cavitation damage in the piping system. One effective way to catch the cavitation phenomena is through vibration measurement or ultrasonic detections. For example, the cavitation normally can be revealed through the wide-band spectrum in the high frequency range, as indicated in the following velocity spectrum from APSC’s vibration velocity data, in Module 2, at discharge line clamp guide location, Figure 1.

If the initial mitigation measure is proved to be insufficient to control the vibration phenomena and the further investigation is warranted, more data, using more advanced techniques and other technologies maybe required for full analyses. Some suggestions are:

- a) Use ultrasonic technology to identify turbulent fluid flow
- b) Measure and evaluate the vibration energy input from turbulent fluid flow
- c) Collect phase data using a two channel vibration data collector for use of determining torsional vibration and looking for relative motion component by component
- d) Collect natural frequency vibration data using a two channel vibration data collector on piping and structural members for analysis and for confirmation of analytically derived data

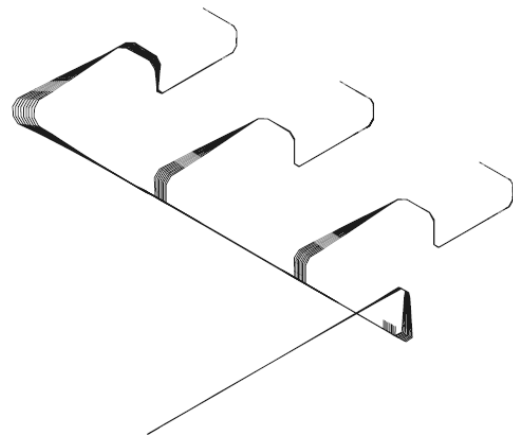
**Figure 3 Dynamic response spectra**

Based on dynamics analysis results of the suction piping system, for a frequency of 2.35 Hz, the maximum deformation appears to be at the elbow section of the piping system, as illustrated in Fig. 3. If incorporating fluid dynamic contribution, it is very likely that the elbow section will be mostly under mix-mode loading, flexural tensile and torsional shear stresses. Based on our experience for ductile metals, at a critical phase angle, the mixed-mode associated fracture toughness will reduce to the half of mode-I (tensile opening mode) only fracture toughness. This could mean that the effective

lifetime of piping system due to fatigue under mixed-mode loading could reduce to the half of the effective lifetime compared to the tensile load only case. Thus, the mixed-mode failure mechanism deserves special attention.

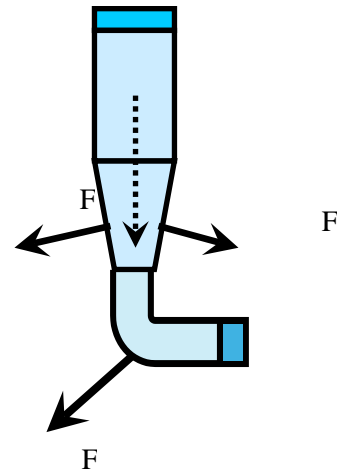
**Figure 5 Fluid dynamic forces.**

A schematic diagram of reducer and/or elbow induced fluid dynamic forces is shown in Fig. 5. Proper anchor design is required to secure the piping system, the reaction transmitted to the pump module in term become the potential vibration source. Furthermore, the turbulent flow and the associated cavitation event is also a potential vibration source. The current suction and discharge piping set-up in the pump module seems to have potential for producing turbulent flow. This is because that at the section where fluid travels within a piping in a horizontal orientation was changed into a vertical orientation piping. The cavitation is the consequence of the induced turbulent flow in such system. The turbulent (vortex) flow and the associated cavitation could be an important vibration source and it may warrant further detailed investigation for verification.

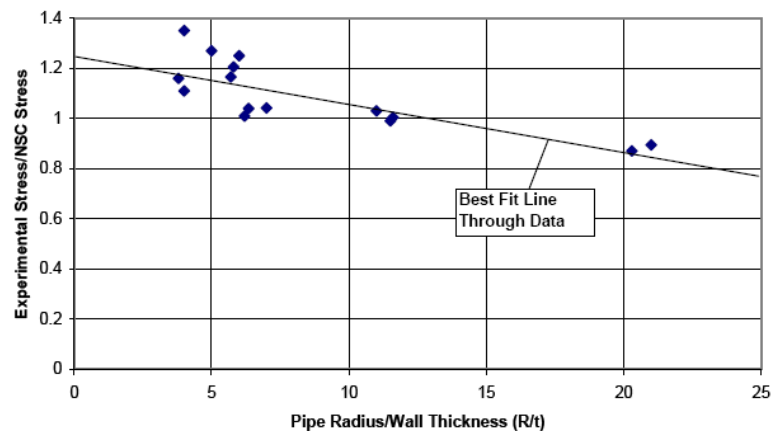
Figure 2.6 Plot of the ratio of the experimental stress to the predicted NSC stress as a function of pipe  $R/t$  ratio for pipes expected to fail under limit-load conditions

load stress, i.e., NSC stress (obtained from the existing database and which do not have sufficient data to cover the high  $R/t$  spectrum). It has been hypothesized that this reduction in load-carrying capacity stems from the pipe cross section ovalizing for the thinner, higher  $R/t$  ratio pipes. For the PS09 of Alyska Pipelines, which has wall thickness around 0.5 inch for 14-in, 20-in, 24-in and 36-in pipe, and the corresponding  $R/t$  ratio are ranged from 28, 40, 48, to 72. Based on Fig. 2.6, for a 14-in pipe with  $R/t=28$ , the load-carrying capacity will drop significantly, ~ 70% of that predicted by NSC predicted stress level.

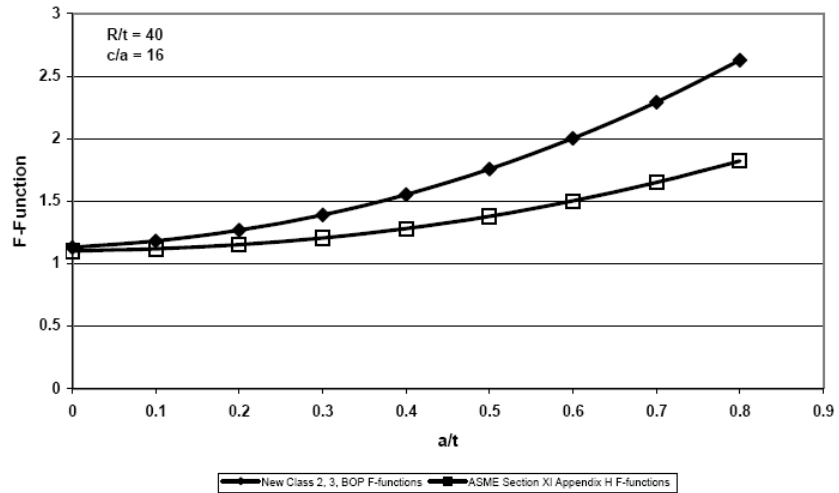
Figure 2.7 Comparison of new Class 2, 3, and BOP F-functions and F-functions in ASME Section XI Appendix H for a crack aspect ratio (c/a) of 16 and a pipe with an R/t ratio of 40 for internal circumferential cracks subject to pure bending.

Furthermore, from Figure 2.7 of the same NRC report, which shows a comparison between the existing ASME Section XI Appendix H F-functions (geometry factor function of the stress intensity factor,  $K$ ) and the newly developed F-functions as a function of crack depth for the case of an internal crack loaded in bending for a normalized crack length ( $c/a$ ) of 16 and for a pipe with an  $R/t$  ratio of 40. As seen from this example, for a flaw depth that is less than workmanship standards ( $a/t < \sim 0.1$ ), the difference in the F-function is near zero, however, as the crack depth ( $a/t$ ) increases (or crack growth), the difference becomes much more substantial. For a very deep crack (75 percent through the thickness), the difference is nearly 45 percent. This means accelerated aging (or reducing the effective lifetime) for high  $R/t$  ratio piping regarding fatigue crack growth during service. Consequently using the existing F-functions in Section XI to predict the behavior of flaws in Class 2, 3, or BOP piping with much higher  $R/t$  ratios would result in a

significant underprediction of the crack-driving force, resulting in a nonconservative in-service flaw-evaluation assessment, at least for this set of conditions.

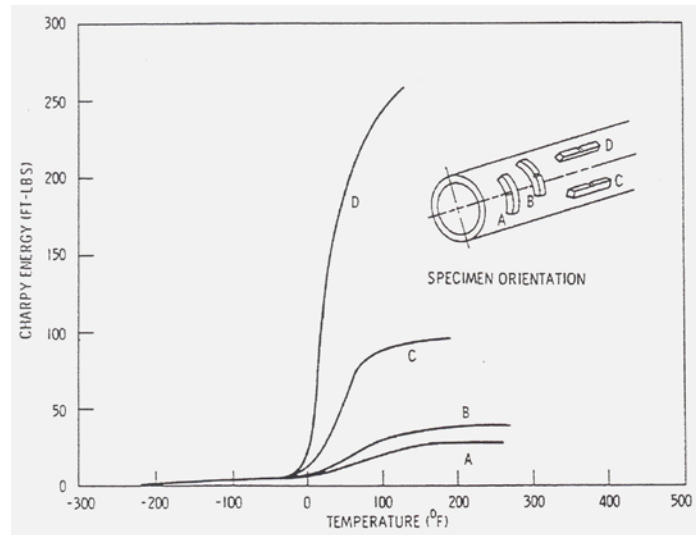
Figure 6 Toughness anisotropy of ASTM A106 Grade B pipe

Regarding the impact of piping material property variability to the piping effective lifetime, I would like to use the toughness anisotropy of A106 Grade-B carbon steel pipe to illustrate its impact. The Fig. 6 shows some data for A106 Grade B pipe material in which the toughness, measured in terms of Charpy impact energy, in the L-R direction (Curve D from Specimen D) is significantly higher than the toughness in the L-C direction (Curve C from Specimen C). As for circumferential oriented specimens, Curve A and Curve B show much less Charpy impact toughness than that of the axial oriented specimens. All these samples are machined from the same pipe. Thus, the nature of crack growth (physical location and crack growth orientation) within a piping system has a significant impact on the piping's effective lifetime. Thus, the hoop stress and axial tensile stress both are important information for pipe fatigue lifetime estimates. In general, from a hydrostatic pressure point, for a thin-wall piping ( $R/t > \sim 10$ ) the hoop stress level is about twice that of the axial tensile stress level.
