SEISMIC DAMAGE MECHANISMS FOR CHURCHES AND DAMAGE SEQUENCE: CONSIDERATIONS FROM A CASE STUDY

4.1 The church of San Bartolomeo at Quistello

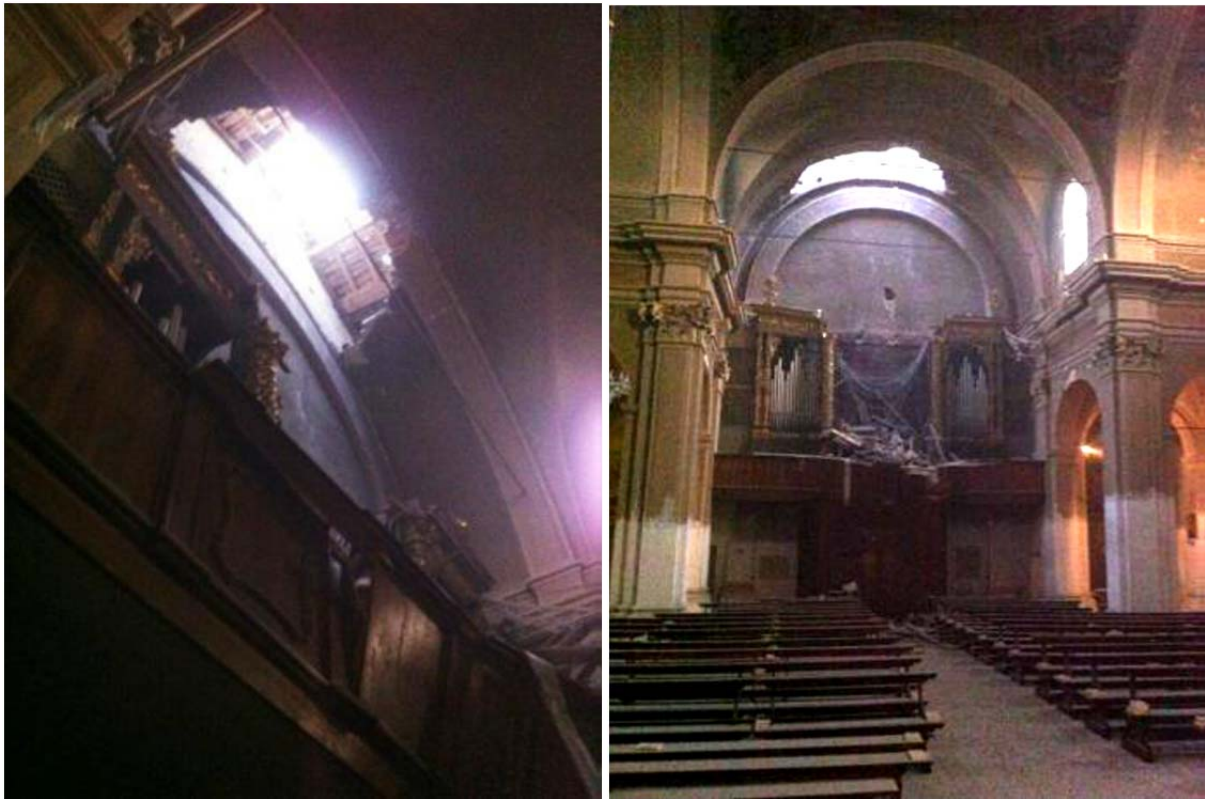
During the earthquakes of 2012, the many seismic shocks that occurred from the 20th and particularly on 29th of May heavily damaged the church that reported collapses of the vaults and wide cracks on many bearing walls of the central nave, as well as the collapse of the roof behind the façade. The event of the 20th of May caused out of plane, overturning cracks on the façade in the proximity of the gable and the overturning toward the interior of the marble element supporting the cross, at the top of the façade, that collapsed into the roof. The fall of such non-structural element caused damage to the roof behind the façade and to the counter-façade vault underneath. This kind of damage was observed in other churches in the area.

The second important shock of the 29th of May, at 9:00 a.m., deteriorated further the situation. Many of the vaults collapsed, causing additional damage to decorations and other art elements below. The damaged vault behind the façade fell, entailing the collapse of the organ, see fig. 5.

Figure 5: Collapse of the vault behind the façade

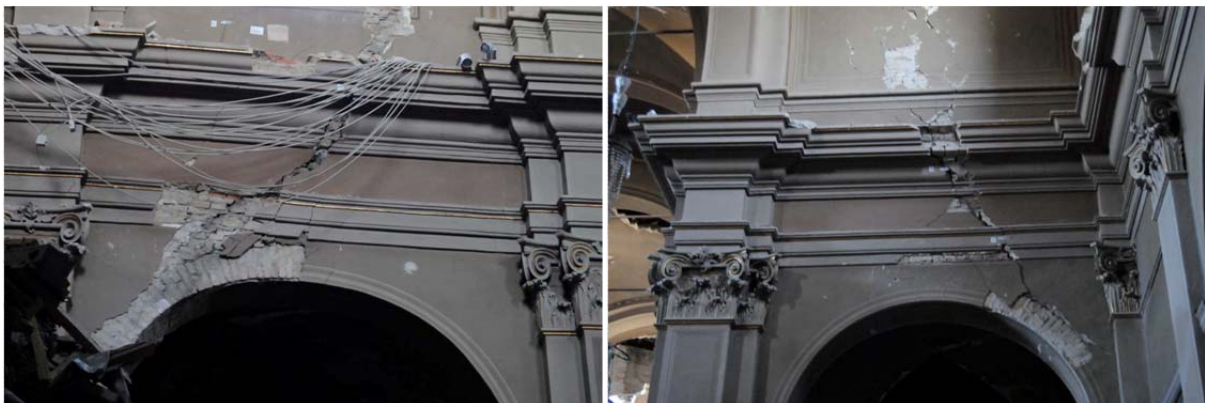
Other elements and parts of the church were also severely damaged. Important cracks opened in the entablature above the arches along the central nave as well as in those between the chapels. In many cases they reached the vaults above, as in fig. 6. The apse developed numerous inclined cracks, which are frequently found in such element: a situation that has been listed in the abacus of typical mechanisms.

Figure 6: Cracks in the arches along the nave and transversal to it.

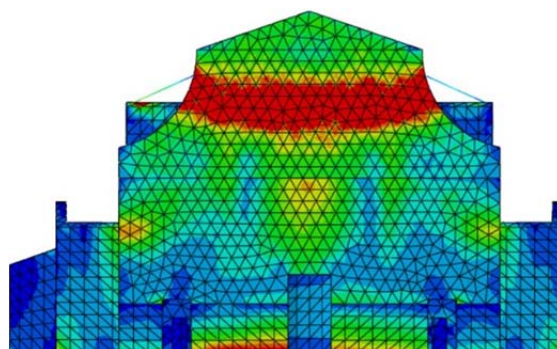
The aim of a *response spectrum analysis* was to find the general distribution of stresses and the most solicited elements, until damage would become significant. Once more, the façade top appeared to concentrate the highest stress levels clearly showing out-of-plane bending, as in fig. 11. Vaults and arches, especially those close to the façade, also appeared in critical conditions.

Figure 11: tensile stress distributions, where blue is null and red the maximum value

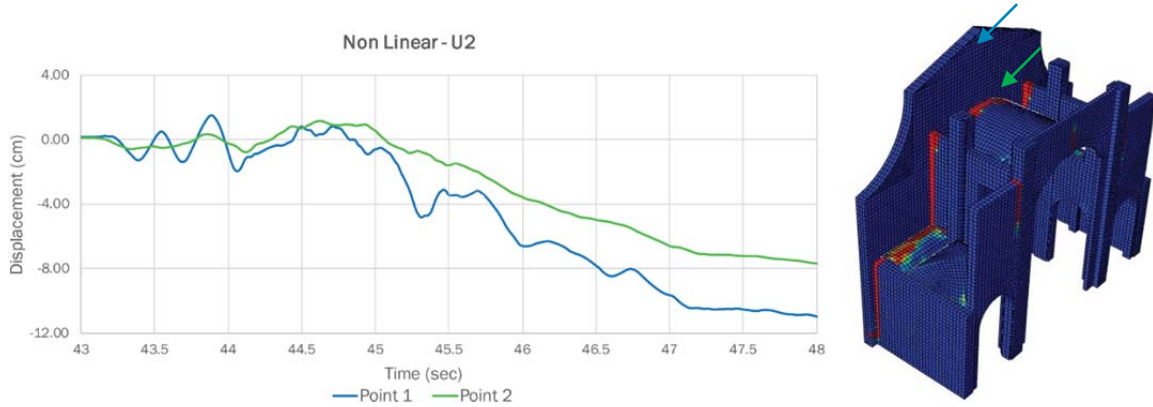
Figure 13: development of displacements at the vertex (blue, dark line) and at the connection of façade and vault (green, light line), see arrows, and model in damaged conditions along the red line

Results may be summarized making reference to fig. 13. An initial oscillation occurs at the top, until the connection of the façade with the back part deteriorates; at this time, the entire façade is weakly restrained and a trend toward a full façade rotation sets in.

Meanwhile, larger displacements occur at the vault, now separated from the façade, bringing to its collapse. A switch from an initial gable mechanism to a façade overtopping one has avoided further development of the first; damage in the second has also developed partially. The situation could not be described without a time history analysis, but the reference to codified damage mechanisms has helped in pointing out this particular situation.
