ADAPTATION OF A MID-NINETEETH CENTURY REPRESENTATIVE UNIVERSITY BUILDING TO OFFICE FUNCTIONS

Keywords: Historical Building, Masonry, Revitalization, Structural Solutions, Construction

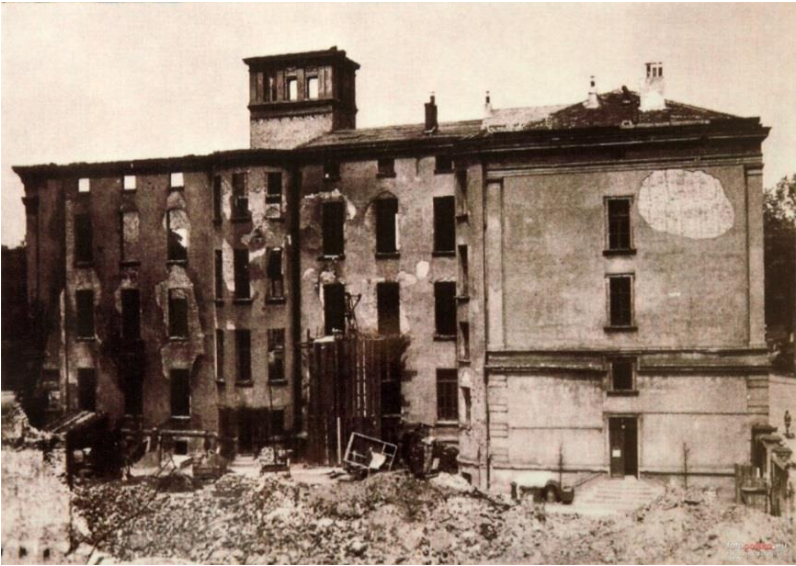
Figure 5: View of the destroyed building in 1945 (southern side) [4]

During the war in 1945, the main body of the building was seriously damaged (Fig. 5). The eastern part of the building, which included the entire lower wing along Szewska Street that was originally residential, survived without any major damage to its body and slate roof. In turn, the main body of the building was completely burned out, and the part located on the west of the vestibule and the main staircase was demolished to ground level. The ruined building was handed over to the Faculty of Medicine of Wroclaw University and to Wroclaw University of Science and Technology. It was meant to be the location for the Pharmaceutical Department.

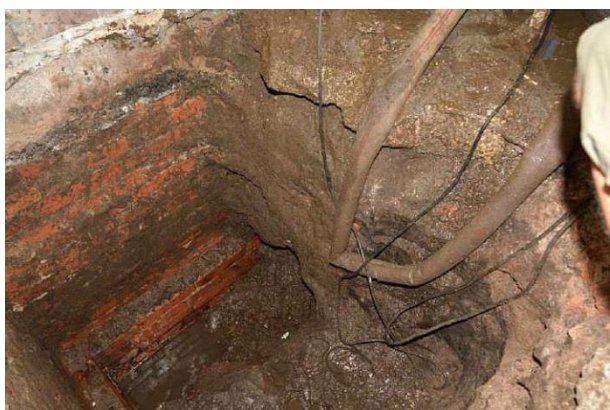
Figure 9: Exposure of the foundation walls

With regards to the condition of the foundations, and based on the conducted exposure works (Fig. 9), it was found that they were probably made at a variable level of the load-bearing soil layers. In addition, the level of groundwater in the vicinity of the building is above the level of the native load-bearing soils, and a quick water flow into the executed excavations was observed. It was also found that all the basement walls have a very strong moisture content – the existing horizontal insulation no longer fulfills its function (Fig. 10). It was necessary to dry the walls and to at least make horizontal insulation using the injection technique.

Static calculations showed that the foundations of the left internal walls do not have a sufficient load-bearing capacity to transfer the designed loads. These foundations must be reinforced by e.g. jet-grouting. In addition, due to increased vibrations that are generated by trams passing on the neighboring Szewska Street, it was also recommended to jet-grout the wall of the building along this street. However, the analysis of the working conditions of the entire facility after strengthening the foundations showed that jet-grouting of only part of the walls will change the rigidity of the entire building and may contribute to the cracking of walls in different places. Therefore, for the implementation of the modernization project, it was recommended to strengthen the foundations of all the load-bearing walls of the building.

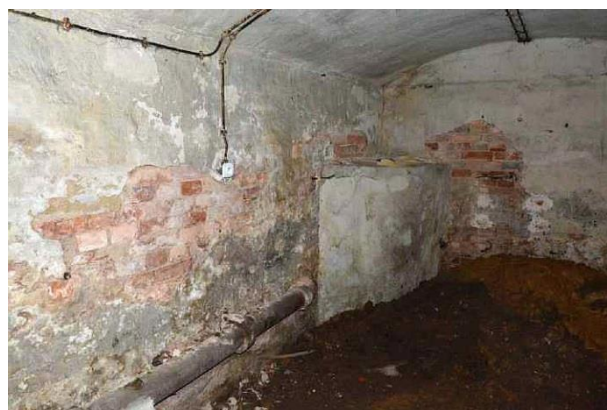
Figure 10: High dampness of the basement walls

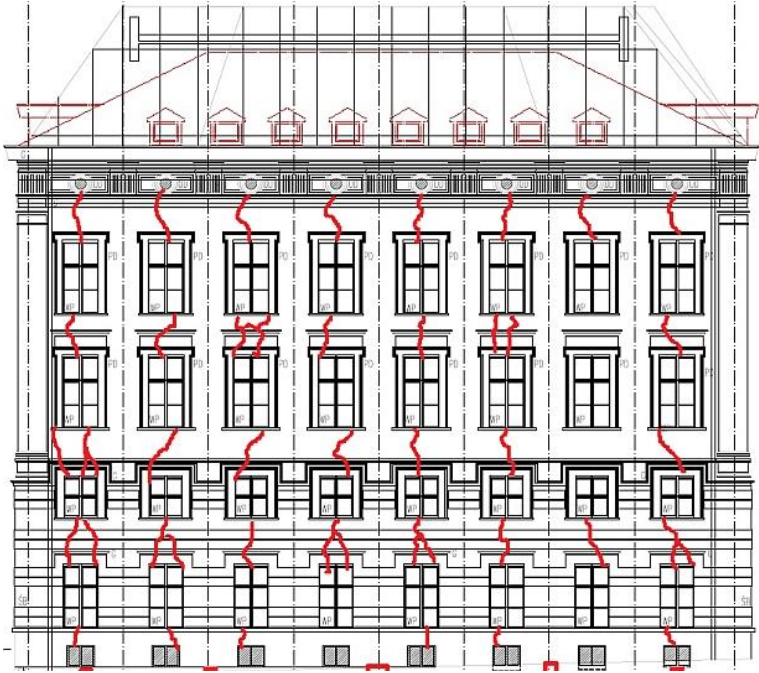
In the external walls, nearly all the brick window lintels and the under-sill walls located underneath them have been scratched or cracked. However, the largest extent of damage occurs in the wall that is located by the street that is loaded with tram traffic (Figures 11, 12, 13). Consequently, it was recommended that all repair work on the brick lintels and windowsill walls should be carried out before the demolition of ceilings.

Figure 11: The location of cracks in the side (eastern) façade lintels and wall

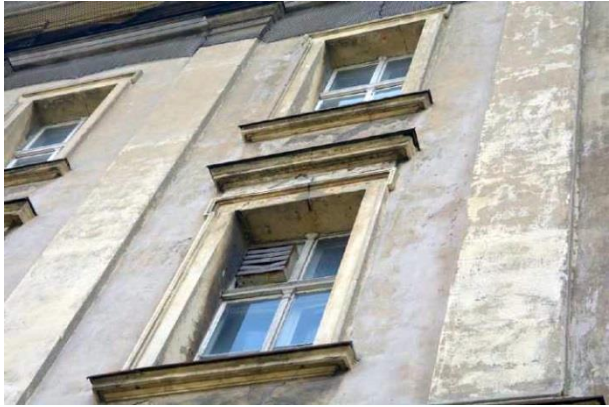
Figure 12: Example of cracks in lintels and walls

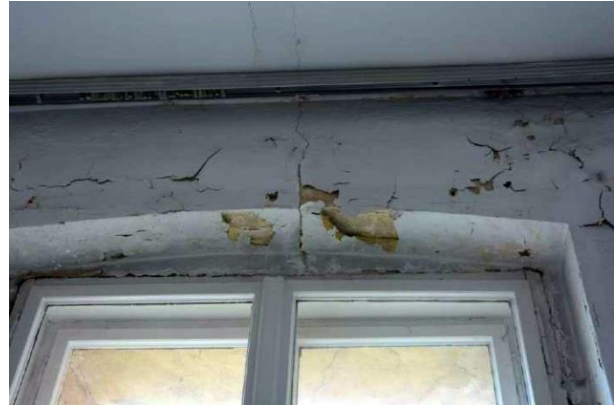
Figure 13: Exemplary cracks in lintels

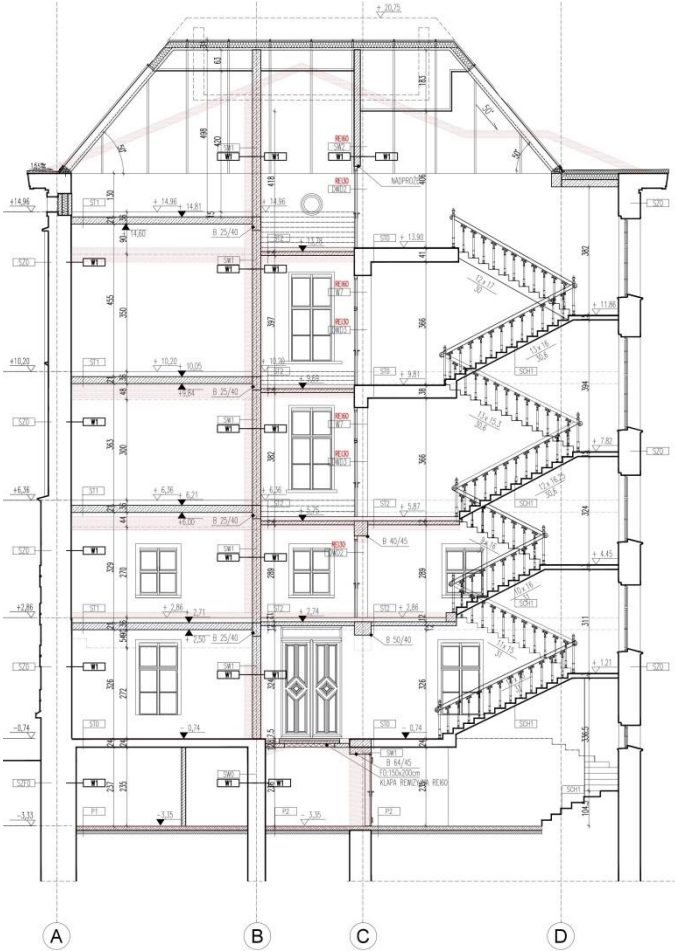
Figure 14: The cross-section (eastern wing) of the building showing the demolition plan (darkened walls) [5]

The design of the reconstruction of the facility for new utility purposes forces the implementation of a very wide range of demolitions (Figs 14, 15). From the existing building, only the external walls, part of the internal walls, a fragment of brick vaults above the basement in the south-east part, and a staircase located in the corner of the building will remain.

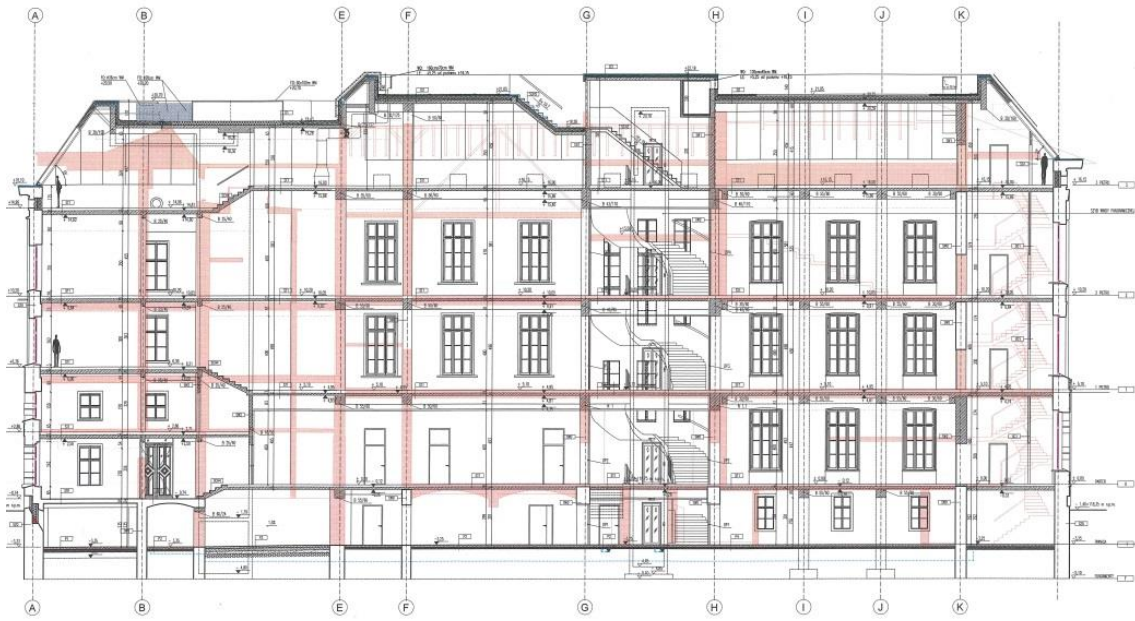
Figure 15: The cross-section (east-west direction) of the building with the demolition plan (darkened lines) [5]

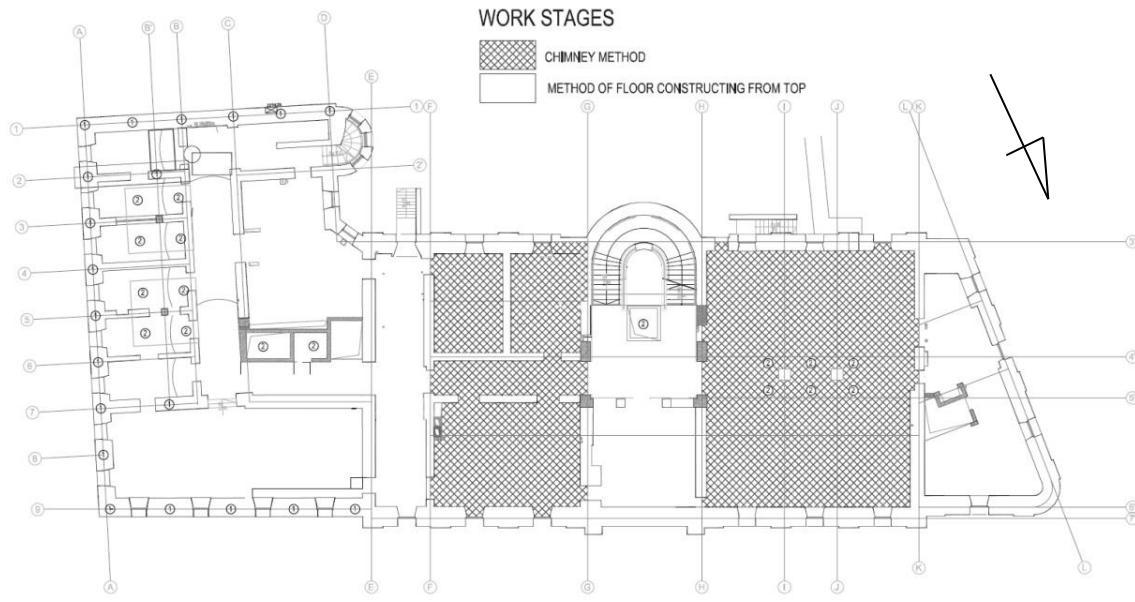
Figure 16: The plan of the combined method of renovating the building [6]

During the implementation of such a wide range of demolitions, it is very important to stage the demolition and reconstruction works. In order to adapt the building to its new form, a one-stage method of building renovation was proposed. It consists of performing demolition and reconstruction works using a combined method – partially using the "chimney" (bottom-up) method, which involves demolishing the ceilings and restoring their structure from the bottom to the top, and partially using successive dismantling of the ceilings with their reconstruction being conducted from the top to the bottom of the building (Fig. 16).

In the part of the building where the ceilings will be demolished up to the basement ceiling, the protection of the walls’ stability will involve the use of a temporary steel structure. Moreover, it is planned to reconstruct all the ceilings from the bottom to the top - the hatched surface in Figure 16. Other parts of the building will be made using the method of successive demolition of ceilings and by reconstructing them from the top to the bottom of the building (Fig. 16).

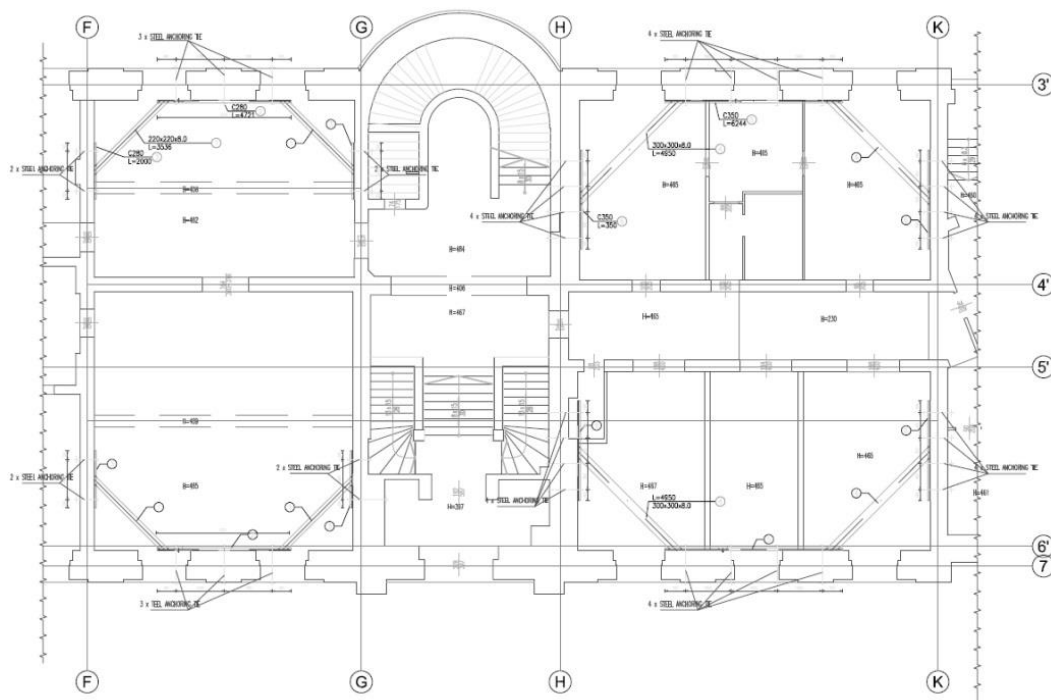
Figure 17: Scheme of wall stability protection that involves a steel structure for the “chimney” method [6]

The use of temporary steel protections for the walls’ stability when using the "chimney" method is shown in Figure 17. The angle brace protections will be installed successively, along with the demolition of the ceilings from the top to the bottom on each floor. The angle brace protection will be installed above the demolished ceiling at a height that is equal to half of the distance between the top of the ceiling and the windowsill in the wall. Such an assembly technique will allow for a collision-free reconstruction of monolithic ceilings from the bottom to the top of the building.
