Aznalcóllar dam failure. Part 2: Stability conditions and failure mechanism

A. GENS* and E. E. ALONSO*

KEYWORDS: clays; dams; plasticity; pore pressure

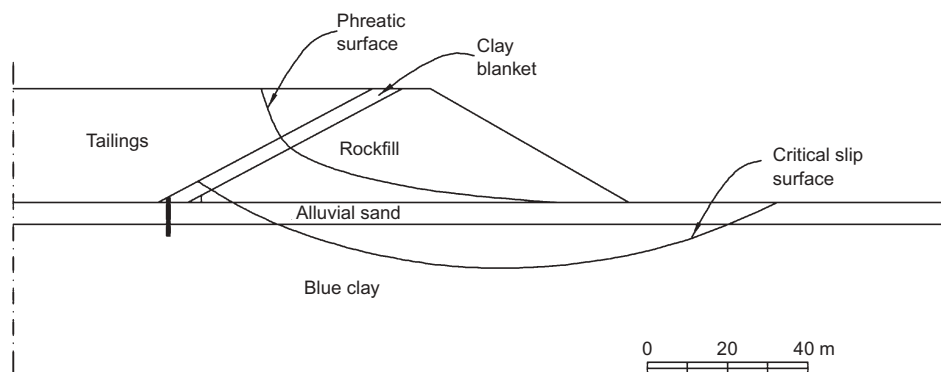
Fig. 2. Estimation of stability conditions at design stage

- Water pressures in the foundation and in the dam were said to correspond to steady-state conditions. A review of the computer records allowed an interpretation of this statement. Fig. 2 shows the position of the ‘phreatic level’ assumed in the analysis. This was a

The critical failure circle was found to be a deep circle, shown in Fig. 2. A safety factor $F = 1.30$ computed for this circle was deemed to be acceptable because it was higher than the recommendation ($F = 1.2$) of the seismic code applied.

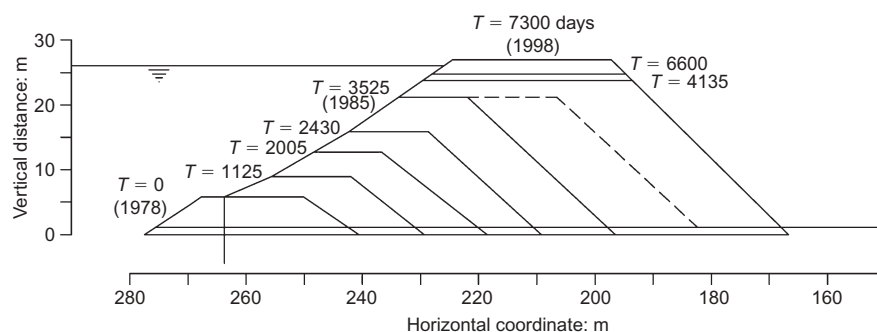
Fig. 3. Evolution of representative cross-section of the dam actually built (east side)

The dam actually built did not follow all the design specifications. A representative cross-section of the failed dam is shown in Fig. 3. A significant change was introduced in 1985, when the downstream slope increased from the projected value of 30° (1V:1.75H) to 39° (1V:1.24H). The downstream slope was maintained unchanged thereafter. A second significant change took place in 1990: the width of the crest of the dam increased from the planned value of 14 m to 36.50 m. At that time, the height of the cross-section was 21 m over foundations. Other changes, which may be identified by comparing Figs 1 and 3, are of minor significance. In 1990 the width of the base of the dam reached a maximum value of 130 m. Subsequent changes in dam height did not modify this base width.

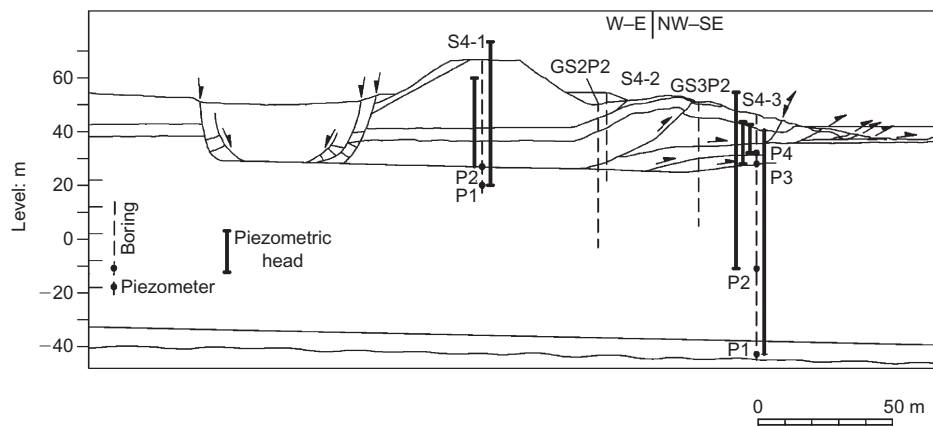
Fig. 5. Pore water pressure measured in piezometers located in Profile 4 (in borings S4-1 and S4-3). Other borings indicated helped to identify the position of sliding surfaces, shown in the plot. The graph also shows the soil profile and the geometry of the displaced dam after failure

On 25 April 1998 the embankment moved to its new position, raising the load of foundation points such as P1 in Borehole S-4-1 (Fig. 5). The point, therefore, experienced an undrained loading followed by a period of dissipation under newly formed boundary conditions. Other points, such as P2 in the same borehole, probably travelled with the moving dam, but were affected by the rapid unloading associated with the sudden decrease of the tailings level in the lagoon. This sequence of events makes any prediction exercise somewhat uncertain. Perhaps the major difficulty is the correct interpretation of the drainage boundaries after the

Piezometers were installed in the vicinity of the sliding surface with the purpose of deriving the pore water pressure conditions at the time of failure. It is clear from Fig. 5 that high pore water pressures, much higher than the values considered in the design, were present in the embankment foundation before the failure. Given the similarities in foundation conditions, Profile 1, located in the non-failed portion of the embankment 400 m north of the breach (Fig. 6), may offer a more direct insight into the pore water pressures existing at the time of failure in the slide area. For Profile 1, data were available upstream of the embankment, in the centre of the embankment and at the downstream toe of the embankment. Profiles of water pressure across the embankment can be plotted (Fig. 6). This time the interpretation is more straightforward because the only significant change, from the date of the failure, was a partial unloading of the upstream level of tailings and the reduction of hydrostatic pressure in the lagoon.

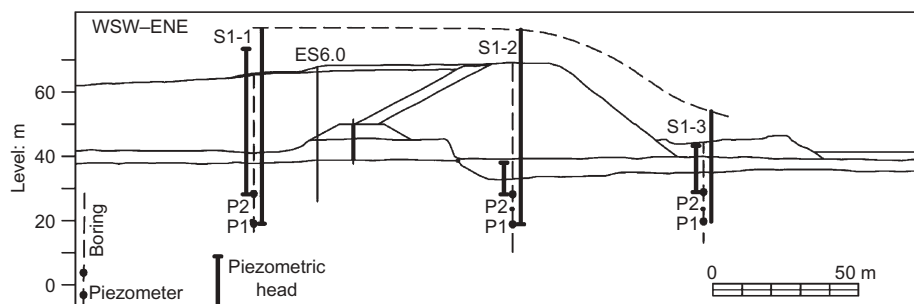
Fig. 6. Pore water pressures measured in piezometers located in borings S1-1, S1-2 and S1-3 in Profile 1 (not affected by the failure). The graph shows also the level of tailings after the failure and the soil profile

Pore water pressures measured in September 1999 are shown in Figs 5 and 6 for Profiles 4 and 1. The locations of the instruments (P1, P2, etc.) are shown in these two figures. The most characteristic result was the high pressure measured in the foundation clay. Profile 4 (Fig. 5) is located in the displaced embankment, and the measured pore water pressures cannot be interpreted in a straightforward manner because they are a consequence of a series of events, as follows

It is interesting to note in Fig. 6 that the readings in the piezometers P2, located in a shallower position within the clay, detect the boundary water pressure upstream and downstream of the cut-off wall. Water pressures in the alluvial granular soil downstream of the embankment appear to have a low value, close to the original ground surface, similar to that measured in open tube piezometers. Upstream of the cut-off, the water level in the alluvium is given by the water level in the lagoon, and this explains the reading in piezometer P2 in borehole S1-1. It is also clear that strong vertical pressure gradients exist below the embankment in the vicinity of the position of the sliding surface (in the failed embankment) as a result of the consolidation process

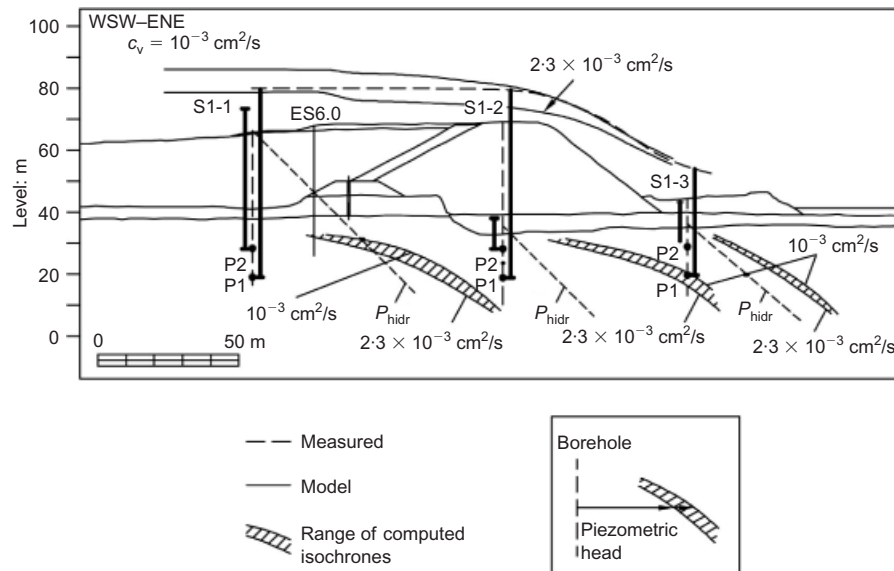
Fig. 8. Calculated and measured distributions of pore water pressures under Profile 1

A comparison of the calculated and measured pore water pressures under the embankment and the lagoon, for Profile 1, is shown in Fig. 8. The calculation simulated the construction process defined in Figs 3 and 7, as well as the reduction in tailings level due to erosion immediately after the failure, the change in boundary condition upstream of the cut-off wall, and the subsequent dissipation time prior to the pore water pressure measurements being performed.

The level of tailings after failure is shown in Fig. 8. It implies an unloading (which was assumed to be undrained) with respect to the tailings level immediately before failure. Fig. 8 shows the calculated pore pressures along the failure plane for two values of c_v ($10^{-3} \text{ cm}^2/\text{s}$ and $2.3 \times 10^{-3} \text{ cm}^2/\text{s}$) and a comparison with measurements in piezometers P1. Also shown in the figure are the calculated and measured vertical profiles of water pressure at the location of boreholes S1-1, S1-2 and S1-3. They show a strong pore pressure gradient in the upper part of the clay deposit. The agreement between calculated and measured pore pressures is very good for a value of c_v close to $10^{-3} \text{ cm}^2/\text{s}$. Remarkably, this back-calculated value is very close to the c_v values derived from consolidation tests on specimens of blue clay (Alonso & Gens, 2006). This agreement is a further indication of the massive and homogeneous nature of the foundation clay. The back-calculated values are of the same order of magnitude as those derived by Vaughan & Walbancke (1973) from observation of cutting slopes in London clay.

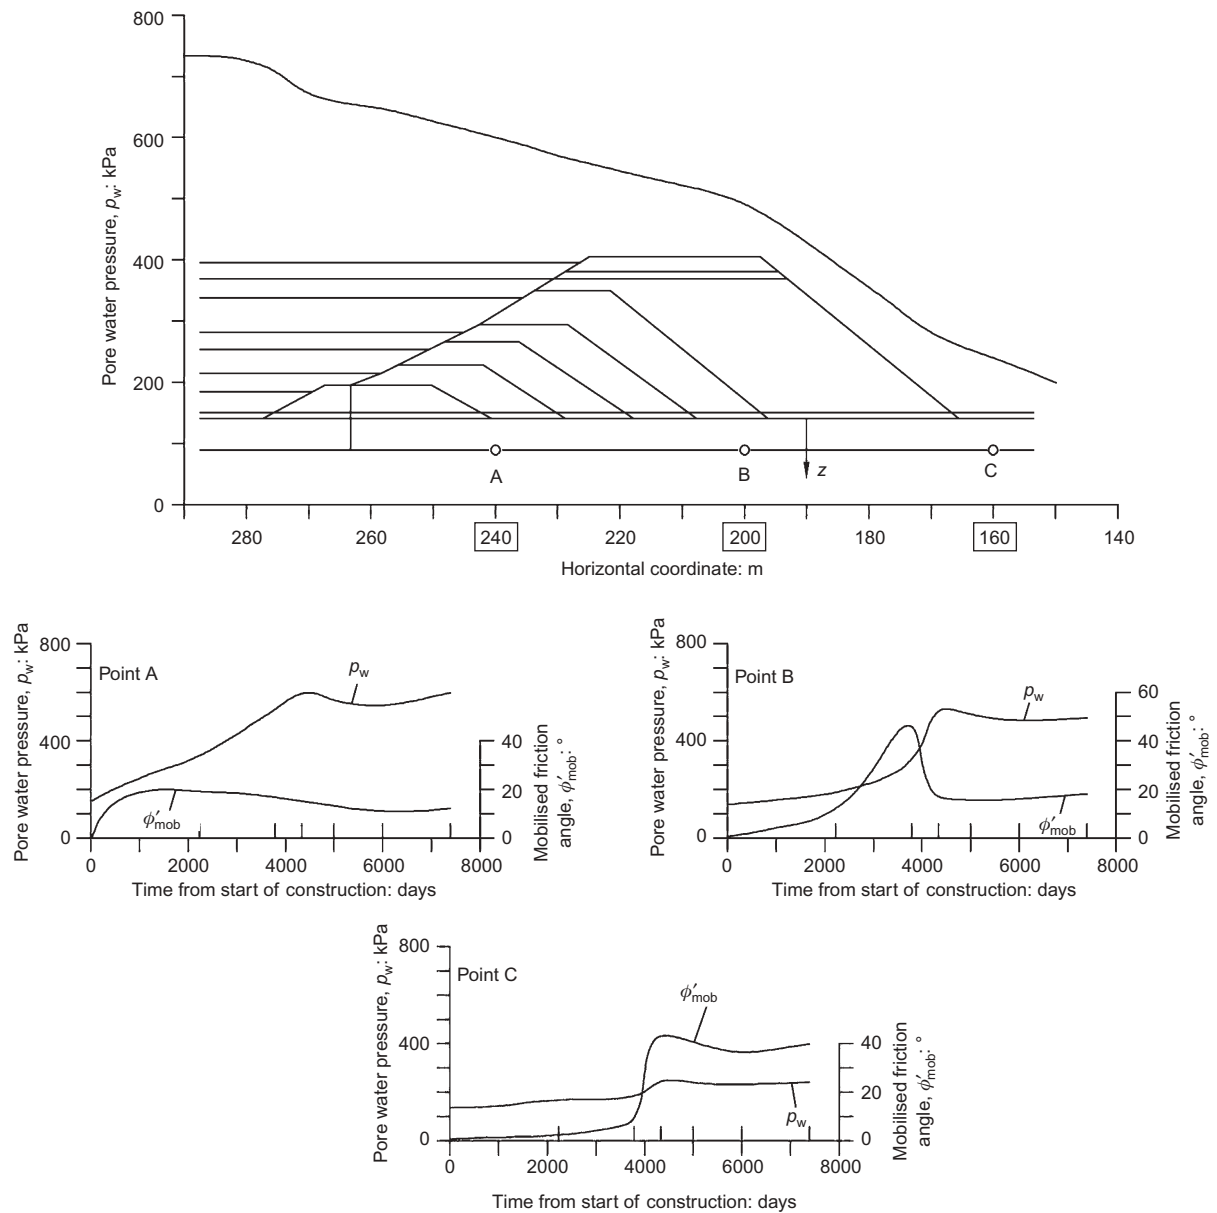
Fig. 9. Calculated water pressures and stress ratios under dam and lagoon at points A, B and C in representative profile of failed southern part of east embankment

The next step in the calculations was the estimation of pore water pressures under the embankment and lagoon for a representative profile of the southern part of the east embankment. A change in the vertical density of the deposited tailings was considered. The evolution of pore water pressures at three points under the embankment, in a horizontal plane, 14 m below the ground surface, is shown in Fig. 9. Also shown in the figure is the estimated cross-profile of pore water pressure immediately before failure for the indicated horizontal plane (which is very close to the position of the actual basal sliding plane). This calculation shows that the pore pressures on the failure plane prior to failure were high, certainly much higher than the values assumed in design.

The plots in Fig. 9 also indicate that pore pressures reached a peak at $t = 4500$ days, around 1990, at the end of a relatively rapid increase in embankment height (Figs 3 and

7). The subsequent slowdown in construction rate resulted in a reduction in pore water pressures followed by a final increase associated with the final and faster stages of embankment construction.

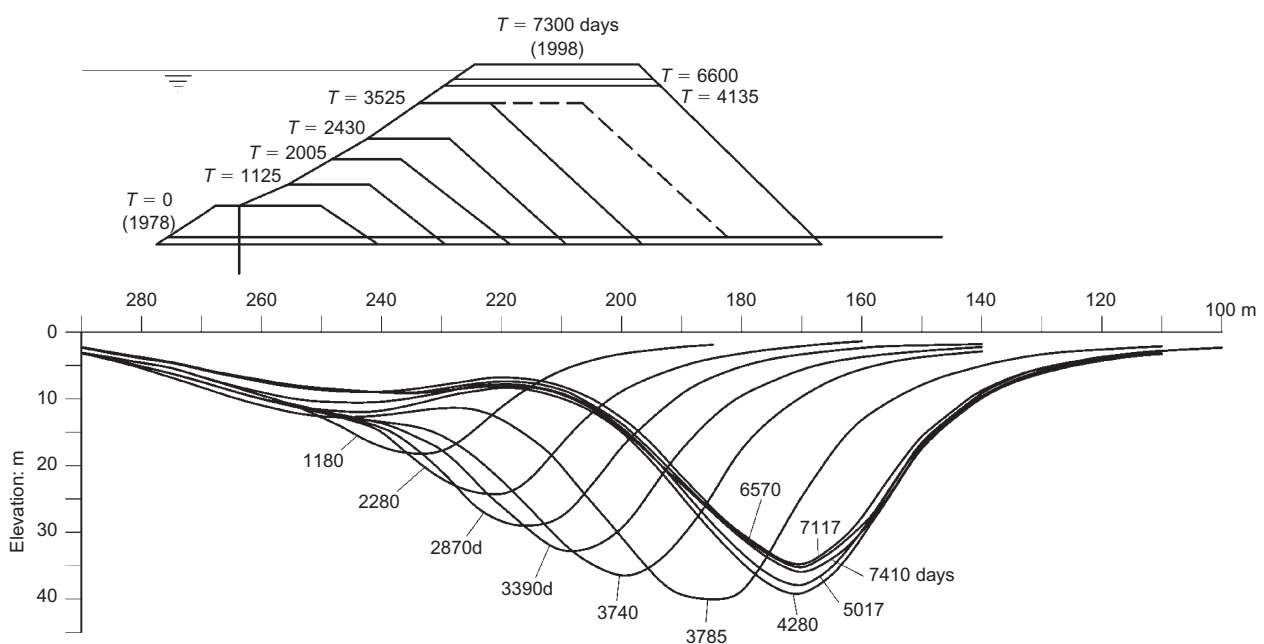
Fig. 10. Variation of mobilised friction in a horizontal plane located at depth $z = 14$ m within clay foundation. Numbers indicate time elapsed (days) since start of dam construction (January, 1978)

Note that the maximum values are high (35 – 45°). If the subhorizontal bedding planes do not have an effective cohesion, the advancing embankment has certainly induced some damage on the bedding planes, which are unable to resist those high stress ratios. Note also that a maximum stress ratio was reached at a time $t \cong 3800$ – 4000 days (around 1988–1989), 10 years before the failure. Later, the dissipation of pore pressures, associated with slower construction rate, led to an increase in normal effective stresses and to a reduction of the stress ratio.

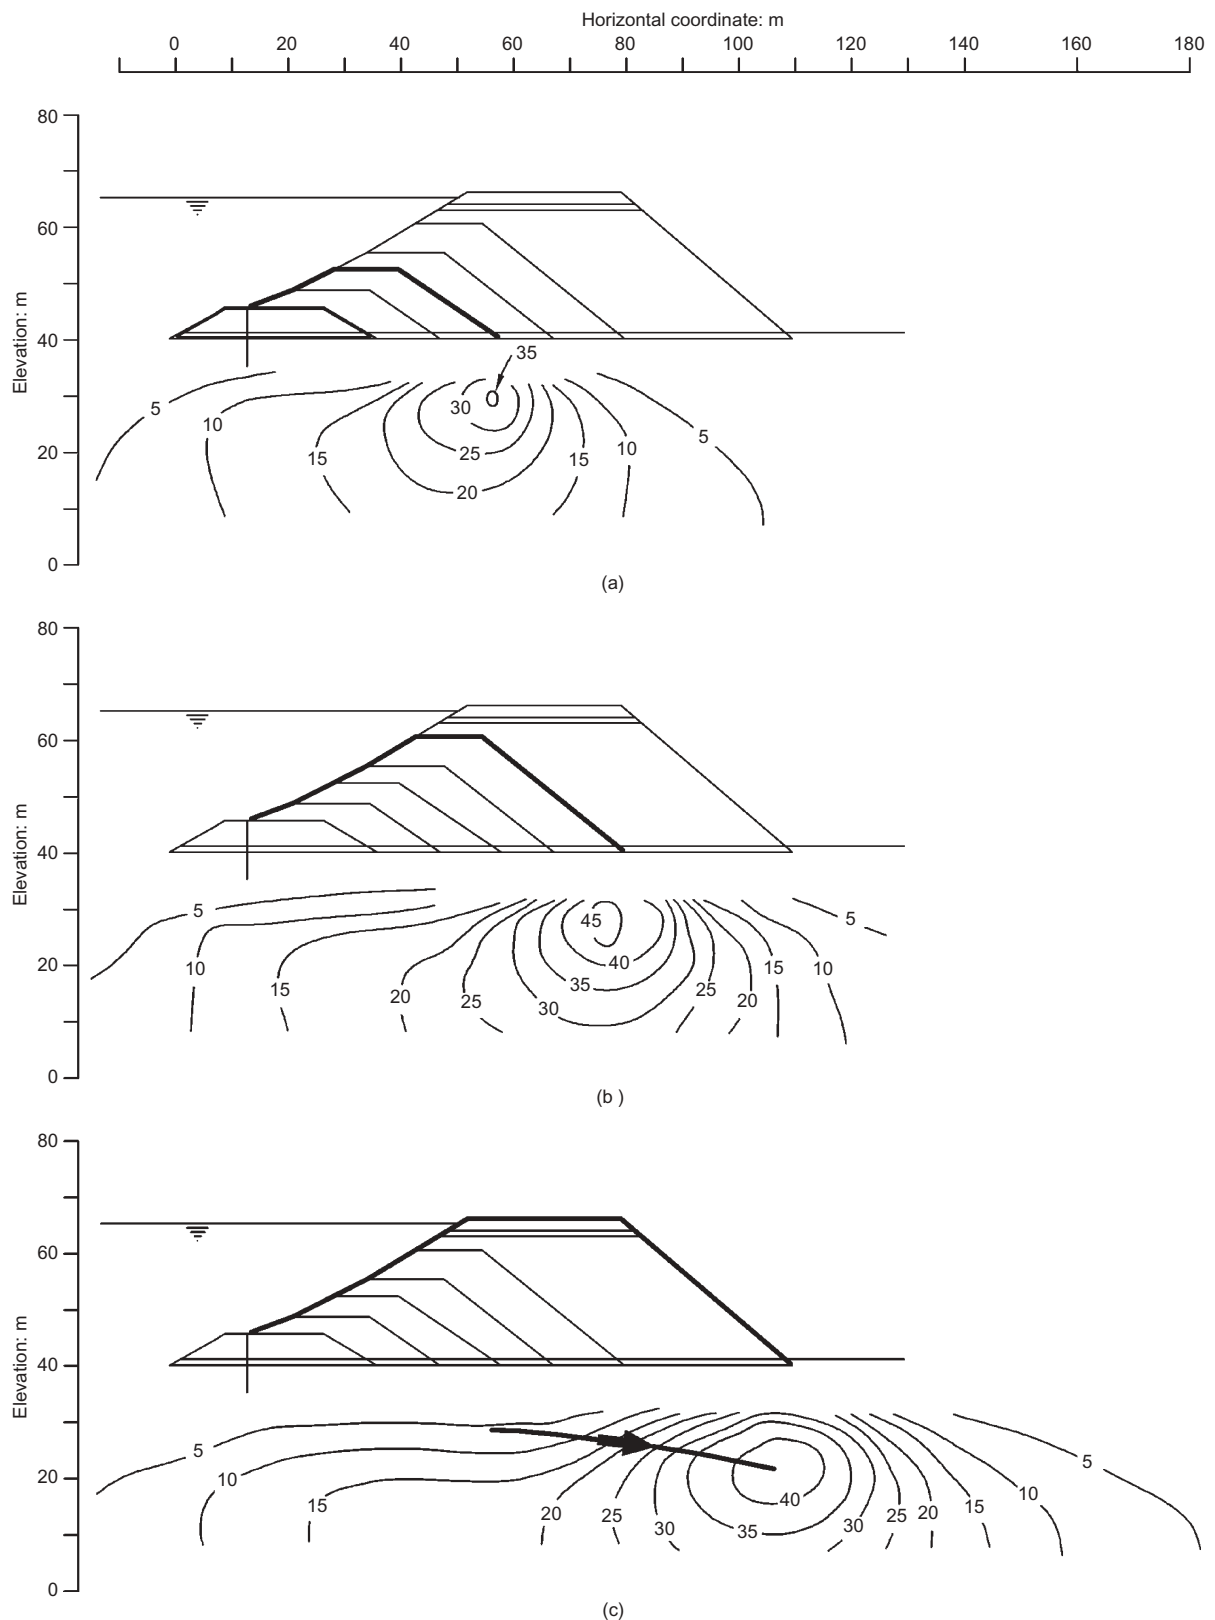
Fig. 11. Contours of equal mobilised friction on horizontal planes for three phases of construction, in terms of dam height: (a) $H = 10$ m; (b) $H = 19$ m; (c) $H = 27$ m. The line with the arrow in (c) shows the locus of the maximum mobilised angle of shearing resistance

A remarkable result is that the stress ratio reaches a peak at a certain depth within the clay. This is a consequence of the variation of pore pressures, controlled by the clay consolidation, and the distribution of shear stresses below the embankment toe. The depth of the maximum τ/σ'_n increases as the height of the embankment increases. For $H = 10$ m the maximum τ/σ'_n is found for $z = 10$ m. It increases to $z = 12$ m and $z = 17$ m when $H = 19$ m and $H = 27$ m. This result indicates the position of the sliding plane, which developed later, as the peak in mobilised friction generates the maximum damage in clay strength. In fact, the brittle behaviour of the clay, and the strength data already reported (Alonso & Gens, 2006), can be now invoked to advance a qualitative interpretation of the failure mechanism. If bedding planes do not exhibit any effective cohesion, a maximum effective friction angle of around 25° may be assumed for them. Then, in view of Figs 9, 10 and 11, the strength on a critically located bedding plane was exceeded for the first time, when the embankment had a height of 8–10 m. This initial critical point was located at a depth of about $z = 10$ m under the downstream toe of the embankment.

This was the situation as early as 1980–1981. Additional stressing in the following years could not be resisted in some areas of the clay. The brittle nature of the clay allowed additional straining in the vicinity of the critical points in a typical progressive failure mechanism. The forward construction of the embankment resulted, therefore, in an increasing extension of the area affected by progressive failure. The line plotted in Fig. 11(c) joins the points of maximum stress ratio. It is viewed as a first approximation of the position of the failed surface under the embankment. Its position is quite close to the position of the future failure plane. The inclination of this line has probably helped to concentrate critical conditions on a specific bedding plane. The line thus defined is an approximation to the failed or damaged surface immediately before failure.

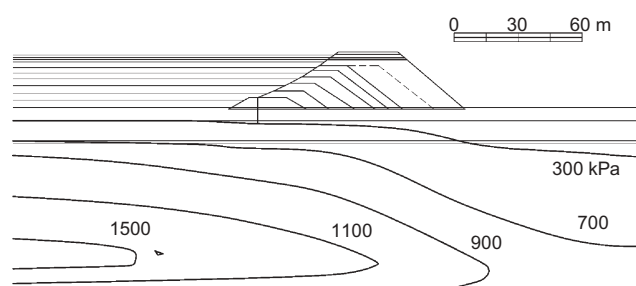
Fig. 14. Distribution of pore water pressures in last stage of FE calculations, immediately prior to failure

This FE analysis also provided data relating to the evolution of pore water pressures in the foundation. Fig. 14 shows the distribution of pressures at the end of the calculation (just prior to rupture). Note the substantial influence of the heavy tailings and the very limited dissipation of pore pressures. A profile of water pressures along the future failure plane is shown in Fig. 15. The FE prediction is compared with the result of the elastic-consolidation analysis reported before. The correspondence is very good.

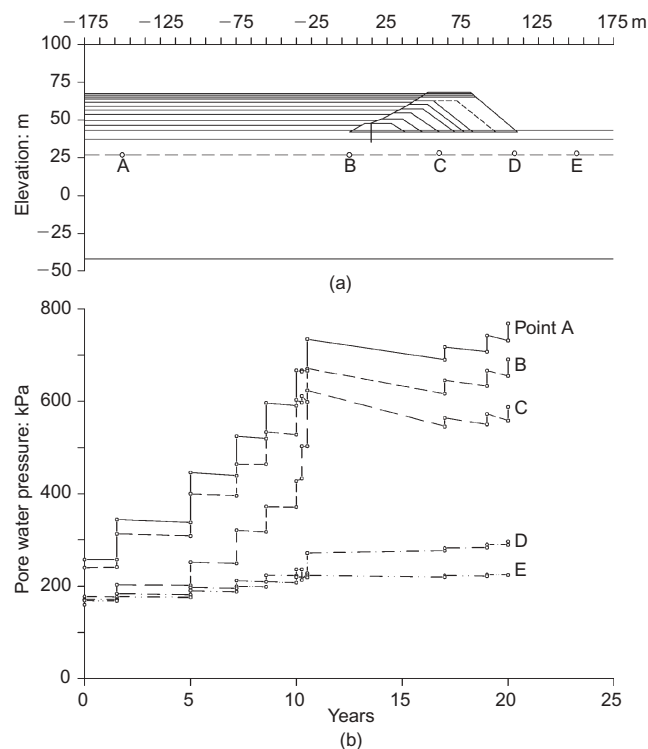
Fig. 16. Calculated development of pore water pressure at points of failure surface: FE analysis

More detailed information on the very limited dissipation of pore water pressures that took place during construction is given in Fig. 16. This shows the calculated evolution of pore water pressures for a few points under the lagoon, under the embankment structure and downstream of the embankment toe. The magnitude of the pore pressure developed is basically controlled by the added weight placed above each of the points considered.

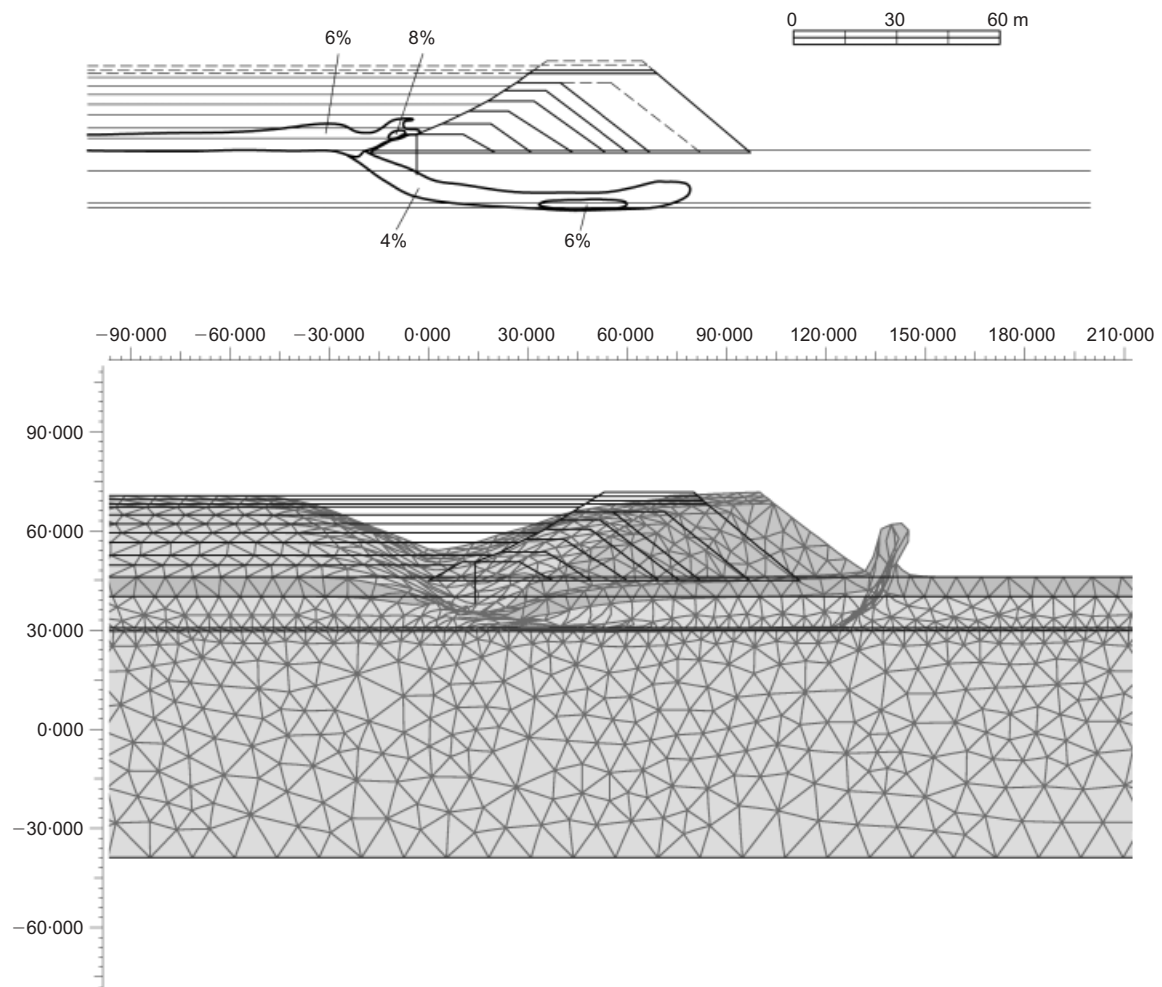
The analysis also confirms that the shear deformations accumulate on the potential failure plane, and they extend as the embankment construction advances (Fig. 17(a)). The rupture mechanism, identified by means of the mesh deformation (Fig. 17(b)), is similar to the actual failure mechanism described in the companion paper (Alonso & Gens, 2006). The failure phase was induced by a final reduction of strength parameters. Fig. 17(b) shows the passive wedge developed at the distal end of the slide, and a classic

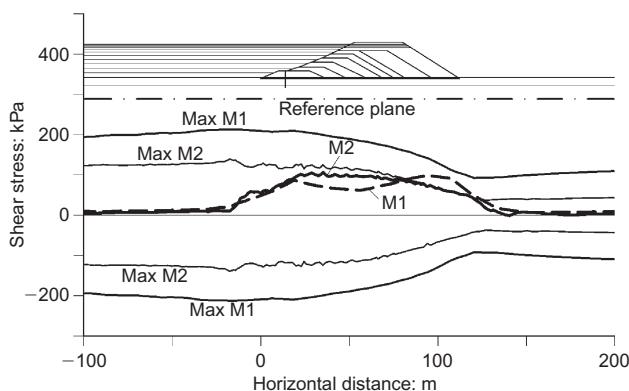
Fig. 18. Distribution of shear stresses along failure plane for two FE analyses performed. Horizontal coordinates start at upstream toe

The computed distributions of shear stresses on the failure plane at the end of the construction period are shown in Fig. 18 for the two cases analysed: M1, uniform strength ($c' = 65$ kPa; $\phi' = 24^\circ$); and M2, the case of a discontinuity with a reduced strength ($c' = 1$ kPa; $\phi' = 21.5^\circ$). The calculated shear stresses' profiles are similar in the two cases. But the real difference is clearly illustrated when the strength limits for both cases are considered. Those limits are also indicated in the figure. They have been calculated on the basis of the effective normal stresses against the failure plane and the corresponding strength parameters. When homogeneous matrix properties are considered, all the points remain within the strength limits, and failure cannot be explained. When a reduced strength is introduced, the excess shear stress has to be redistributed, increasing the length of the failure surface that lies at or very close to failure.

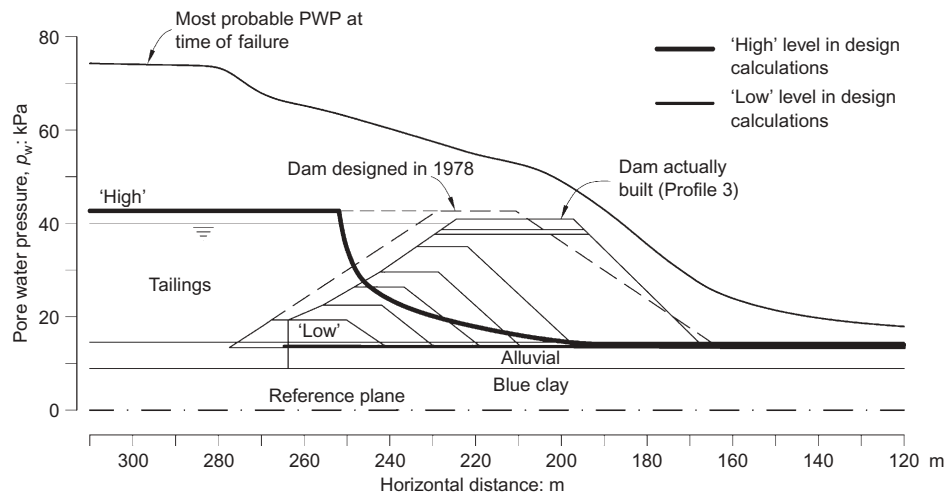
Fig. 22. Phreatic surface used in design calculations and best estimate of pore water pressure existing on sliding plane at time of failure

Pore water pressures were conventionally taken as given by a steady-state flow net, a common practice in dam design. In addition, the water levels measured in open pipes located under the dam in 1996 were taken as an indication of a general phreatic surface located within the surface

granular terrace layer. Limit equilibrium calculations using this phreatic level indicated a safety factor against downstream sliding of 1.40 for the dam configuration existing in 1998 (27 m above ground level). The two phreatic levels used in design calculations are compared in Fig. 22 with the best estimate of water pressures prevailing on the sliding surface at the time of the failure.
