RENOVATION OF 16TH CENTURY SALT HOUSE ROOF (LUBAŃ, LOWER SILESIA, POLAND) – CASE STUDY

KRZYSZTOF AŁYKOW^{1*}, MAGDALENA NAPIÓRKOWSKA-AŁYKOW²

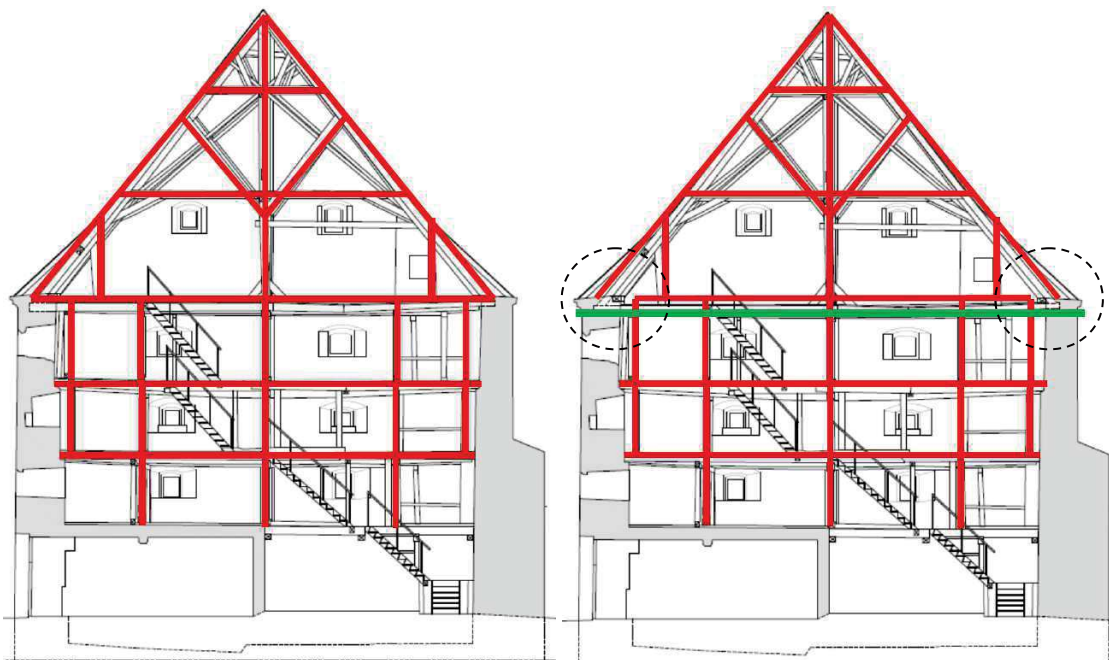
Figure 2: Cross section – original static scheme (left) and after change of its work (right); carpenter construction scheme – red, added steel tie rods – green, dashed circle – separation area

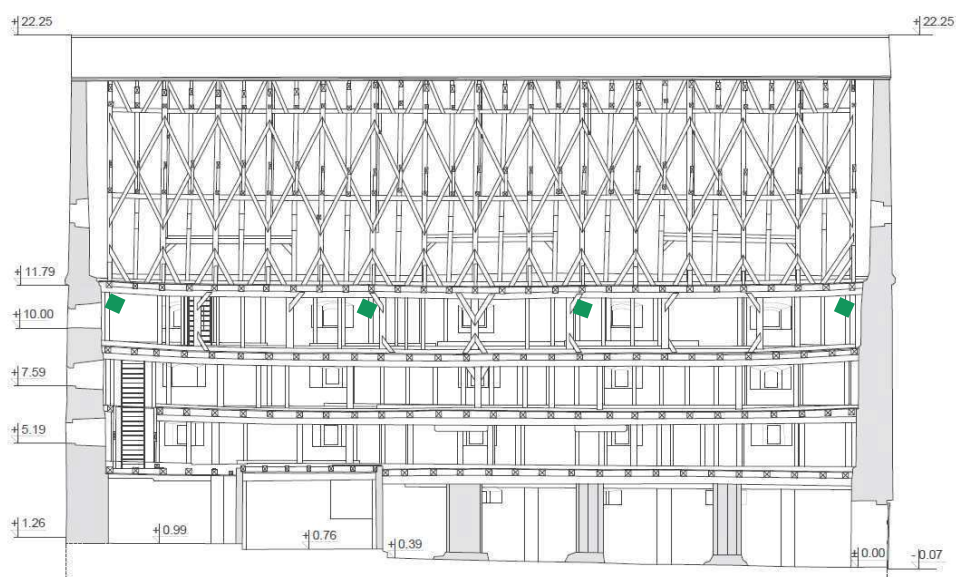
Figure 3: Longitudinal section; added steel tie rods - green

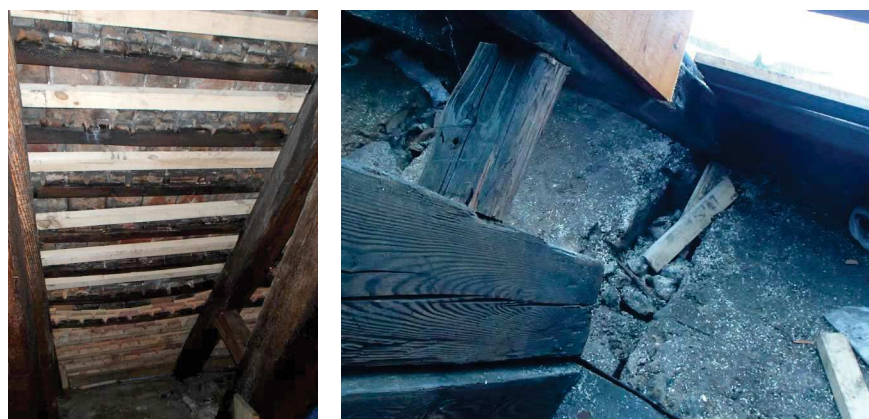
Figure 4: False rafters and reinforced timber roof truss components

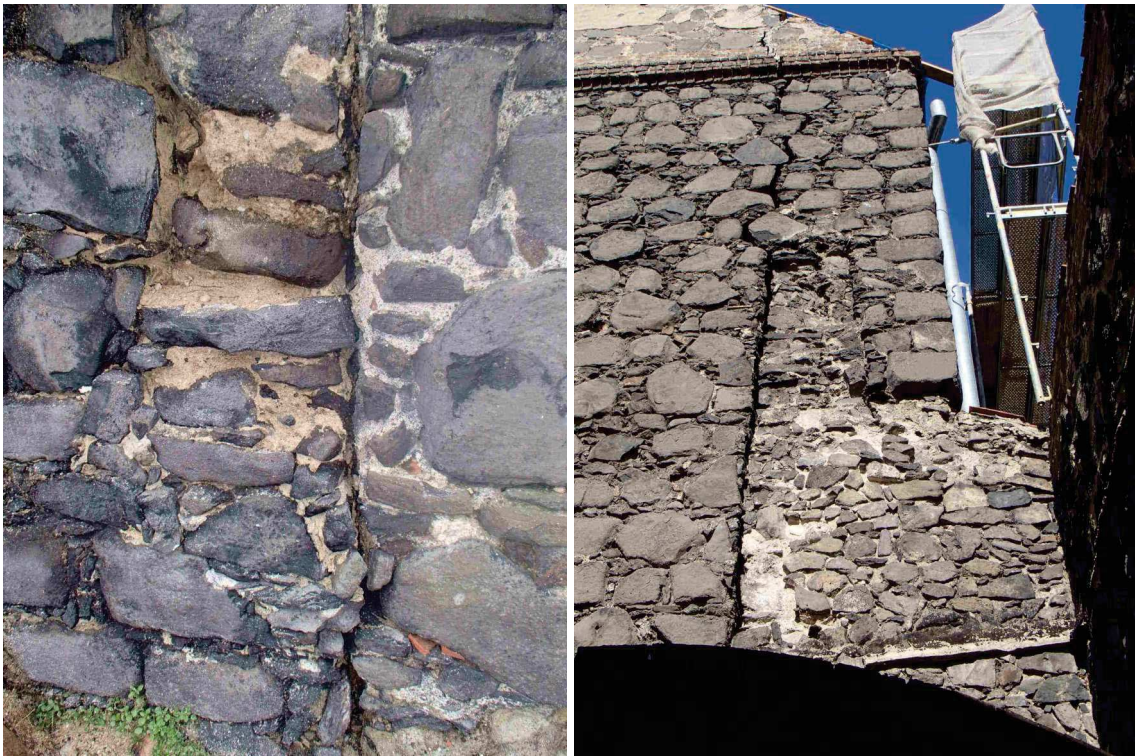
Figure 6: Exterior of the end walls with cracks along the external face of the defense wall

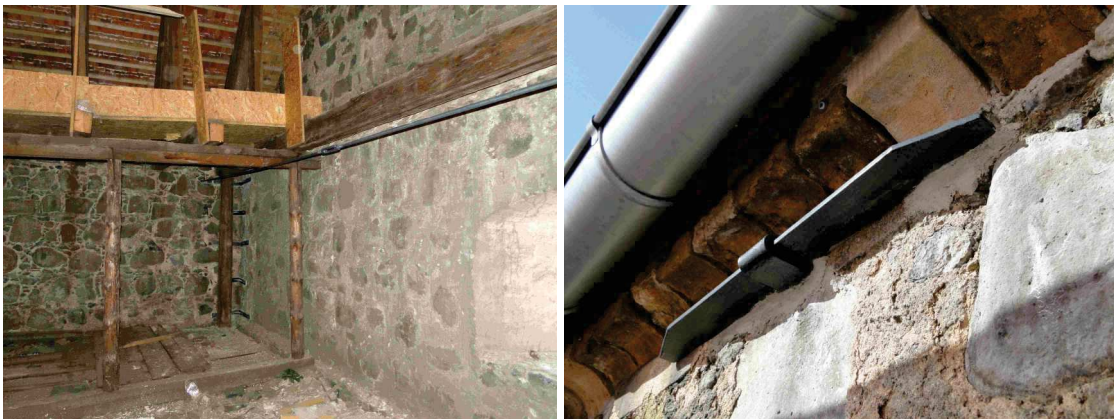
Figure 7: A set of tie rods and the anchor plate under the cornice
