Relationships between Outside and Interior Appearance Inspection and Actual Bio-Deterioration of Structural Members in Existing Wood Houses

Keywords: *Appearance Inspection, Degradation, Bio-Deterioration, Used Wood House.*

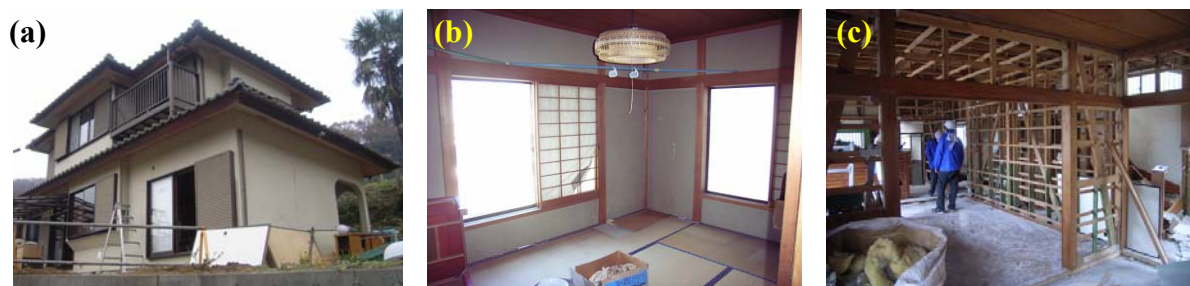
Photo 1. Overview of (a) inspected house, (b) appearance inspection and (c) bio-deterioration survey.

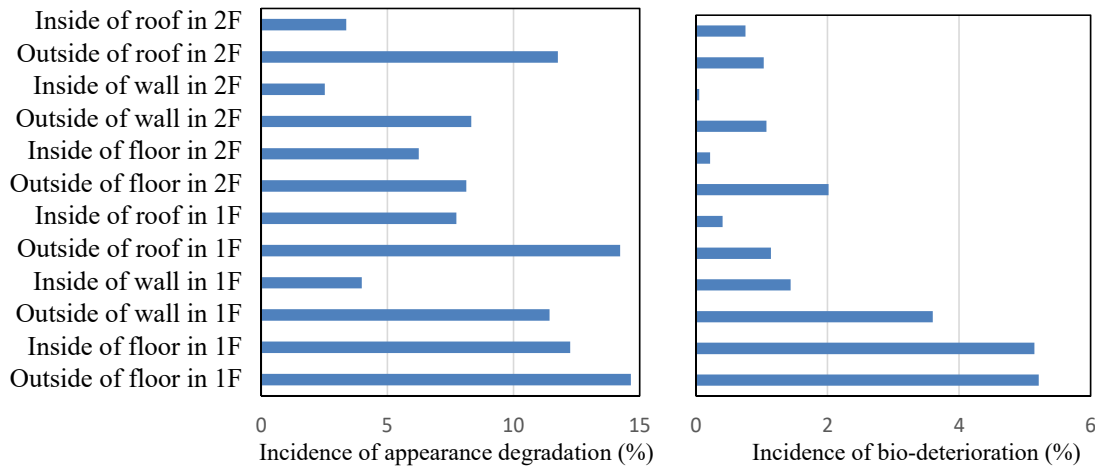
Figure 4 shows the incidence of them for each building part. Both of the appearance degradation and the bio-deterioration of the structural member often occurred on the 1st story and outside rather than the 2nd story and inside, respectively.

Figure 4. Incidence of the appearance degradation (left) and the bio-deterioration (right) for each building part.

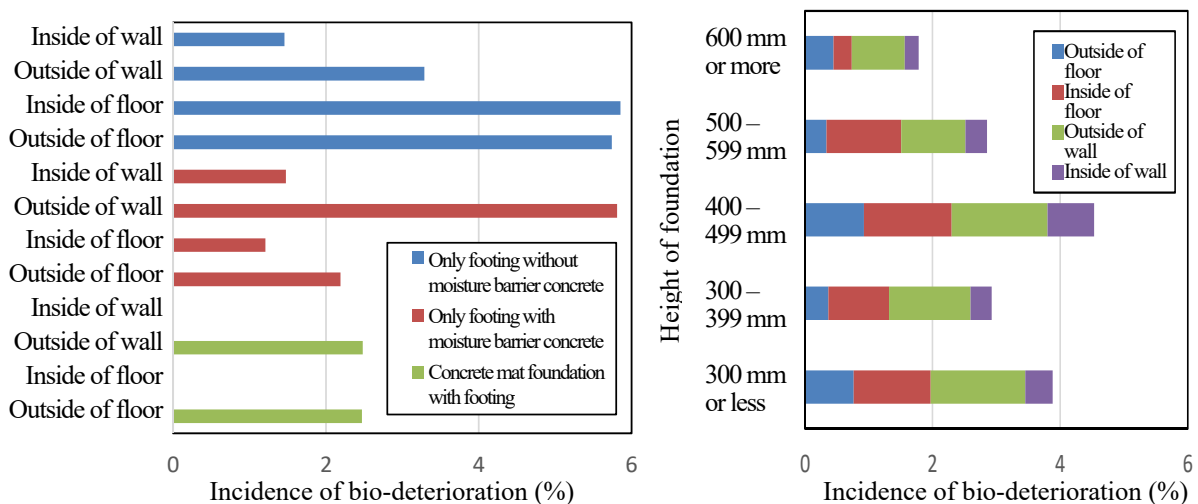
Figure 5 shows the relationships between the construction method and height of the foundation and the bio-deterioration of the structural member in the 1st story. The incidence of the bio-deterioration was lower in the order of the concrete mat foundation with footing, only the footing with the moisture barrier concrete and the one without the moisture barrier concrete. The mat foundation and the moisture barrier concrete are effective in preventing the bio-deterioration of the structural member in the 1st story. Although there were some exceptions, the incidence of the bio-deterioration almost decreased as the foundation height raised.

Figure 5. Relationships between the construction method (left) and height (right) of the foundation and the bio-deterioration of the structural member in the 1st story.

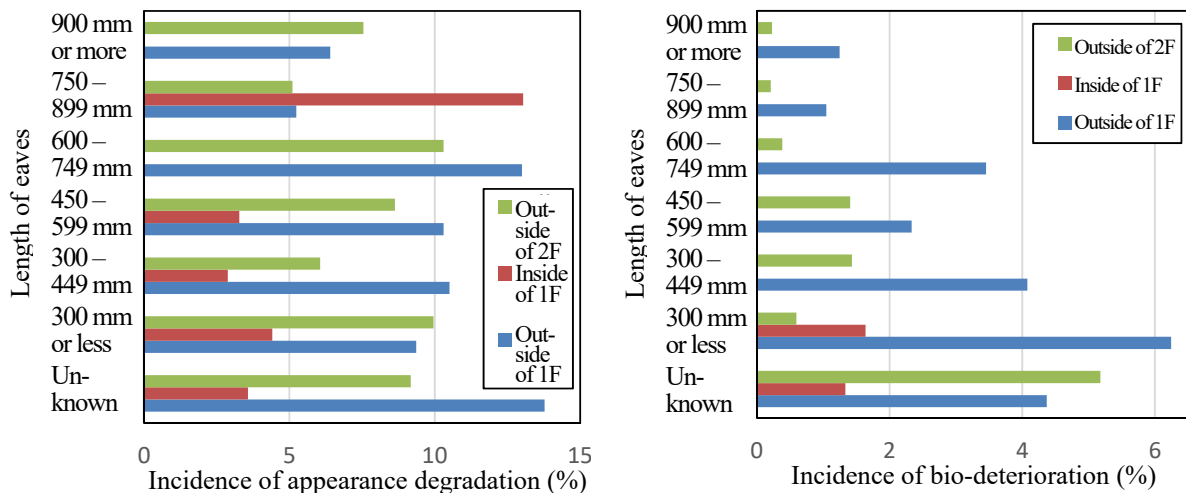
Figure 7 shows the effect of the eaves length on the incidence of the appearance degradation and the bio-deterioration of the structural members. The length of the eaves didn't clearly affect the incidence of the appearance degradation. However, as the length of the eaves increased, the incidence of the bio-deterioration almost decreased.

Figure 7. Relationships between the incidence of the appearance degradation (left) and the bio-deterioration (right) and the length of the eaves.

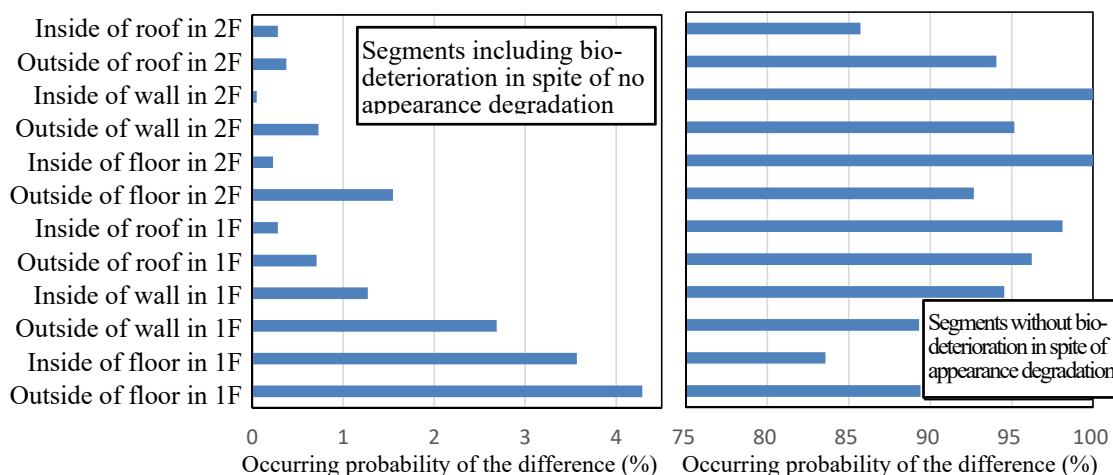
Next, the distribution of segments including those differences for each building part was studied, as shown in Figure 10. The incidence of the segments with the bio-deterioration in spite of the no appearance degradation in the 1st story was higher than that in the 2nd story and high in the order of the floor, the wall and the roof. From these, even if the occurrence rate of such differences depends on the incidence rate of biological deterioration, the appearance degradation, the structural members in the 1st story, especially in the floor, should be inspected or surveyed carefully, regardless of the appearance degradation. On the other hand, the distribution of the segments without the bio-deterioration in spite of the appearance degradation didn't have clear tendency for each building part and in each part the incidence was over 80%. One possible reason is that it takes time for the outside rain leak to penetrate the structural members, and the water evaporates before the water reaches the structural members.

Figure 10. Distribution in each building part of the segments including the bio-deterioration in spite of no appearance degradation (left) and without the bio-deterioration in spite of appearance degradation (right).
