Analysis of the Degradation Condition of Elementary Schools

Buildings Department, Laboratório Nacional de Engenharia Civil, Av. do Brasil 101, 1700-066
Lisboa, Portugal, sraposo@lnec.pt

Abstract. Currently, there is still no information regarding the performance of public buildings after their construction and the relationship with the needs for carrying out maintenance activities. This paper presents some of the main anomalies detected in six schools, built between 1997 and 2003 in Lisbon. The analysis of the degradation condition of these schools was based on data obtained through detailed visual inspections, carried out in three distinct periods of their operation phase, 2007, 2013 and 2018. The highest level of severity mainly concerns defects on buildings structure and buildings envelope and results from bad decisions made during design and/or construction. Therefore, there are serious problems related to the premature deterioration of these educational buildings, requiring expensive, complex and unplanned major repairs to achieve their specified design service life. This work highlights the need for greater involvement of school building management entities, in the early st

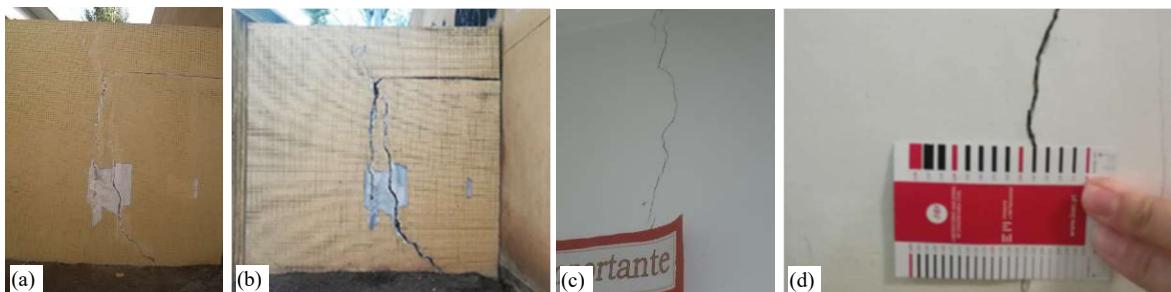
The structure of VA School building is a system of slabs, columns and beams in reinforced concrete. The inspection carried out at this school in 2018, revealed the existence of serious anomalies in the structure namely, the existence of extensive structural deformations and the existence of wide opening cracks in multiple walls and ceilings on the two floors of the building.

Figure 1 shows the result obtained through inspections carried out in 2007 and 2018, where it is possible to observe the degradation mechanism of the building's structure and interior and exterior partition walls. They were identified foundations settlement problems and water infiltration through the roof in several classrooms (Vilhena *et al.*, 2019). Following this inspection, the school was closed for further rehabilitation intervention.

Figure 1. VA School: deterioration process of the exterior partition wall in 2007 (a) and 2018 (b). Cracks in walls in 2007 (c) and 2018 (d).

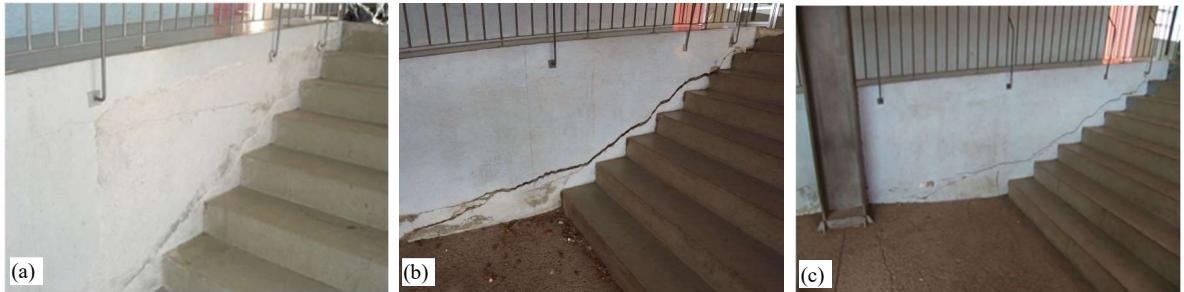
The 2018 survey, carried out in AF school, revealed the existence of anomalies in the outdoor constructive elements. The most frequent anomalies in these elements are oriented cracking,

severe fracture, differential settlements and deteriorated expansion joints without sealant. Some of these defects were detected since 2007, when only six years had passed on handover of the building. Figure 2 shows the result obtained through inspections carried out in 2007, 2013 and 2018, on the supporting wall located in AF school's outdoor spaces. It is possible to observe the existence of settlements and structural movements that remain unsolved.

Figure 2. AF School-outdoor spaces: deformation and settlement of the supporting wall and the recurring appearance of cracks. Anomaly evolution in 2007 (a), 2013 (b) and 2018 (c).

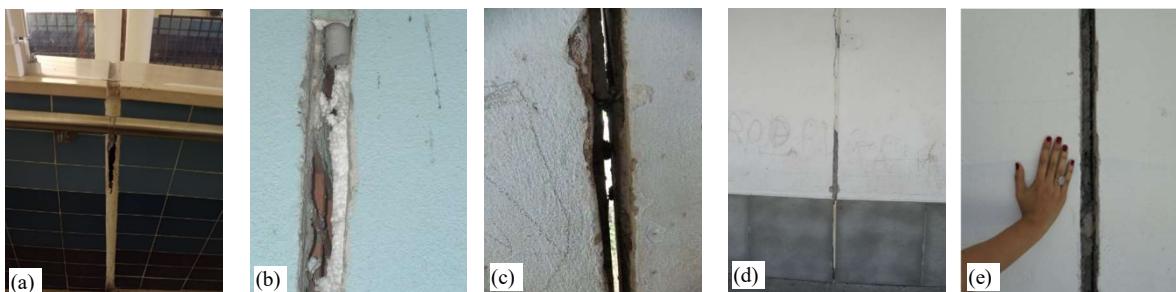
AL School was implanted on a landfill site, which is very steep along the longitudinal and transversal development of the building. The building structure is in reinforced concrete and is made of two blocks connected by an access ramp and stairs. In 2007, the existence of several anomalies resulting from the differential settlement of the two blocks was already visible (cracking in walls and broken elements). Although several repairs have been carried out in the building, 2013 and 2018 surveys revealed that the settlement movement remains active and the cracks in the walls and floors continue to appear (Fig. 3a). In AL, AF and PRM Schools, deteriorated expansion joints without filling material and sealant was observed (Fig. 3b,c,d,e). Lack of repair of the joints exposes the building elements to water infiltration and mechanical actions.

Figure 3. AL School: foundation settlement movement: broken stone and construction joint opening in 2013 (a). Expansion joints without sealant: AF School in 2007 (b) and 2018 (c); PRM School in 2007 (d) and 2018 (e).

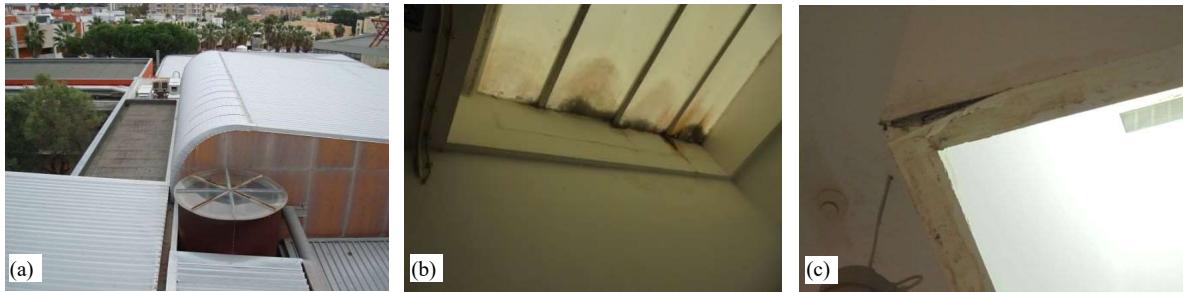
ceramic tiles, and VG School presents a non-traditional roof covering made of ceramic pellets. In PM School, infiltrations water problems continue to be observed since 2007 survey, in the area of the gymnasium affecting both the ceiling and the floor. The AF School continues to present problems between the several flat and sloped roofs boundary buildings (Fig. 4a). Skylights are the element that most frequently presents anomalies caused by water infiltration. It was possible to observe the degradation mechanism in ceilings, walls and floor coatings, caused by water infiltration through skylights in PMR School (Fig. 4b,c).

Figure 4. AF School: mixture of flat and sloping roofs in metal sheet (a). Water infiltration problems between the building's roofs. PMR School skylights problems in 2018 (b), (c).

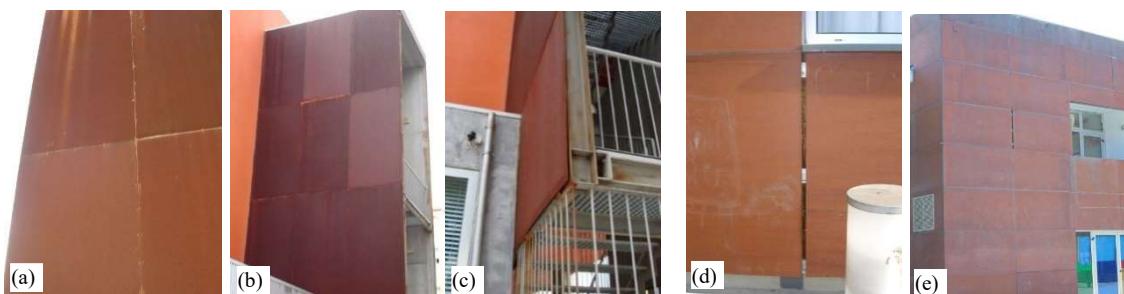
Part of the exterior walls of AF School is made up of Corten steel panels and it was found that over the years, colour changed from orange-brown to dark brown as expected (the rust layer transforms into a patina layer) (Fig. 5a, 5b). However, aesthetically the overall wall covering did not result because there are panels with different colors, which may have been the result of localized repair work or replacement of some panels over the years. The wall facade presented serious problems of corrosion and lack of fixation, with risk for building users (Fig. 5c). In PRM School, the cladding of ventilated facades in wooden panels presented several anomalies related to acts of vandalism (scratches and graffiti), stains and non-uniforme darkening of the surface and unequal joint opening (with large local openings) without any filling (Fig. 5d,e) exposing the building elements to water infiltration.

Figure 5. AF School – exterior walls in *Corten* steel panels: colour change from 2007 (a) to 2018 (b). Corrosion and fixation problems in panels in 2018 (c). PRM School wooden panels degradation in 2007 (d) and in 2018 (e) with 16 years of service life.

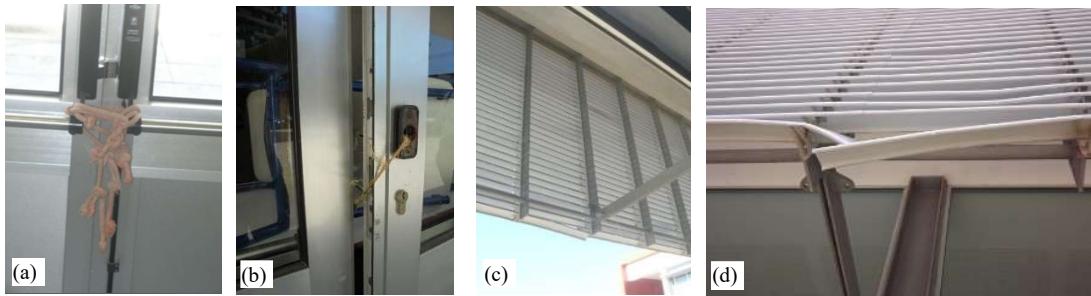
In PRM School, damaged or missing door locks and handles were observed in the surveys. These failures severely reduces the adequate serviceability of the exterior doors (Fig. 6a,b).

These anomalies were detected in 2007 in doors with 5 years of service life. In general, some problems with rain penetration were observed in windows and non-operational interior polystyrene blinds is a very frequent anomaly. In AF School the outdoors shading were broken and deformed caused by its proximity to the playing field (Fig. 6c,d).

Figure 6. PRM School: missing door locks and handles 2007 (a) and 2018 (b). AF School: outdoors shading broken and deformed in 2007 (c) and 2018 (d).

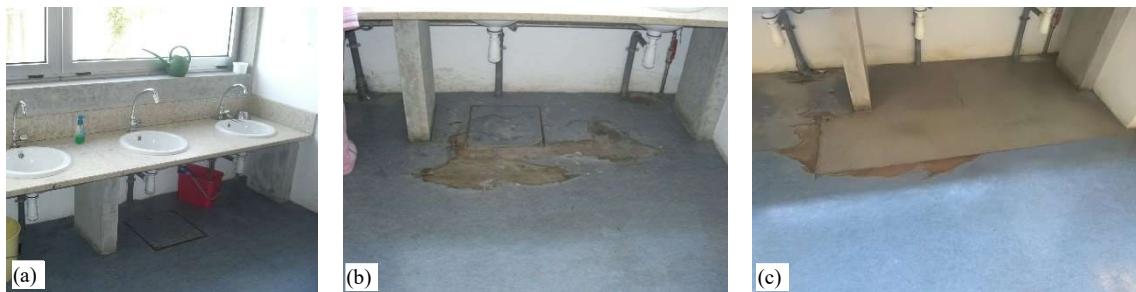
At PRM School, the degradation mechanism of the floor finishes, in the arts and crafts areas, next to the classrooms, caused by frequent water leakages from the washbasin siphons, has been observed since the 2007 inspection. In 2018, the placement of floor covering patches in this area was observed. Figure 7 (a,b,c) shows three stages of the vinyl floor covering degradation process caused by wet-dry cycles exposure conditions.

Figure 7. PRM School: vinyl floor degradation process caused by wet-dry cycles exposure conditions. Area in good condition and severely damaged area in 2007 (a,b); floor repaired in 2018 (c).

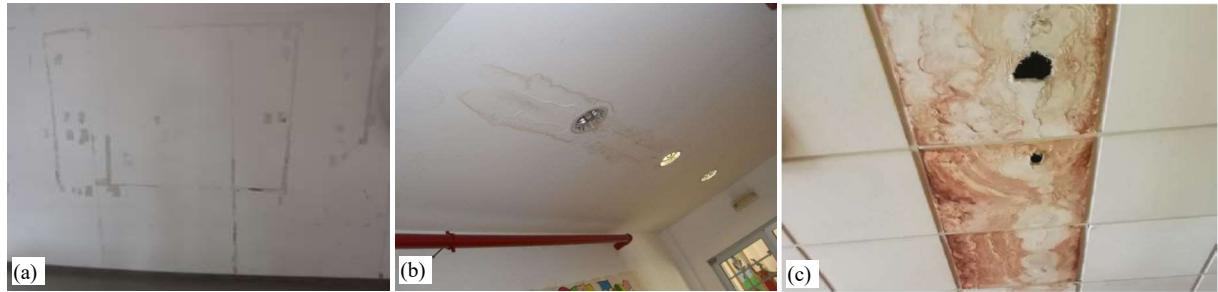
Degradation in wall painting due to the use of adhesive tape for the exhibition of students' work was observed in the inspection carried out in 2007. In 2018 survey this anomaly was observed more frequently and over a larger area of walls (Fig. 8a).

In ceilings, moisture and water ingress are the most frequent anomalies. Figure 8 (b,c) shows the increased severity of this phenomenon in VA School, that may have resulted initially from lack or loss of waterproofing capacity of the building envelope (in 2007) and later resulted from the combination of several causes including building structural and foundations settlement problems (in 2018).

Figure 8. AF School: degradation in wall painting due to the use of adhesive tape for the exhibition of students' work in 2018 (a). VA School: water infiltrations in the ceilings in 2007 (b) and in 2018 (c).

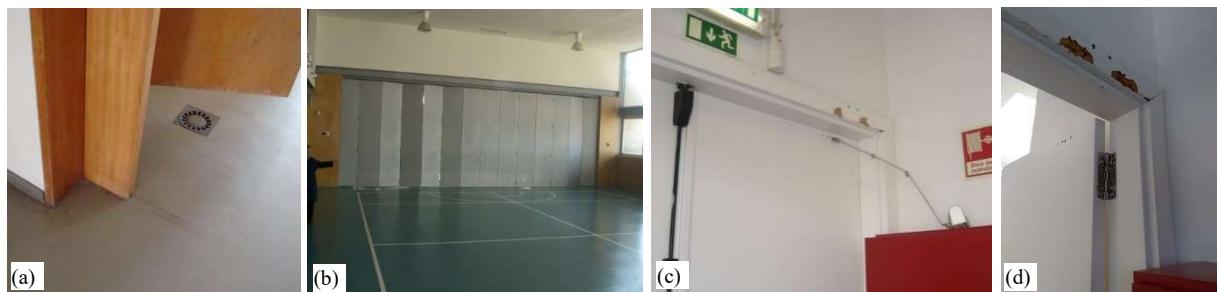
The model of the sliding doors used to separate the classrooms from the arts and crafts areas and in bathrooms (PRM, PM and AF Schools) presented several functional problems related to unsuitable serviceability, vertical misalignment and deficient fixation tracks causing localized wear on the floors finishes (Fig. 9a). The use of large bellows doors to separate the gym from school cafeteria is a widely used solution in these recent buildings schools. This solution aims to open the spaces with an area for students to perform shows/theaters an area for the audience. Due to their characteristics, these doors are large (length and height) and are heavy, which makes manual maneuvering difficult. These doors are now permanently closed and are not used because they require maintenance and repair actions without which their safe use is not guaranteed (Fig. 9b). At PRM School, door closer need to be repaired in interior fire doors. In 2007, these elements were damaged (Fig. 9c), while in the 2018 survey it was found that the element was not placed where it was supposed to be (Fig. 9d).

Figure 9. AF School: sliding door anomaly (a) non-operational bellows doors (b). PRM School: door closer anomaly in fire doors in 2007 (c) and 2018 (d).

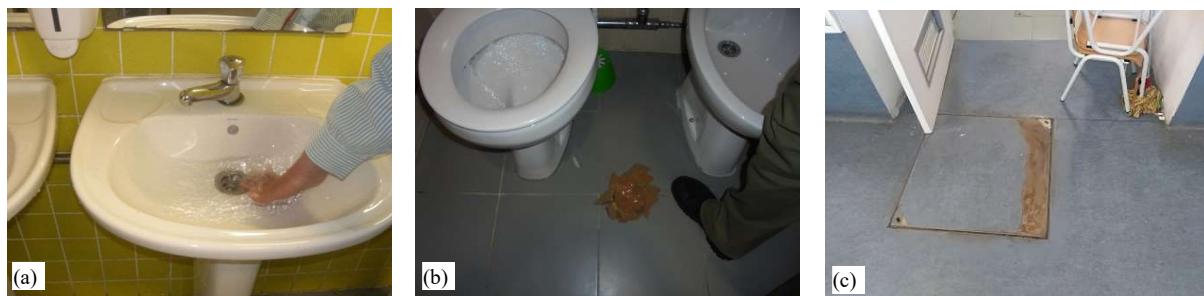
anomalies in these systems continue to be (i) the breakdown of the toilet flushes, (ii) fixing problems of water faucets and (iii) problems with the drainage capacity of the wastewater network. The lack of proper maintenance and misuse, results in nonfunctional equipment and sometimes in floods. Figure 10 (a) shows the poor fixing of the water tap and deficient drainage of the wastewater, (b) failure in the flushing system causing waste of water and (c) anomaly in the floor box of the wastewater network.

Figure 10. PRM School: anomalies on water tap and in the water flow, 2007 (a) failure in the flushing system, 2018 (b) and anomaly in the floor box covering finish of the wastewater network, 2018 (c).
