A PROTECTED LANDMARK MONUMENT: REINFORCEMENT, REHABILITATION, AND RESTORATION OF THE CATHEDRAL BASILICA OF MANIZALES

OMAR D. CARDONA^{1*} AND SAMUEL D. PRIETO (1949-2016)²

Keywords: Historical Building, Vulnerability Assessment, Seismic Retrofitting.

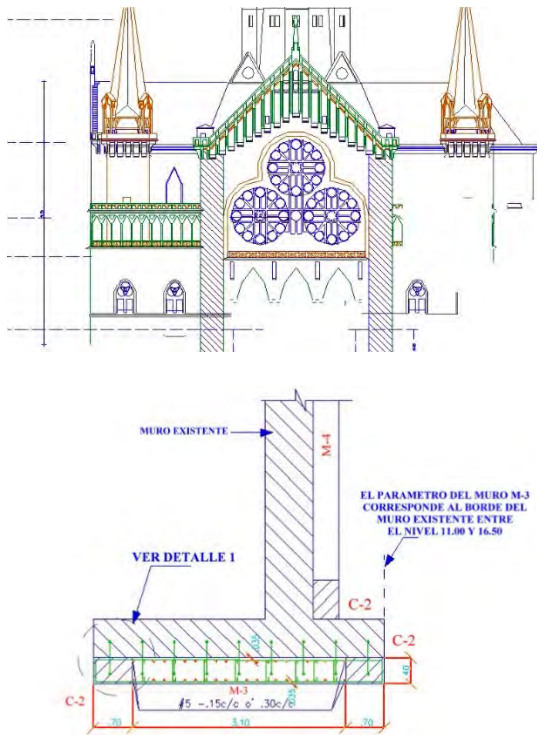
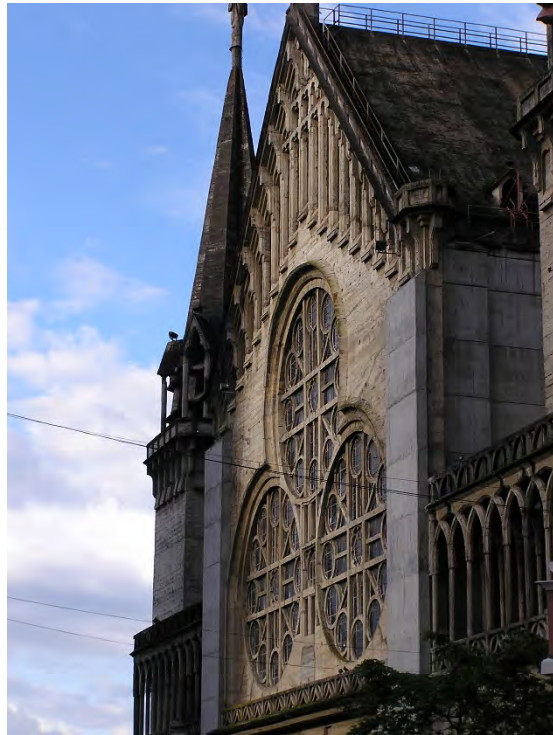
Figure 3: Attached walls were built to provide greater stiffness, resistance and energy dissipation

For a better behavior before the lateral loads it had been established that it was necessary to reinforce the structure by means of eight new orthogonal structural walls located in the periphery; in the places considered of greater efficiency for structural effects and where they will not cause major changes in the original architecture of the building. These walls could replace existing walls, however, due to the difficulties that this meant for the construction, it was established that said walls should be built attached by means of anchors to the existing walls (see Figure 3). This situation, although minorly modifying the façade, was preferable since the vertical loads were still transferred to the foundation by the existing walls. On the other hand, great difficulties and risks were avoided in the construction process, otherwise it would have been necessary to temporarily

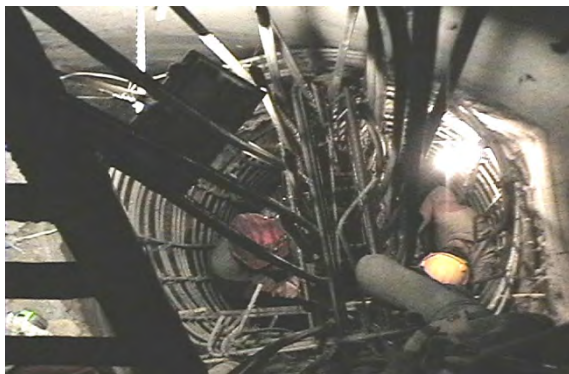
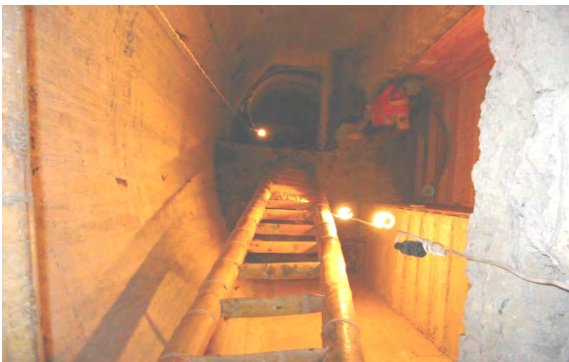
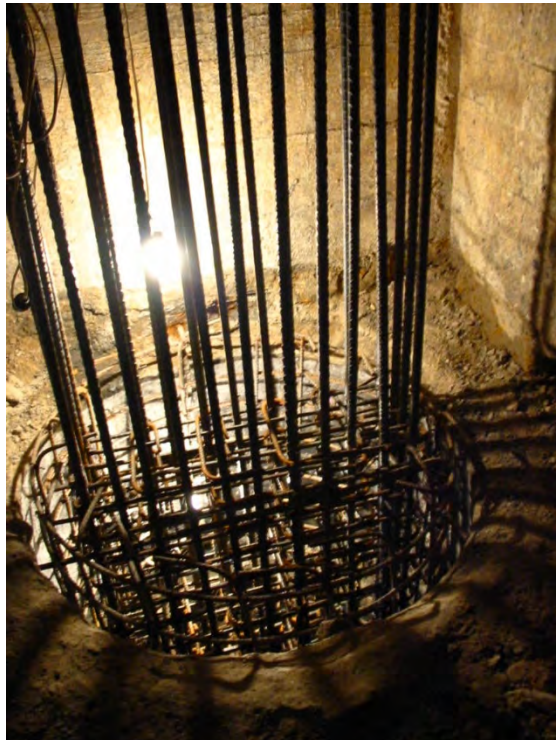
Figure 4: Foundation with caissons to prevent rotation at the base of the structural walls

hold large vertical loads as well as the thrusts of the arches that converge there. These new walls had to have edge elements capable of supporting the moments that would be generated in case of an earthquake and that must reach the foundation based on a new high foundation beam, located below the existing foundation, which in turn should be built supported by caissons that will guarantee the embedding or non-rotation of the new walls; issue that was very difficult to carry out but that was necessary (see Figure 4). These new structural walls had beams at different levels and at the top to ensure that they could be connected by a network of new beams that formed a ring at the level of the diaphragm between levels 24 and 27 meters and with the purpose to provide an ideal system to absorb tension stresses when the structure would be moved by an earthquake. These beams were built using steel plates attached and bolted to the high ribs of the vaults that reach the heads of the walls and that connect to the dome under the central spire, achieving the connection and transmission of forces and the effect of diaphragm with the new structural walls in the form of L and that finally they were built internally and externally attached to the walls of the structure (see Figure 5).

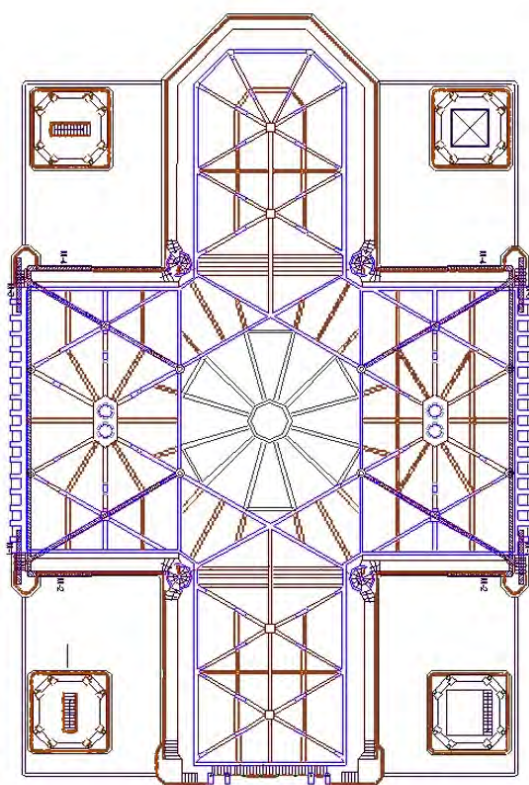
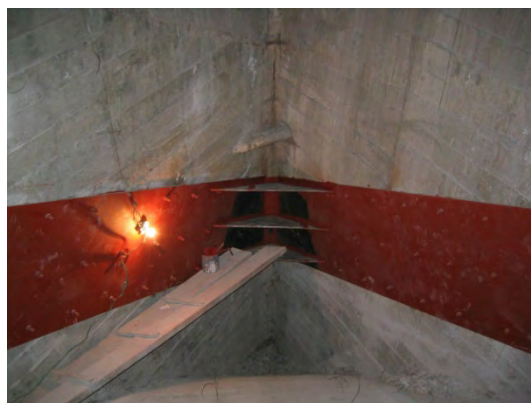
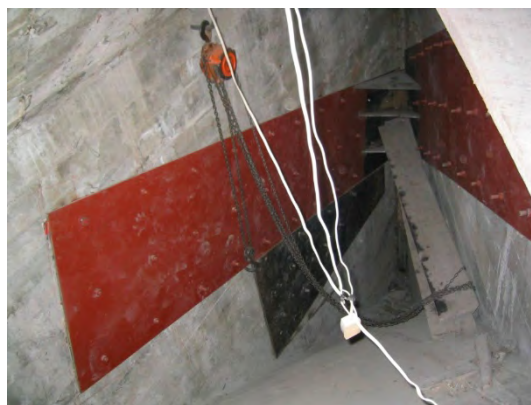
Figure 5: Steel beams make up a diaphragm and connect the heads of the structural walls

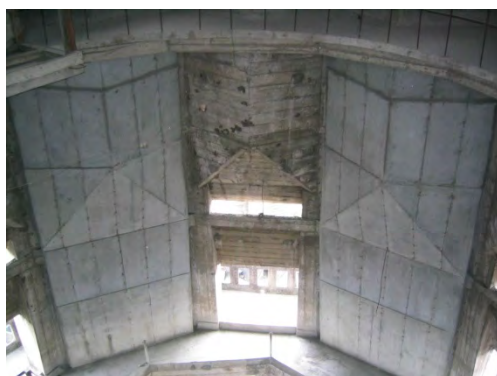
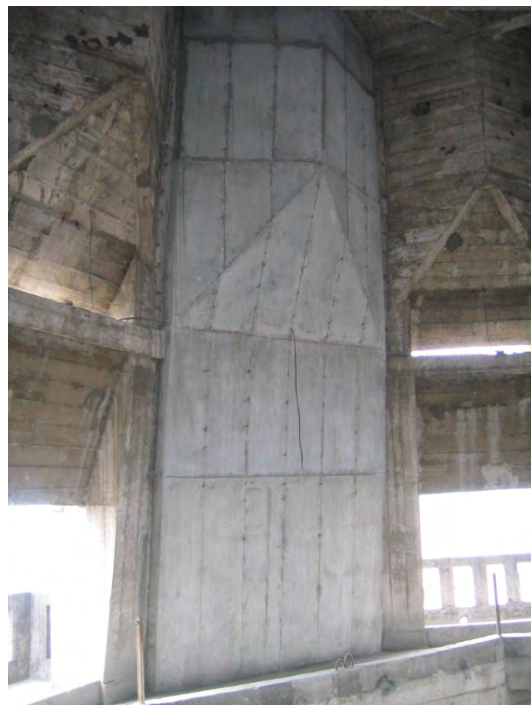
It was also detected that the central spire induced remarkable efforts at its base when it vibrated at the action of an earthquake. Since near its base where the folded plate that forms the tower was supported in a group of pillars whose reinforcement was insufficient to absorb tension stresses, it was considered that this area was critical and would have to be reinforced. Finally, it could be ratified that the towers or corner spires that had been reinforced after the 1962 earthquake with an internal steel structure were not properly anchored, offering a high possibility of instability in case of a severe earthquake. For this reason, it was considered pertinent to carry out an intervention that could guarantee greater stability and foundation anchorage.

Figure 6: Internally attached reinforcing walls were constructed at the base of the central spire

The central spire was intervened at its base by means of six reinforcing walls attached to the folded plate that forms the tower. In this way, the capacity of the structure at the base of the spire to withstand tension stresses when it becomes subject to lateral forces caused by earthquakes was improved. These walls were built internally so that from the outside it is not possible to see them and because of a recent earthquake they have already presented cracks, which illustrates that they have already been working (see Figure 6). In addition, this internal work was used in the central spire to make a new internal metallic helical staircase that allows people to climb up to the tip of the central spire where is placed the so-called “Polish Corridor”.

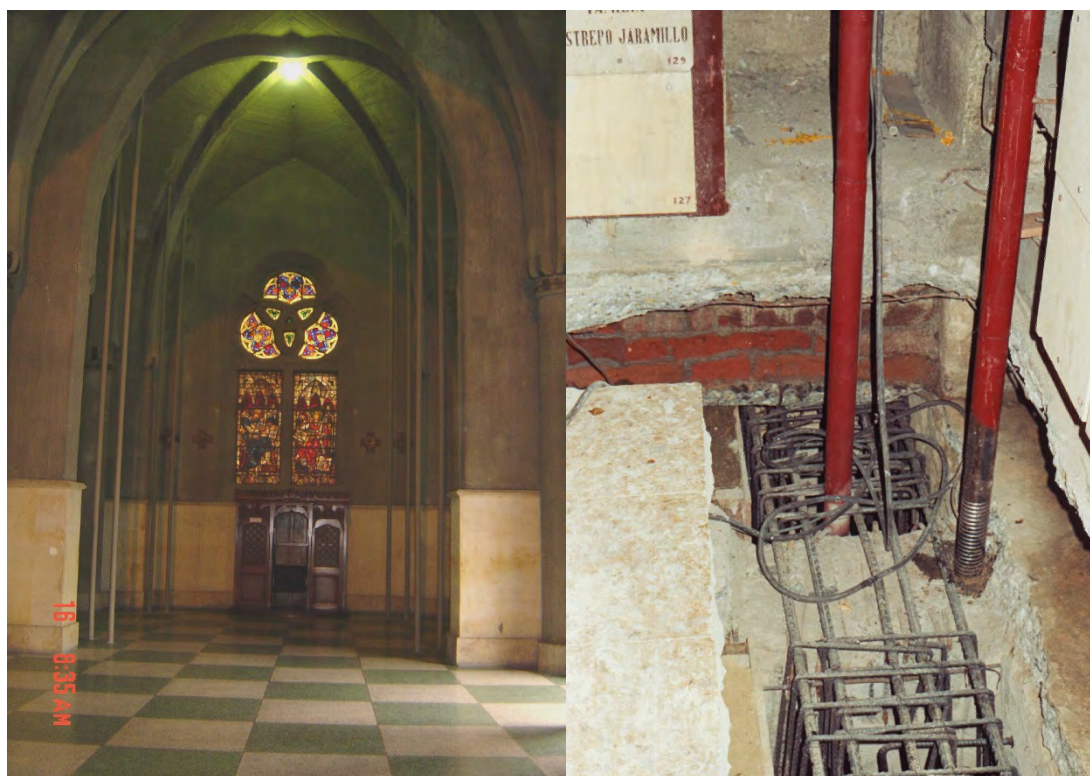
Figure 7: Eight rods or tensioners provide stability to corner spires in case of an earthquake

Finally, in order to improve the stability of the corner spires, a connection was made using eight special rods of 7.5 cm in diameter that connect the base of the internal steel reinforcement structure of each tower at the 11.20 meter level with a new beam located in the foundation to which they must be anchored (see Figure 7). In this way these rods act as tensioners that prevent the turn of the towers in case of a strong earthquake.

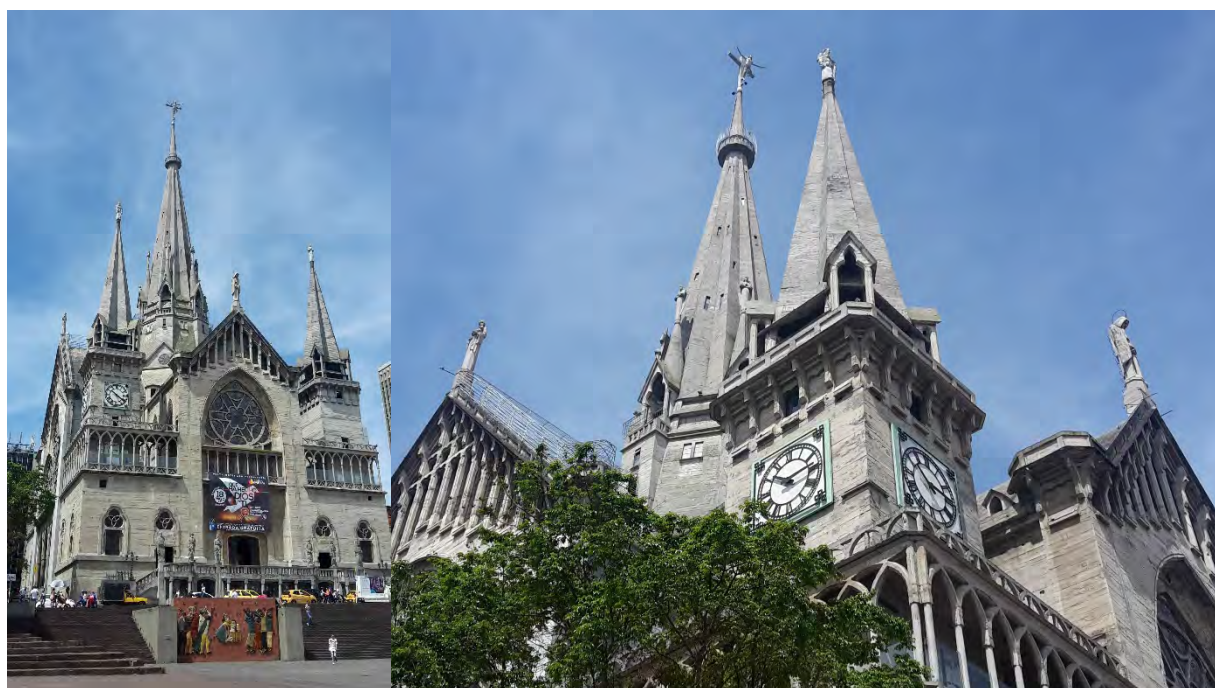
Figure 8: The current appearance of the Cathedral after washing and concrete treatment and protection

Two phases of this maintenance were planned. In its first phase, the most urgent activities were included. On the one hand, the removal of mortars from terraces, canals, and walkways, which were replaced with sloping cement to improve adhesion, waterproofing and mechanical resistance to traction and bending. This process was complemented by the application of a product that minimized cracking and where necessary additional reinforcements were made with welded mesh. The slopes were oriented towards the grilles that were projected according to the new hydraulic installations that were projected and made. Also, the washing and disinfection of the façade were carried out by applying a corrosion inhibitor and a water repellent was applied. A type of biocide with properly diluted benzalkonium chloride was applied and for the minimum recommended time, which was also facilitated with the use of plastic bristle brushes to improve the action of this product in the different layers of the dirt layers, particles pollutants, and biofilm that had formed over the years. Then the cleaning was carried out with a pressure washer with a pressure less than 750 psi, with a fan jet and more than 30 cm away between the nozzle and the concrete to avoid damage to the concrete. Once the surface dried, for which at least three sunny days were required, the corrosion inhibitor or passivator was applied to the reinforced concrete at the sites of greatest relevance of the bases and towers. This process had setbacks due to changes in color in the concrete that had to be corrected with abundant rinses and due to the need for the surface to dry, which was not facilitated due to persistent rains. Additionally, due to the lack of water pressure in the highest parts of the temple, a system that kept the pressure constant had to be developed. The final stage was the application of the water repellent in order to repel water, prevent corrosion and achieve a coating that prevents the new appearance of moss. To the extent that this product was applied, gaps and fissures were intervened with another product suitable for this type of repairs, on façades and towers from top to bottom to the 11.20 m level, pending completion of this work in a new phase that allows continuing until this treatment to the base of the temple. Figure 8 illustrates the new clean and clear appearance of the concrete surface of the Cathedral. The dark appearance that it had due to the dirt and carbonation that the concrete had suffered for many years was eliminated.

On the other hand, this was also the opportunity to repair the cornices and decorative elements of the façade, as well as the covering of the downspouts using a mixture of mortars or concrete using proportions of dyes. Multiple trial and error tests were performed in order to simulate the original color of the concrete of the Cathedral. Sixty-five samples and cores were taken to verify the carbonation state of the concrete and dust extraction tests to verify from a chemical point of view in the laboratory the condition of the concrete paste. Cleaning the interior vaults of bird droppings, garbage, fragments and even wood that were from the construction was carried out, and synthetic meshes were also placed to prevent birds from entering these sites as they did before. To improve water management that was very precarious, an appropriate system of siphons, grilles, and downspouts was constructed, and the sewer of the surrounding streets was replaced due to its very poor condition when its respective revision was made. Finally, as a result of the strong deterioration, twenty-two sculptures of the five spires of the temple were changed, replacing them with new ones or repairing them, which allowed preserving the original icons of the Cathedral. These images were made using weather-resistant epoxy resin and the existing cross in the central spire was replaced by the one called the Levitating Christ, which required not only careful technical work on materials, construction processes, platforms and scaffolding in height, but the skill and artistic ability of a renowned sculptor of the city. The concrete sculptures that are located on the roofs were also maintained, as well as the sculptures of the guardian angels located at the base of the central spire. The concrete of these images was washed, disinfected and hydrofuge was applied like in the structure.
