SENATE BUILDING OF CANADA CASE STUDY: SEISMIC REHABILITATION

LISA M. NICOL¹

¹Senior Structural Engineer
at John G. Cooke & Associates Ltd. (JCAL)
17 Fitzgerald Road, Suite 200
Ottawa, Ontario K2H 9G1
e-mail: lnicol@jgcooke.com, www.jgcooke.com

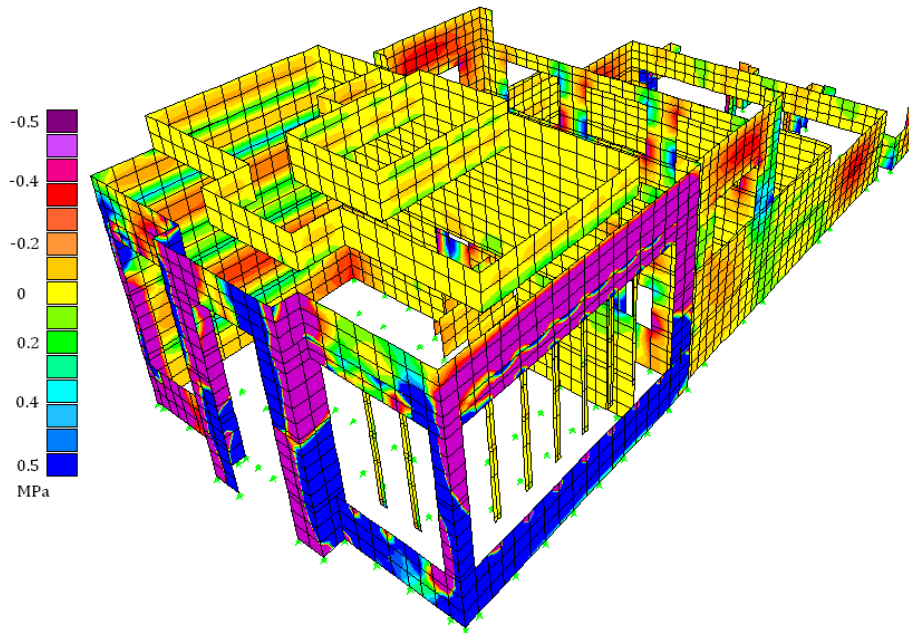
Figure 3: ETABS model of existing building

A lot of time was spent confirming that the model output was verifiable based on stresses on the building materials noted during on site assessments. The model is only as good as the level of accuracy it contains with the on-site existing conditions. For example, the existing building on site review of the masonry showed stress cracking and fractures at the North West corner of the MEB. When the model was reviewed, it also showed high levels of deflection and torsion at this same corner.

The on-site assessments also showed that there was masonry cracking at the corners of both the GWR Block and the Concourse Block, where the masonry walls had multi-storey unbraced heights. When reviewing the model, these corners were all high stress areas, due to excessive deflections and weak connections to the roof diaphragm.

The model was responding the same way the existing building had over its lifetime. This is a critical requirement of a model on any rehabilitation project, the importance of which cannot be stressed enough. Once the model is in tune with the existing building's behavior, the model becomes an extremely useful tool for seismic upgrades that meet the intent of current codes without over strengthening or stiffening the building. There is a definite point, where stronger and stiffer solutions do not provide favourable results, as it changes the way the building has generally performed over the course of its lifetime, producing an overall negative effect.
