Earth Construction Durability: In-Service Deterioration of Compressed and Stabilized Earth Block (CSEB) Housing in Algeria

Abstract. *The present work deals with a unique in-service valuation of CSEB structures in Algeria. The inspection tries to bring out the impact of long time exposure under different and opposite climate and micro-seismic contexts. The diagnosis methodology is inspired by the approach largely adopted for the rehabilitation of traditional architecture. It involves the compilation of the previous survey reports, visual inspection of the structures, in-situ and laboratory tests to assess the residual CSEB mechanical properties. The CSEB constructions are located in the coastal north and the desertical south part of Algeria and were exposed respectively to a long-term Mediterranean and Saharian climate. The results of the investigation show that the CSEB in the construction located in the northern region is increasingly altered by the humidity. As the relative humidity rises, the fouling layers grow over some level. The surface pitting which is the consequence of long exposure to the wetting/drying cycles is also observed. The outer surfaces of the walls were hone

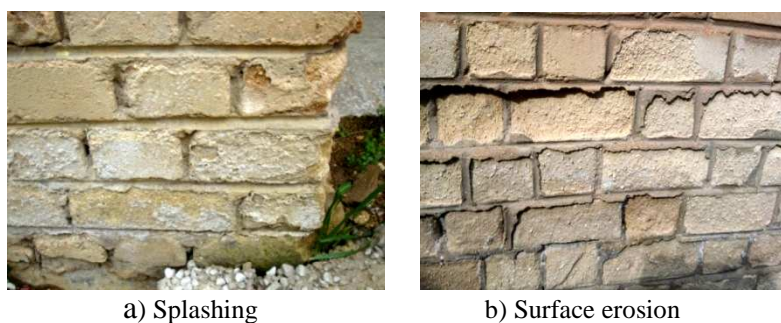
- i) The direct and repeated impact of the violent rain alters the surface of the external elements and causes a crumbling,
- ii) The flow of rainwater on a surface (runoff phenomenon) causes surface erosion of the blocks which thereby provokes detachment of render,
- iii) The splashing and infiltration generated by the indirect and repeated impact of rain on the ground, awning, exterior pavement, salient or re-entrant elements, followed by weathering, crumbling and digging.

As depicted on figure 7.a, the crumbling due to the impact of splashing attains generally the area close to the ground where the runoff phenomenon could provoke erosion in a large surface above the base (figure 7.b).

Figure 7. Impact of the mechanical action of the rainwater.

- Maintenance of the terraces according to the geographical situation and the climatic conditions.
- Cleaning walls affected by fouling and biological colonization.
- Checking the correct drainage of rainwater (avoid stagnation of water) to provide a good circulation and evacuation of the collected rainwater.
- Removing the element likely to cause seasonal variations in humidity in particular the vegetation near the building.
- Elevating the base, putting a sufficient roof overhang or installing an anti-capillary barrier especially in the North region.
- Resorting to the earth construction guide in the selection of the soil nature and the process of stabilization.
- Installing a windbreak and / or choosing an appropriate orientation of the structure minimizing the direct exposure to the winds.

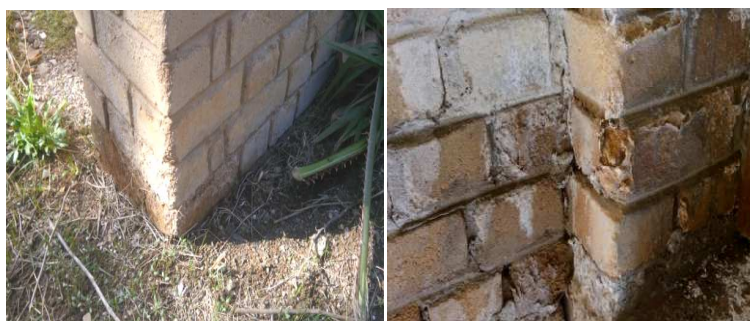
The inattention on removing the element likely to cause seasonal variations in humidity in particular the vegetation near the building participate actively on the development of humid pathology (figure 8).

Figure 8. Degradation observed in the north region (humid pathology).

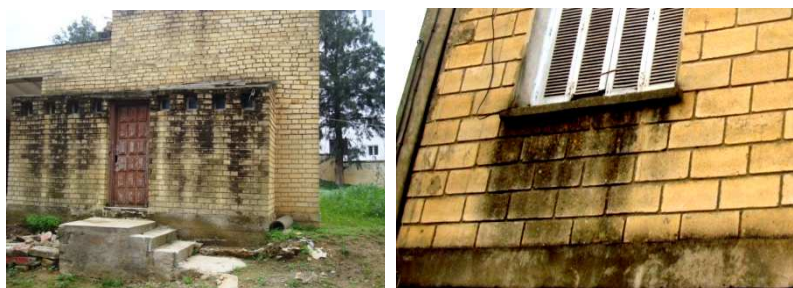
Furthermore, due to the high humidity rate, the pollution released in the air is fixed on the structures' external envelopes by dirtying the contact surfaces and favouring biological colonization (figure 9).

Figure 9 : Wall Pollution.

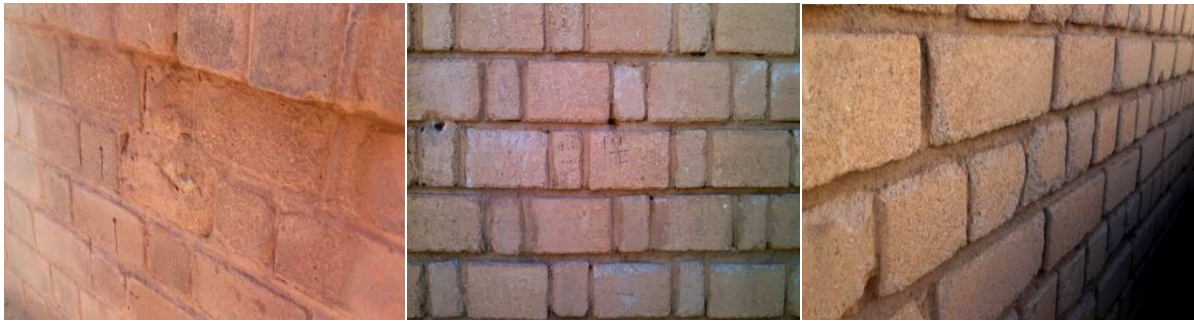
For the southern region, the investigation has ultimately identified very little pathologies due to exposure to climate, characterized by very low rainfall. On the other hand, the very frequent winds activity in this region has a stronger mechanical action when they carry suspended particles, such as the sands. The most common defects observed included: surface roughening, erosion and surface pitting. However, the inspection in the North and South regions has highlighted significant degradation resulting from poor design, production and implementation of the blocks, as well as others due to human intervention such as undertaking fitting out works or installation of air conditioning equipments.

Figure 10. Direct impact of the mechanical action of the wind.
