## STRUCTURAL ASSESSMENT OF THE 13TH CENTURY GREAT MOSQUE AND HOSPITAL OF DIVRIGI: A WORLD HERITAGE LISTED STRUCTURE

**Abstract.** *The Great Mosque and Hospital of Divrigi is located in the central eastern part of Turkey, in Divrigi, Sivas. The historical facility consists of a monumental mosque and a two-story hospital, which are adjacent to each other. The structure dates back to 13th century Mengujekids period and has been listed by the UNESCO as a World Heritage since 1985. Great Mosque and Hospital of Divrigi is particularly notable for its monumental stone portals that are decorated with three-dimensional ornaments carved from stone. The structural system of the monument consists of multi-leaf stone masonry walls and stone piers that support the roof structure which consists of stone and brick arches and vaults. The structure is located about 90 km away from the North Anatolian Fault Line, that has been causing several destructive earthquakes. Consequently, the structure is prone to destructive seismic activities. In this study, after a brief introduction on the structural system and current condition of the structure, the structural performance of the Great Mosque and Hosp

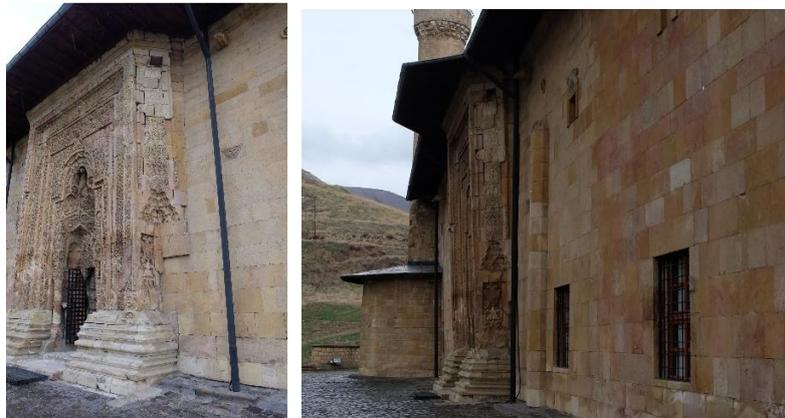
The walls are approximately 1.4 m thick multi-leaf walls with cut-stone outer leaves and a rubble masonry infill. The roof structure consists of stone arches and vaults. The only exception to this use of stone masonry is the brick masonry vaults (Figure 5) covering the areas adjacent to the western façade that are known to be damaged/collapsed and rebuilt together with stone buttresses adjoining with the western façade main wall. Another surviving trace of this incident is the significant out-of-plumb top displacement (almost 60 cm) of the mosque section western façade wall and portal (Figure 6).

**Figure 6:** Out-of-plumb deformation of the western façade mosque portal

In order to enhance the structural integrity and increase the OOP bending moment capacity, steel-timber composite bonding beams were proposed to be placed above the main walls. The projected system includes two timber beams having 100 x 100 mm x mm cross-section dimensions with two steel plates attached on both sides of each timber frame. The attached steel plates have 10 x 100 mm x mm cross-section dimensions. In plan, the two composite beams are connected together by steel cross ties at each 750 mm distance. The cross ties have square tube cross-sections with 60 mm of edge length and 6 mm of wall thickness. The view of a typical wall section with the top bonding beam is presented in Figure 16a.

provide ties to whole structure, 50-mm-diameter tension rods with AISI 316 steel class were proposed to connect the vertical components of the structure. The stress-strain relationship of AISI 316 and a view of the planned layout of the steel ties are shown in Figure 13b and Figure 16b, respectively.

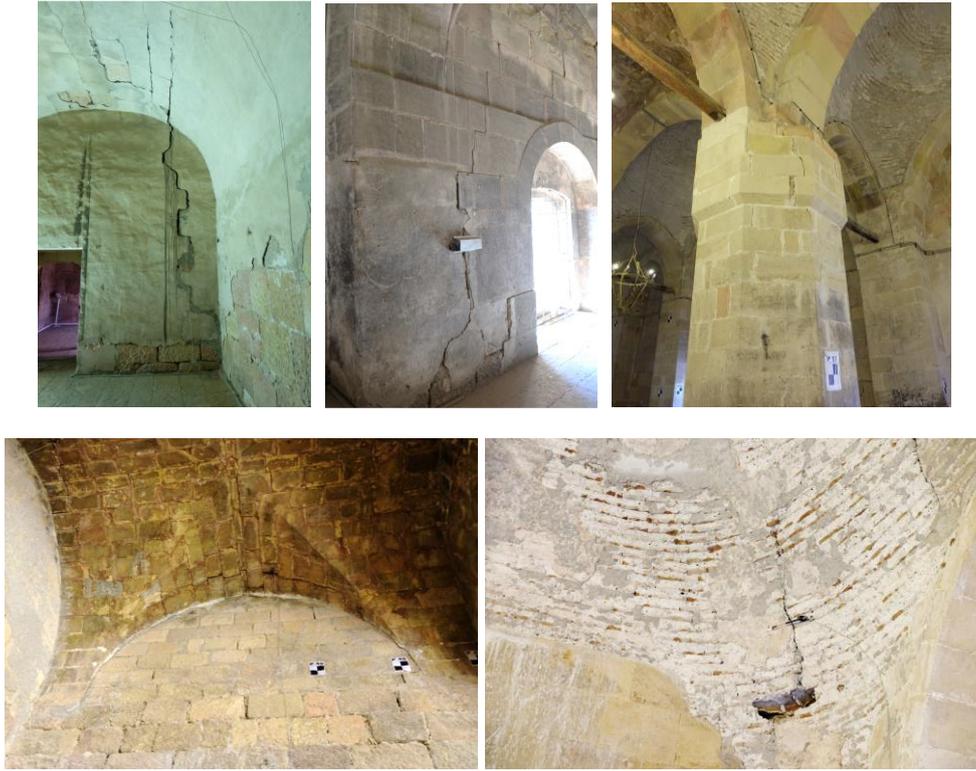
Located at about 90 km away from the North Anatolian Fault Line, that is known to have created  $M_w > 7.0$  earthquakes in the past, the structure is prone to destructive seismic activities. Being in such an active seismic region, the structure underwent several extensive repair and intervention works not only during the Ottoman, but also during the Republic periods. Although at its current state the structure is intact, several structural deformations in the form of cracks,

material losses and dislocations can be observed over the walls, piers and vaults (Figure 7). Additionally, material deteriorations and traces of malpractices of past restoration works (i.e.. poor workmanship, use of unsuitable materials like cement, interventions structurally and architecturally not coherent with the original techniques) can also be widely observed.

**Figure 7:** Typical damages on structural members

In addition to the above mentioned reinforcing methodologies, other structural interventions such as lime grout injection to walls and cracks, local repairs, replacement of heavily damaged/decayed masonry units, retrofitting of vaults with textile reinforced mortar (TRM) and bracing of cracked piers/pier caps are also planned.

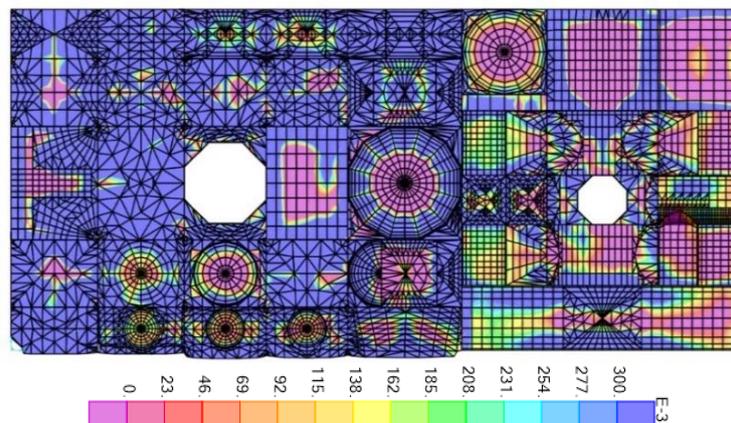
The mechanical properties of the structural materials were taken from [1] based on the site observations and masonry quality. Accordingly, the modulus of elasticity values for the stone masonry and brick masonry were taken as 1750 MPa and 2100 MPa, respectively. Similarly, the compressive and tensile strengths of stone masonry were considered as 1.80 MPa and 0.20 MPa, respectively. While they were 2.20 MPa and 0.20 MPa and for brick masonry, respectively. Also, the initial shear strength values were 0.065 MPa and 0.075 MPa for stone and brick masonry. The results of the structural analyses indicated that under gravitational loads and 2475-year return period seismic action, the obtained compressive stress values did not exceed the compressive strength values defined for the brick and stone masonry. However, the tensile stress values obtained at the critical sections of the vaults and the domes were generally greater than the assumed tensile strength values. Figure 9 shows the tensile stress distribution obtained for the roof structure.

**Figure 9:** Tensile stress distribution for the roof structure [MPa]

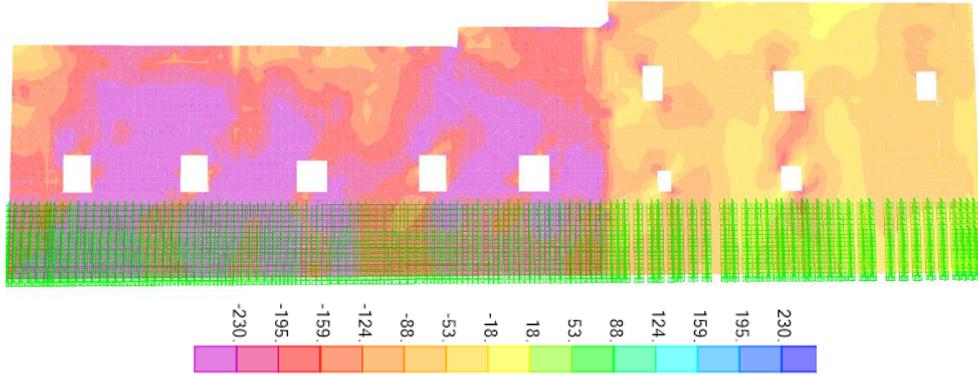
The shear stress values obtained for the masonry walls were compared with the calculated shear strengths of the materials. The shear strength ( $\tau$ ) at the critical sections was calculated using Equation 1, where  $\tau_0$  is the initial shear strength and  $\sigma$  is the compressive stress at the corresponding section. Shear stress distribution obtained for the western wall is shown in Figure 10.

**Figure 10:** Shear stress distribution on the western wall (unit: kPa)

On the whole, the obtained internal forces for shear, tension and out-of-plane (OOP) bending moment were greater than the calculated capacities of the many structural components. Hence, it was concluded that with its present condition, the structure does not satisfy the Controlled Damage performance level for 2475 years return period ground motion predefined in Guidelines for Management of Seismic Risks for Historical Constructions [1]. However, when the analyses were repeated for a 475 years period ground motion for Controlled Damage state (with  $R=3$ ), it has been observed that the capacities of main walls and piers were found to be acceptable except for the out-of-plane behavior of the main façade walls of the mosque section. This observation was also compared and confirmed with simple mechanism-based calculations for overturning of these main walls.

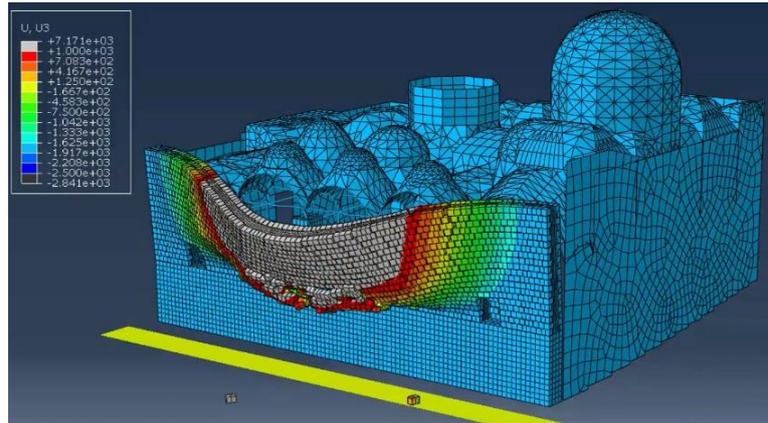
Site-specific response spectrum with 475-year return period was used to investigate the safety status of the western wall against seismic actions with its current condition. As a case study, an acceleration time history record was provided from PEER Ground Motion Database [8]. H1 component of ‘RSN1161’ Kocaeli earthquake record (1999) was selected and scaled by 1.185 to match the site-specific response spectra (Figure 14). The acceleration time history was applied in the out-of-plane (OOP) direction of the western wall. In the time-history analysis, the wall exhibited large OOP displacements which eventually initiated the instability and resulted with the collapse of the wall (Figure 15).

**Figure 15:** Out-of-plane collapse of the western façade wall observed during the time-history analysis (horizontal displacement contour in mm unit)

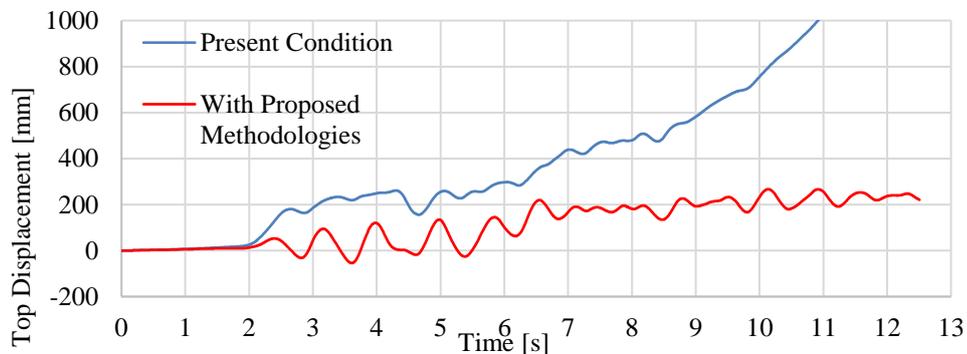
The described rehabilitation methodologies above were then defined in the nonlinear FE model and the time-history analysis was repeated under the same earthquake excitation. The rehabilitated wall did not exhibit instability and managed to withstand the seismic excitations until the end of the analysis. Displacement time histories measured at the top of the wall are presented in Figure 17 for both cases. It was concluded that, with the application of the proposed rehabilitation methods, the OOP displacement of the western wall can be reduced to nearly 25% of the same displacement obtained with the present condition of the wall.

**Figure 17:** Wall out-of-plane displacement at the top (measured relative to the ground)
