Failure Analysis of a Total Damage by Hail Impact of an External Thermal Insulation Composite Systems

Abstract. *A hailstorm has heavily damaged a glass fibre mesh reinforced mineral render of an externally insulated composite system (ETICS) of a family house. While a neighbouring house of identical design and of the same age showed only minor defects, for the house under investigation it was a total failure of the render. Material probes were taken from the damaged façade and analysed physically and chemically. Before renovation, the hail resistance of the façade was determined with a unique artificial hail impact test method: Clear ice balls were shot against the façade with the help of a launcher, where the kinetic energy of the projectile can precisely be controlled. The type of damage due to natural hail could be reproduced. The impact energy needed to cause a damage similar to the one caused by the natural hail was determined. The hail impact damage was also identical to results from hail testing performed in the laboratory on similar systems. Since the amount of rendering material on the façade was not according to standards of the Swiss Society of Engineers and Architects

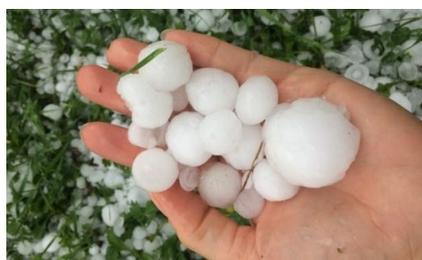
August 1st 2017 was a typical high summer day with a flat atmospheric pressure distribution over Europe. In the meteorological forecast for Eastern Switzerland the development of thunderstorms was expected with hail of hailstones up to 4 cm in diameter. Observations of hail in the neighborhood of the house under investigation stated hailstones of as large as 32 mm, s. Fig 1.

Figure 1. Hailstones of the thunderstorm on August 1st 2017 in Winterthur.

These observations confirmed a hailstorm of class 3, which has an occurrence probability of one in in 5 to 20 years in this region. Therefore such a hailstorm as to be considered in the design of a building, because a building should last for 30 to 40 years, (Kempton, Chap, and Alani, 2002). According to CFIA standards, the façade should be class 3 hail resistant, which means, that this specific event should have been survived undamaged. The first conclusion was, that the façade was not as strong as it should be according to CFIA regulations.

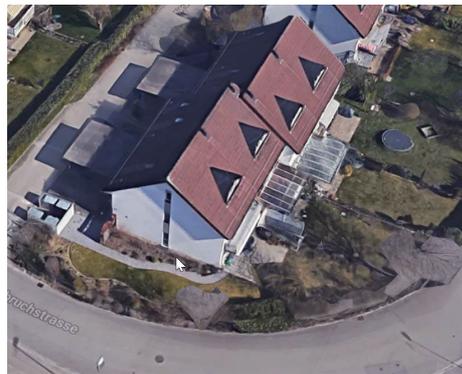
The house was exposed to Northwest. An aerial view of the house with the affected façade from West is shown in Fig. 2. A detailed visual inspection showed 147 damage locations evenly distributed over the façade's area of 70 m². The damages found were classified in three categories: cracks (low level damage), full circle fracture (medium level damage) and breakout of the render with uncovering of the reinforcement (high level damage). Typical representations of these three types of damage are shown in Fig. 3. 71 locations showed a low level, 51 a medium level and 21 locations a high level damage. The morphology of these damages was similar to damages found in artificial hail tests on ETICS (Steinbauer, 2016).

Figure 2. Aerial view of the façade from West.

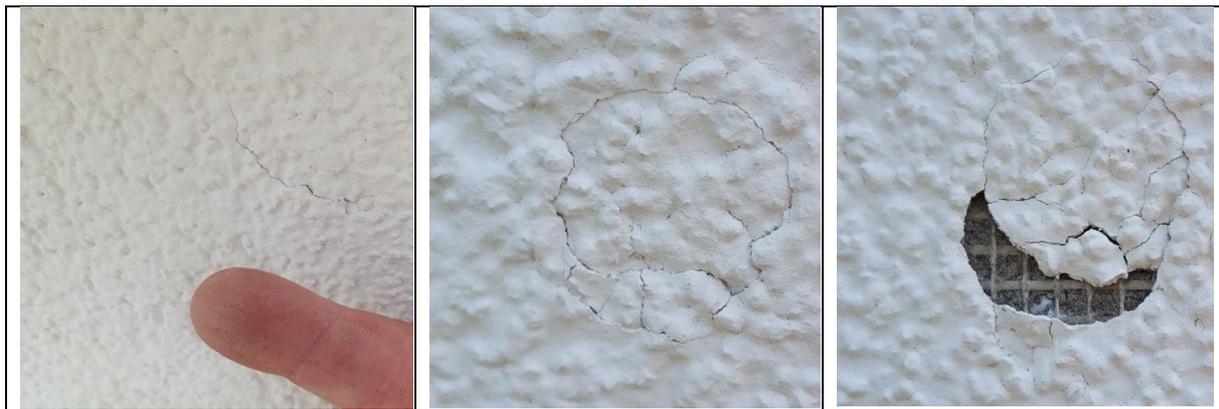
Figure 3. Representations of the damage classes: crack (left), full circle fracture (center) and breakout (right).

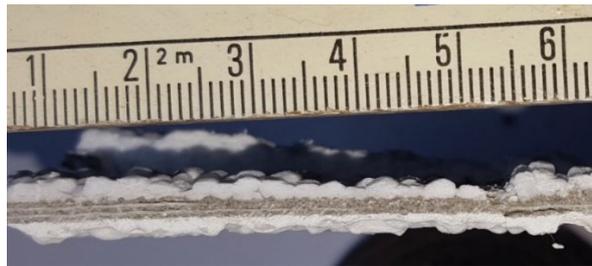
The thermal isolation was a polystyrene foam with grain size of 2.8 mm and a density of 19.2 kg/m^3 . The rendering was characterized with Thermal Gravimetric Analysis (TGA), Infrared Spectroscopy (IRS), and X-Ray Diffraction (XRD). The render was cement-bound. The main crystalline phase was calcite (aggregate, filler and carbonated binder). In addition, it contains dolomite, quartz and layer silicates as aggregates and filler. The calcium hydroxide was no longer visible from the cement, because it was carbonated (also not visible in the TGA). However, residues of the cement clinker phases were still visible. Mono-carbonate was seen as the hydration product. Some gypsum was also found. The chemical composition was as for a typical high strength mineral render bonded with Portland cement for thin layer application. The rendering was reinforced with a single or double layer of a mesh of glass fibers with an acrylic and polystyrene coating. The dimensions of the different layers were measured, s. Fig. 4. and table 1. Some those findings quality questions arose.

Figure 4. Cross section through the rendering (inside up – outside down): double reinforcement on the left, single reinforcement in the middle and on the right.

For the strength of the rendering system, the paint coat and the finishing coat are of secondary importance. Therefore, in order to assess the quality of the rendering system, the focus was on the thickness of the base coat. According to the Swiss standard for Engineers and Architects SIA 243 (SIA, 1998), the base coat must have a thickness of 2 mm to 7 mm. Also the Austrian standard ÖNorm B 6410 specifies a minimum layer thickness of 2 mm. A new version of this standard requires an average layer thickness of 3.0 mm and a reinforcement mesh which must be covered with a minimum of 1.0 mm to a maximum of 3.0 mm of concealed render. Therefor we concluded, that the layer structure of the rendering of the façade under investigation was seriously defective and thus not carried out in accordance with the state of the art.

The results of the study leaves the possibility open that a thickness effect or an effect of the reinforcement only occurs in the aged state. A further possibility is that the ageing effect only occurs when the layer structure is correctly applied, but not when it is too thin. An indication that the first possibility applies is the comparison of the façade examined here with the façade of the neighboring house. Both houses have the same design and are of the same age. Assuming that the façade of the neighboring house was correctly manufactured, the thickness effect in the aged condition could be assessed by comparing these two façades. The façade of the neighboring house had only a few impact damages, which could be repaired locally. This indicates that it was not the advanced age that caused the massive damage to the façade, but the poor workmanship. The repair was a complete rebuilding of the rendering.

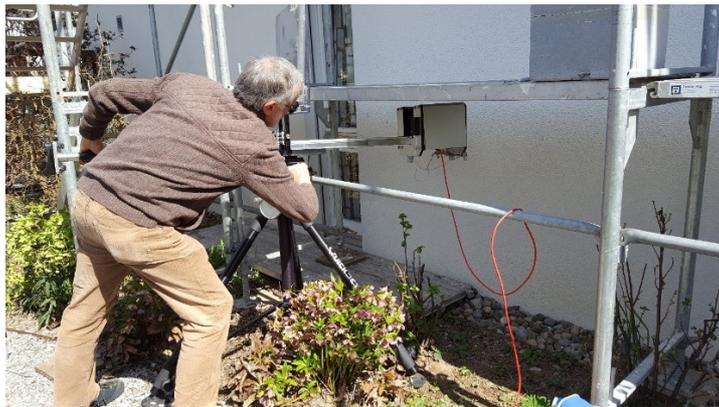
Figure 5. On-site determination of the hail resistance with an ice ball launcher.

The damage caused by the artificial hail, e.g. the bombardment with ice balls, largely corresponded to the damage caused by the natural hailstorm of August 1st 2017. The shot with the lowest kinetic energy provoking a damage was 2.5 J, which corresponds to a natural hailstone of approx. 25 mm diameter in free fall. It resulted in a dent and a full circle fracture in the façade. When the façade was bombarded with 40 mm ice balls and with an energy beyond 10.0 J also breakout of the render was observed. The façade did not show a class 3 hail resistance according to the ACFI guidelines.
