SLOW-MOVING LANDSLIDE DAMAGE ASSESSMENT OF HISTORIC MASONRY CHURCHES: SOME CASE-STUDIES IN ITALY

CHIARA FERRERO^{1,2*}, LUDOVICA CAMBIAGGI¹, ANDREA FENIALDI¹, PERE ROCA², RITA VECCHIATTINI³ AND CHIARA CALDERINI¹

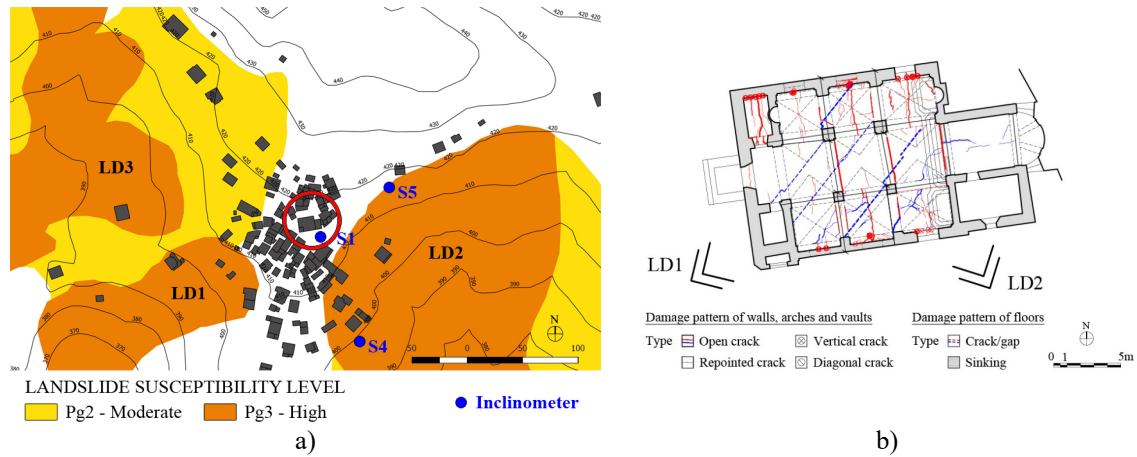
Figure 2: San Martino church in Cembrano: a) position of the church and inclinometers on landslide maps, b) damage pattern.

The crack pattern surveyed in San Martino church is reported in Figure 2b. Extensive and severe damage is observed throughout the building. Significant cracks are present in the longitudinal walls in the middle of each bay (Figure 3a). In the first two bays behind the façade cracks are vertical, while in the third bay they exhibit a diagonal orientation up to the window and then they become vertical. These cracks progress along almost the entire height of the wall, increasing in width with height, and continue up into the arches and vaults above, cutting them transversally (Figure 3b). Conversely, no continuity is observed with the gaps of the floor. Since cracks propagate downwards with descending closure, such a crack pattern (colored in red in Figure 2b) can be associated with tensile stresses occurring in the upper walls due a concave-upward bending (hogging) of the structure along the longitudinal axis of the church. Such a hogging mechanism is consequence of incremental vertical ground movements in the longitudinal direction of the building. Since landslide LD1 moves in this direction, it is reasonable to assume that this one caused the observed hogging mechanism and corresponding crack pattern.

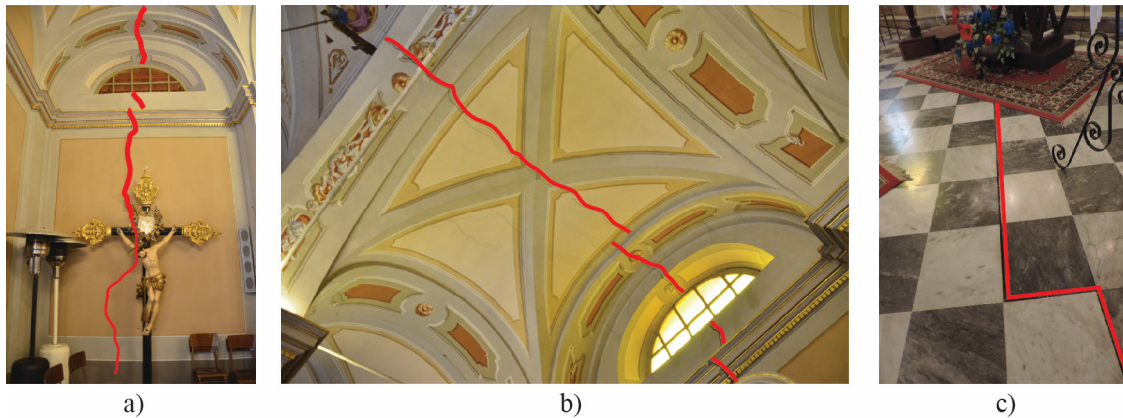
Figure 3: Damage observed in San Martino church in Cembrano: a) vertical cracks in the longitudinal walls, b) cracks continuing up into arches and vaults, c) parallel oblique gaps in the floor.

In addition to the damage pattern described above, the presence of three parallel gaps (i.e. separations developing at the joints among tiles [1]) cutting diagonally the entire floor is observed (Figure 3c). Gap width ranges from 3 mm to 10 mm, for a total of 24 mm along the entire length of the naves. Diagonal cracks are also observed in some vaults of the central and left nave, oriented in the same direction as the gaps of the floor. One of these cracks also continues into the barrel vault of the presbytery at mid-span. The horizontal separation among tiles, amounting in total to 24 mm, suggests that the church was subjected to a horizontal movement in the direction perpendicular to the gaps of floors (and cracks of vaults). As shown in Figure 2b, the latter corresponds to the direction of movement of landslide LD2. Consequently, the crack pattern shown in blue in Figure 2b can be associated to an extension mechanism produced by landslide LD2. It is important to highlight that this outcome does not conflict with the negligible values of horizontal displacements recorded by inclinometer S1 between 2010 and 2016. Indeed, the landslide was monitored for a very short time compared to the history of church. Furthermore, it is known that the cracks currently visible can be dated back at least to 2012, thus they probably occurred before the monitoring system was installed. On the other hand, the significant horizontal displacements measured by inclinometer S5 indicates that landslide LD2 is characterized by a significant component of horizontal movement, which is congruent with the crack pattern observed in the church.

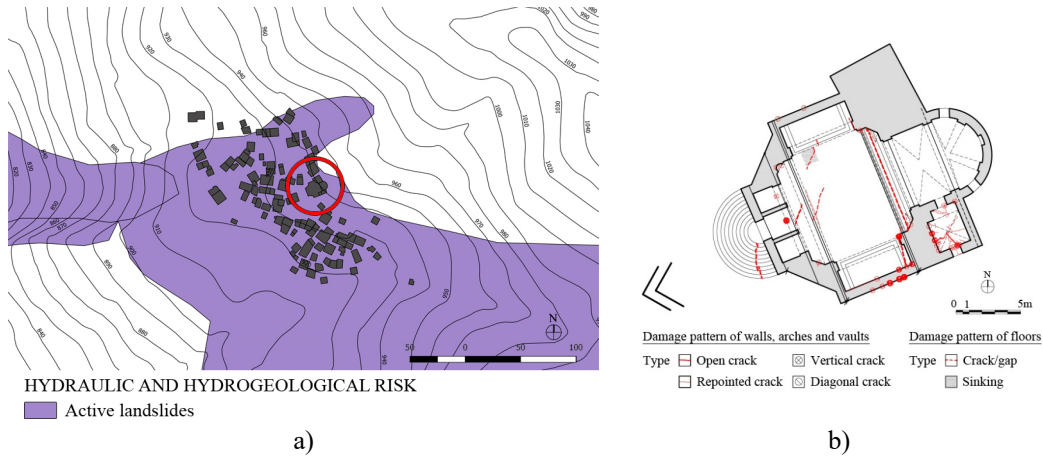
Figure 4: San Bernardo da Mentone church in Ascona: a) position on landslide maps, b) damage pattern.

The crack pattern observed in San Bernardo da Mentone church is depicted in Figure 4b. Both longitudinal walls present large diagonal cracks extending from the ground level and propagating upwards towards the façade (Figure 5a). A large gap crosses transversally the entire floor at the intersection between nave and presbytery (Figure 5b). It is observed that this gap propagates between the cracks of the longitudinal walls. A series of parallel oblique cracks is also detected in the floor (Figure 5c). Furthermore, minor cracks can be observed in the walls and vaults of the canonical house.

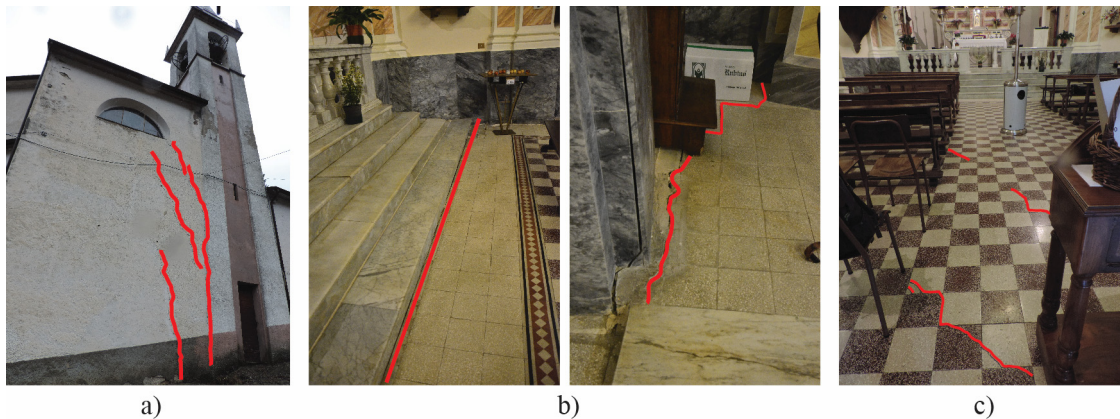
Figure 5: Damage observed in San Bernardo da Mentone church in Ascona: a) diagonal cracks in longitudinal walls, b) large gap/crack in the floor, c) parallel oblique cracks in the floor.

The diagonal cracks occurring in the longitudinal walls at both sides of the church suggest that the building suffered a shear deformation due to differential vertical ground movements in the direction of the longitudinal axis of the church. On the other hand, the large separation among tiles present in the floor at the intersection between nave and presbytery indicates the presence of horizontal displacements. Since both components of ground movements are

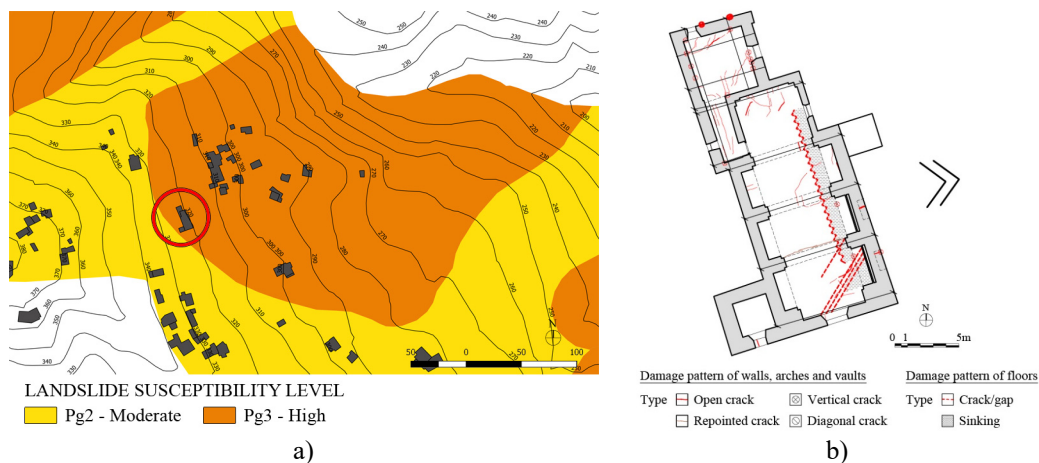
Figure 6: San Lorenzo church in Sorbolo: a) position on landslide maps, b) damage pattern.

The crack survey of San Lorenzo church is depicted in Figure 6b. It is important to point out that the authors reported the damage currently visible in walls and vaults, while the damage of floor, which was refurbished, was reconstructed thanks to some pictures dating back to 1994. The floor presented extensive damage in the form of gaps among tiles and sinking. In particular, close to the right longitudinal wall, the floor was affected by a saw-tooth gap extending longitudinally over almost the entire length of the nave and presbytery (Figure 7a). In that area, a significant sinking of the floor could also be observed. Furthermore, multiple parallel oblique gaps accompanied by sinking were noticed in the floor of the first bay behind the façade. Damage of walls is localized in the sacristy, which exhibits two large cracks in the north external wall. Regarding vaults, only few minor open cracks can be observed in both the nave and sacristy.

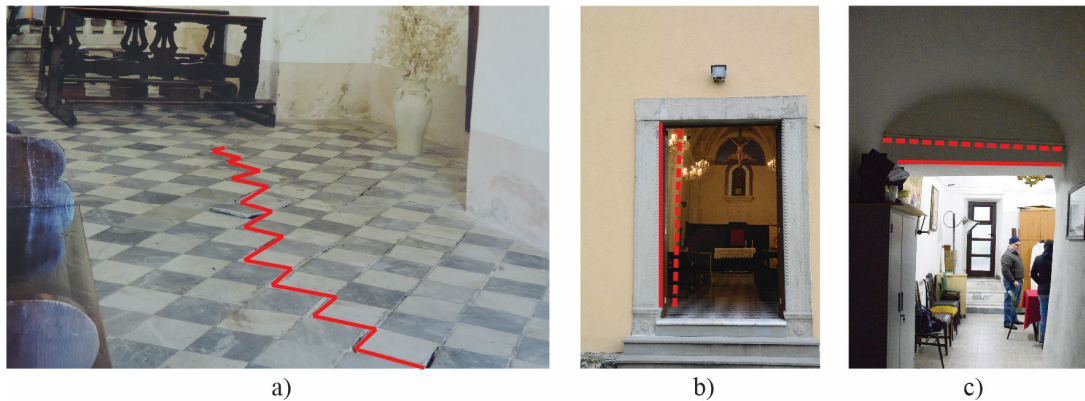
Figure 7: Damage observed in San Lorenzo church in Sorbolo: a) saw-tooth longitudinal gap and sinking, b) out-of-plumbness of longitudinal walls, c) distortion of transverse arches and loss of horizontality of tie-rods.

The most significant damage observed in the church are large deformations. Indeed, the building experienced a global rigid rotation downhill along its transverse axis. This can be easily seen from the presence of out-of-plumbness of the both longitudinal walls in the same direction (Figure 7b), distortion of transverse arches (Figure 7c) and loss of horizontality of tie-rods (Figure 7c). These deformations as well as the sinking of the floor on the downstream side of the church suggest that the building was subjected to incremental vertical ground movements in the direction of the transverse axis of the church. Such movements can be reasonably attributed to the landslide acting in the area since the latter is oriented parallel to the transverse axis of the building. Furthermore, such a global mechanism affecting the whole church can hardly be attributed to local subsidence or foundation settlements, which usually produce more localized damage in historical structures. Conversely, slow-moving landslides are associated to large mass movements that can affect the church in its entirety.

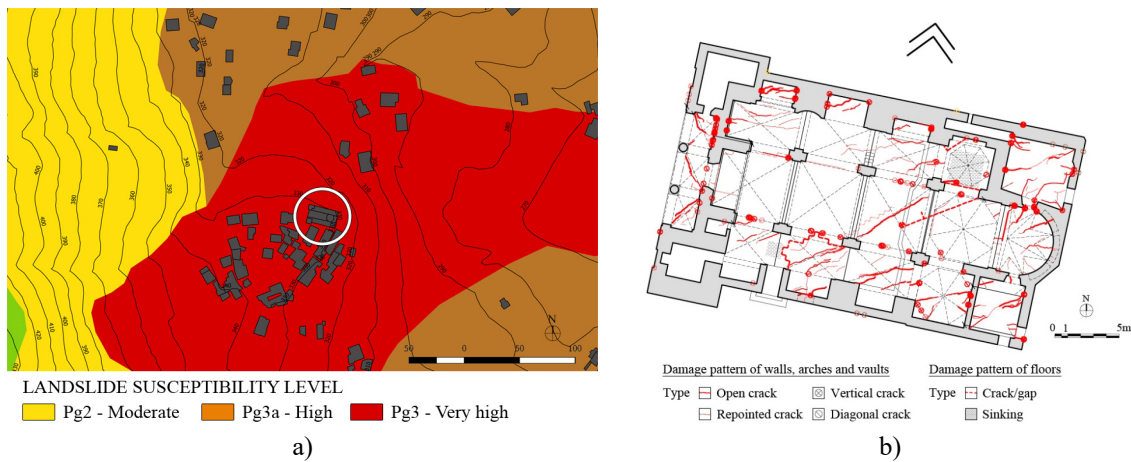
Figure 8: Santa Margherita church in Diano Arentino: a) position on landslide maps, b) damage pattern.

The crack pattern of Santa Margherita church is reported in Figure 8b. The church exhibits extensive and severe damage. The floor presents a series of parallel oblique gaps affecting both the central nave and the lateral naves. Such gaps are very large, reaching a width of some centimeters (Figure 9a). Moderate to severe damage can be observed throughout the vaults. In particular, the vaults of the central nave, lateral naves, sacristies, apse as well as the right lateral dome of the transept exhibit diagonal shear cracks (Figure 9b), all oriented in the same direction and parallel to the gaps of the floor (Figure 8b). Cracks are also visible in the transverse arches at mid-span. Severe vertical cracks can be observed in the lateral walls as well as in left side of the façade wall. These cracks progress upwards from the level of the ground and cut the structure over its entire height, continuing up into vaults (Figure 9c).

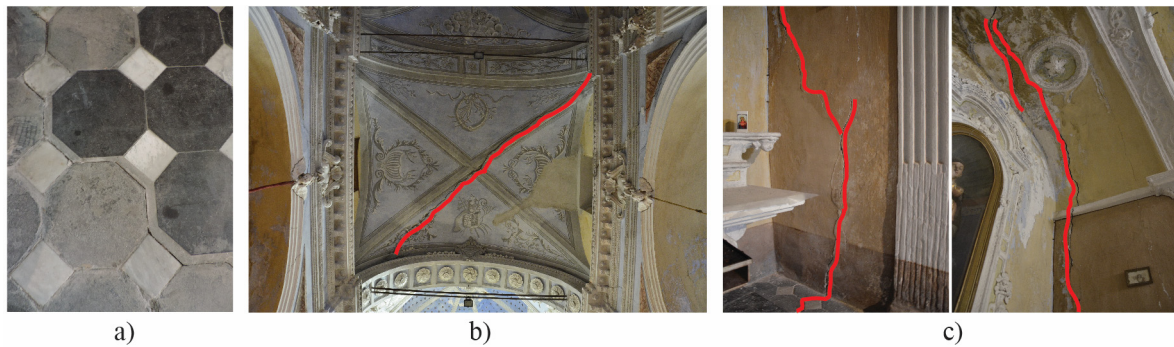
Figure 9: Damage observed in Santa Margherita church in Diano Arentino: a) large gap in the floor, b) diagonal shear cracks of vaults, c) vertical crack progressing over the entire height of the wall from floor to vaults.

Although no information is available regarding the magnitude of the vertical and horizontal components of movement produced by the landslide, the damage pattern observed in the church suggests the presence of a significant component of horizontal displacement. Indeed, the large gaps observed in the floor clearly indicate that tiles moved apart in the horizontal direction. Furthermore, the presence of cracks cutting the structure over the entire height, from floor to vaults, suggests that the church experienced an extension in the landslide direction. The presence of a significant component of horizontal movement again confirms that the damage observed in the church was induced by a landslide. Indeed, phenomena like subsidence or foundation settlements only produce vertical ground movements.
