CHARACTERIZATION OF HISTORIC MORTARS FOR COMPATIBLE RESTORATION: CASE STUDY OF SOUTH AFRICA

Maphole E. Loke^{1*}, Kumar Pallav² and Rainer Haldenwang³

Keywords: Historical Structures, Mortar characterization, Compatibility, Restoration

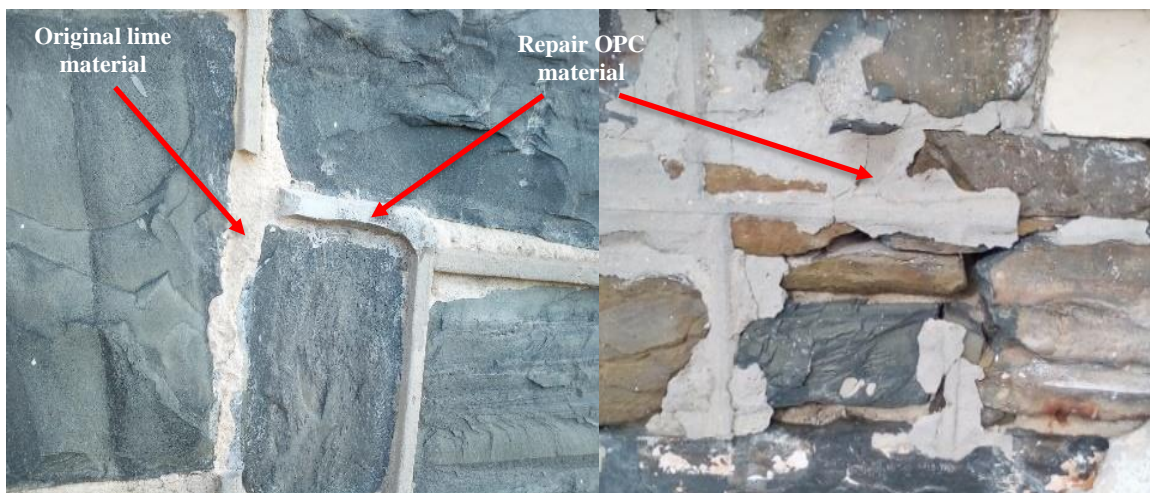
The use of Portland cement for the repair of historical monuments as mentioned by SAHRA Bult Environment Manager is visible on the Robben Island and Castle of Good Hope, in South Africa. The island has undergone maintenance and repair works in recent years (1999 onwards) ^[6]. In the Island's assessment report, it was stated that the repairs on the wall pointing did not consider how air circulates through wall sections and how condensation and dampness were to be treated. It has been concluded that the repair work caused further damages to wall sections. SAHRA has proposed maintenance work to rectify the previous restoration mistakes on the island. The deterioration seen on some of the oldest buildings on the island is shown in Figure 1. Regrettably, the material used for repair proved to be incompatible with both the original mortar and the masonry surface itself, and thus are seen to be detaching from the original surface on both the maximum-security prison (1700s) and the pre-primary school building (1800s).

Figure 1: Deterioration and use of Portland cement on Robben Island masonry

The disparity in materials (Figure 1) is due to the difference in properties of the lime materials that have a low modulus of elasticity and high permeability to water and water vapour ^[9]. The Portland cement, on the other hand, has a high soluble salts content which results in salt crystallization, large thermal expansion coefficient and low porosity ^[2].

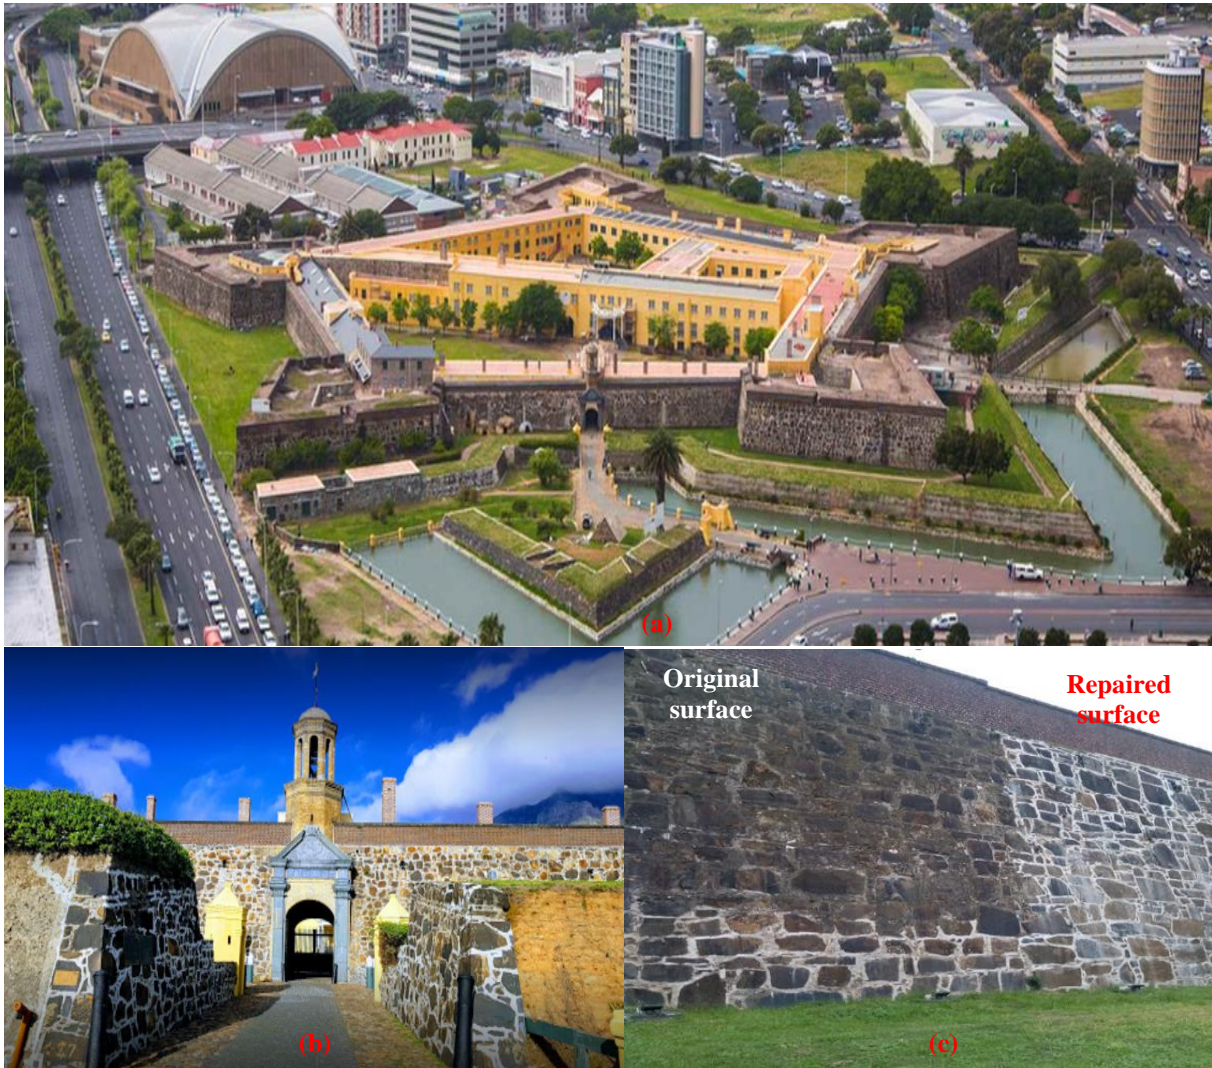
The Castle of Good Hope is located in Cape Town, South Africa. It is the second fort at the Cape, dating from 1666 to 1679, and is the oldest existing colonial building in South Africa ^[15]. It was originally located on the coastline of Table Bay, but, after land reclamation activities, it is now some distance from the coast ^[15]. It has a pentagonal shape (Figure 2a) and is made of stone and block masonry, as shown in Figures 2(b) and (c). The castle, like any other old building, experienced deterioration, threatening its continued use and even existence. A complete restoration was executed around the mid to late 1960s ^[16]. Some of the most recent repairs on the Castle are visible from a distance, as depicted in Figure (2c).

Figure 2: (a) Sky view of the Castle^[17] (b) Entrance (c) Masonry

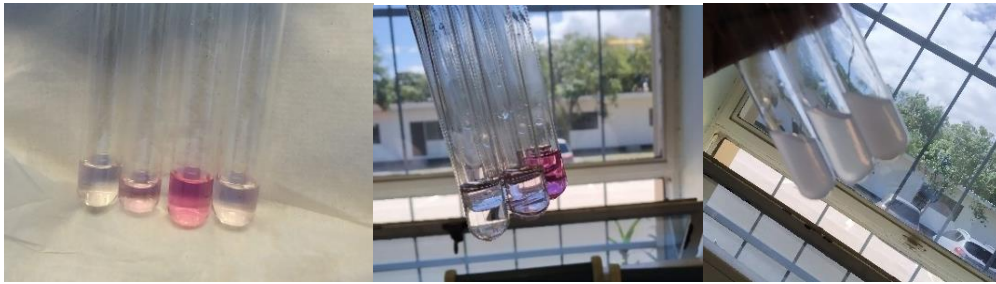
The mineralogical characterization was carried out using the precipitation method, which analyzes the colour change, denoting the presence of the salt minerals in a filtrate of mortar sample, as shown in Figure 3.

Figure 3: Precipitation of salts infiltrates of mortar

A majority of the Castle materials were high in chlorides and carbonates, while the nitrates were present in limited quantities for both the binder enriched materials (Particles < 0.063 mm) and the aggregates (Particles > 0.063 mm) as indicated in Tables 2 and 3.
