## MODERN CONSOLIDATION METHODS FOR CATHOLIC CHURCH IN BAROQUE STYLE FROM ARAD FORTRESS, ROMANIA

ALEXANDRU C. ION<sup>1\*</sup> AND MARIUS MOSOARCA<sup>2</sup>

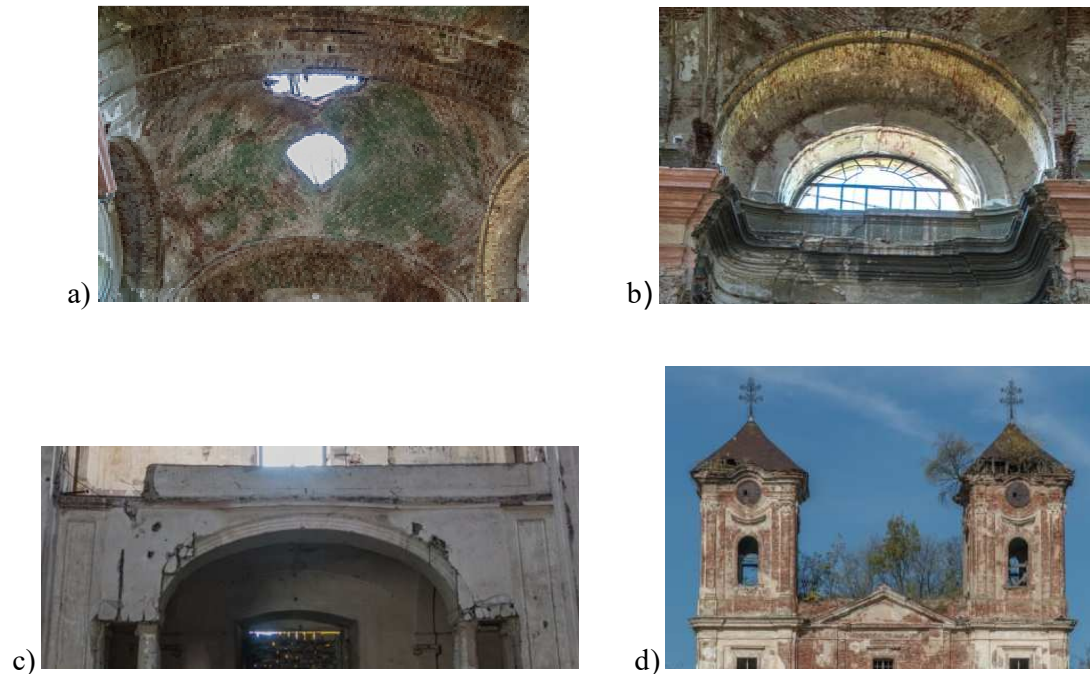
The structural strength of the monastery was severely damaged due to lack of maintenance over time. At the on-site examination of the church observations were made of vertical cracks in vaults and arches (Figure 3 b) and inclined cracks at the corners of the buildings which were caused by the subsidence of the foundations. Water infiltration led to the degradation of the masonry, the degradation and the failure of the vaults (Figure 3 a), the peeling of the plaster and the corrosion of concrete and steel bars (Figure 3 c). Also because of the bad maintenance the framing of the roof and the roof covering are almost completely destroyed allowing water infiltration into the building (Figure 3 d) [7].

**Figure 3:** Structural degradation of the church: a) Vault failure, b) Cracked arches, c) Corrosion of the RC arch, d) Roof degradation

The proposal for the arches (Figure 16 a) was that they would be consolidated on the soffit with galvanized steel fibers Geosteel G 1200, mortar GeoCalce G Antiseismico and Steel DryFix 10 connectors.

The loads from the transversal vaults of the church will be transferred through vertical steel bars to a proposed network of steel beams which lean on the perimeter structural walls (Figure 16 b). This network of beams also transfers the loads from the roof to the structural walls [7, 9].

For the foundations an underpinning of the foundation (Figure 19 b) was chosen as the proposed consolidation method that would stop the subsidence of the foundations and the cracking of the structure.

The wood framing and covering of the roof will be remade in its entirety if possible using wood elements from what is left of the existing roof [7, 9].

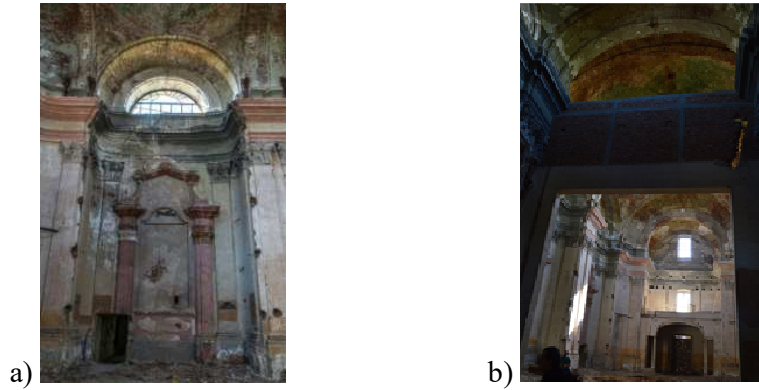
Observations were also made of some unauthorized interventions to the structure of the church: two doorway holes on the side walls (Figure 4 a) and the construction of a masonry wall with RC frame to separate the churches apse (Figure 4 b) [7].

**Figure 4:** Unauthorized interventions: a) Doorway hole, b) Masonry wall with RC frame

Regarding the unauthorized interventions, it was chosen to demolish the masonry wall with RC frame that separates the apse from the rest of the church. The door holes in the lateral walls will be rebuilt to recreate the structural integrity and the authenticity of the church.

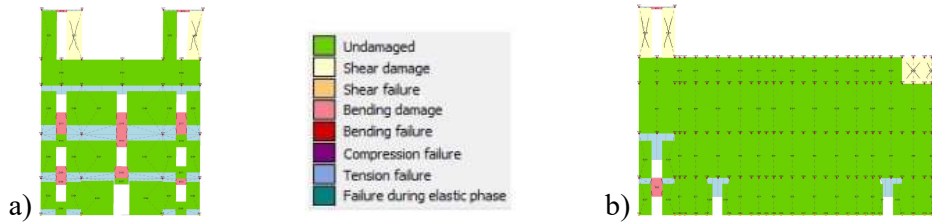
Figure 8 presents the failure mechanisms of the structure on the Ox axis after an earthquake. On the main façade the earthquake produces diagonal cracks in the piers of the tower. On the lateral façade of the church we have diagonal cracks only at the top of the wall and at the tower. Spandrels generally have a ductile yield through bending [7, 8].

**Figure 8:** Failure mechanisms of the structure on the ox axis: a) main façade b) lateral façade

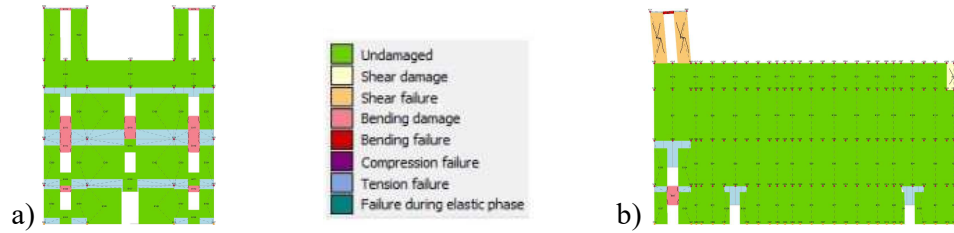
In Figure 10 there are presented the failure mechanisms of the church on the Oy axis after an earthquake. We can see only ductile yielding on the main façade on the spandrels. On the lateral façade we have brittle yielding on the upper side of the structure.

**Figure 10:** Failure mechanisms of the structure on the Oy axis: a) main façade, b) lateral façade

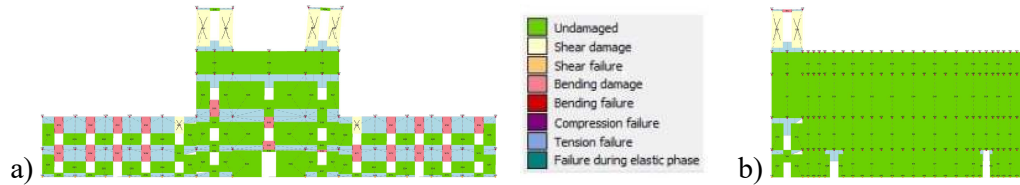
As we can see from Figure 13, there are a lot less failure mechanisms compared to the analysis where just the church was modeled. On the main façade we have ductile yielding on the spandrels, but brittle yielding can only be observed at the towers and two spandrels instead of the entire façade like in the first analysis. On the lateral façade we have failure mechanisms only on the towers.

**Figure 13:** Failure mechanisms on the aggregate structure on Ox axis: a) main façade, b) lateral façade

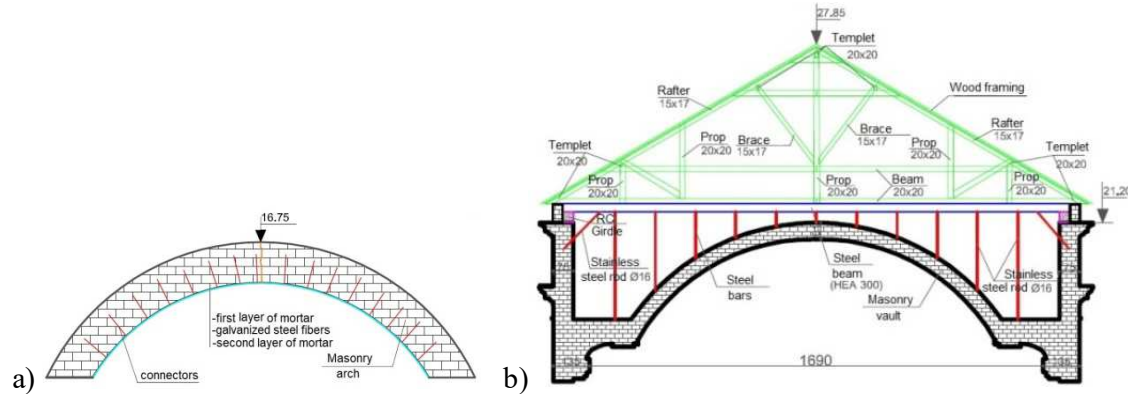
**Figure 16:** Proposed consolidation methods: a) Consolidation of the arches, b) consolidation of the vaults

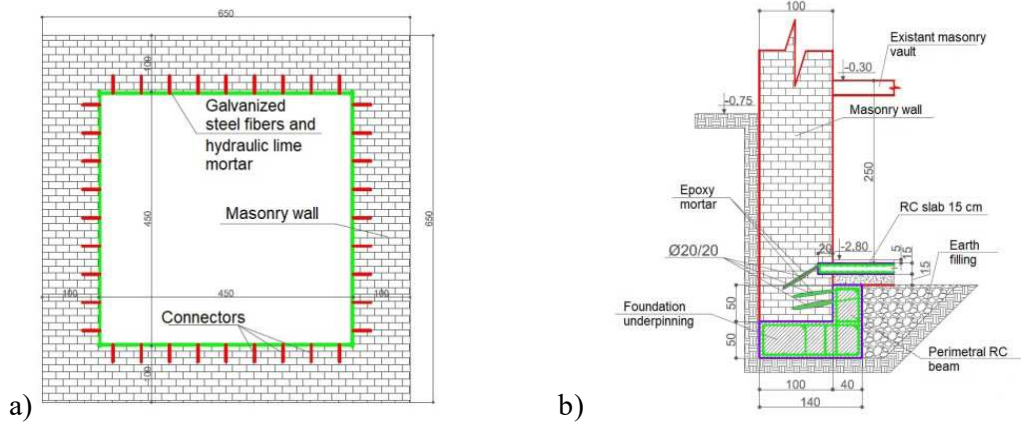
**Figure 19:** Proposed consolidation methods: a) Consolidation of the tower, b) Consolidation of the foundation

The towers of the church (Figure 19 a) will be consolidated on the inside with galvanized steel fibers Geosteel G 1200, mortar GeoCalce G Antiseismico and Steel DryFix 12 connectors.

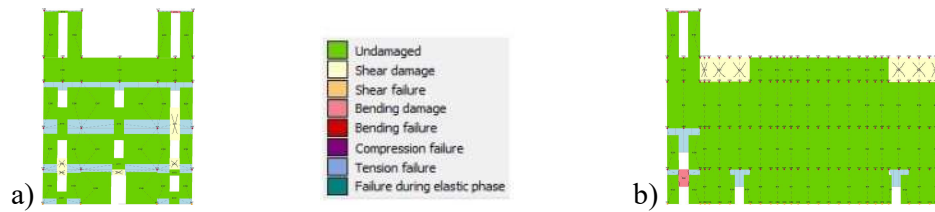
On the main façade (Figure 21 a) observations were made that there is a disappearance of failure mechanisms which remain only in the spandrels. There are a few failure mechanisms left on the spandrels. On the lateral façade (Figure 21 b) there are failure mechanisms at the top of the wall and ductile yielding in the spandrels [7, 8].

**Figure 21:** Failure mechanisms of the consolidated structure on Ox axis: a) the main façade b) the lateral façade

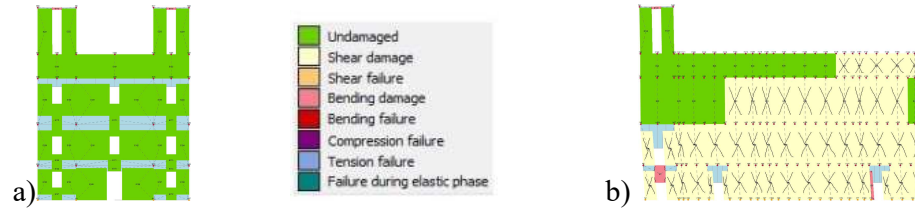
On the main façade of the building (Figure 23 a) there are failure mechanisms only at the spandrels of the tower and on the lateral façade (Figure 23 b) multiple failure mechanisms appear along the entire wall.

**Figure 23:** Failure mechanisms of the consolidated structure on Oy axis: a) the main façade, b) the lateral façade
