SELECTED PROBLEMS REGARDING CONSTRUCTION OF LIGHTWEIGHT MOTORCYCLE SWINGARM

WOJCIECH NOSKO¹, MIROSLAW W. MRZYGLÓD²

Abstract. Manufacturers of light motorcycles have always sought the use of more and more advanced materials. The application of carbon fiber in motorcycle parts design can bring high strength, stiffness, and low weight in a manner previously unavailable. This article contains selected problems regarding the construction of a swingarm made of carbon fiber reinforced plastics (CFRP). The swingarm was made specifically for Honda NSF 100. For the analysis, series of tests such as geometry, FEM, and structural analysis was chosen. The analysis concludes that the swingarm shape that was adopted from the original steel made part is not suitable for CFRP use. The analysis showed manufacturing errors, like the inconsistent thickness of laminate and poor quality of assembling. The full potential of the CFRP material was not used.

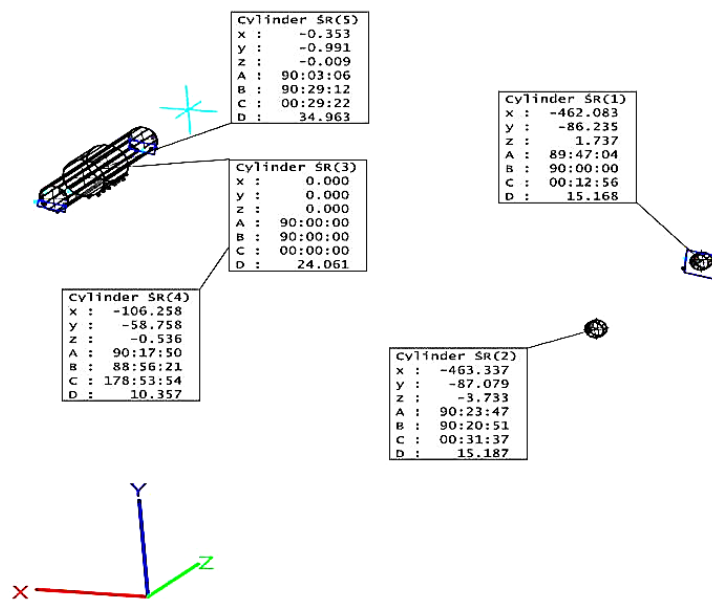
Figure 3: Datasheet of axle parallelism measurements

From the datasheet (Pic. 3) axis parallelism can be estimated. Cylinder ŚR (3) represents the axle of the swingarm pivot insert, and it was adopted as a measuring base. Two other axes of rear inserts (wheel axle mountings) are represented by Cylinder ŚR (1), and Cylinder ŚR. (2). Cylinder ŚR (4) represents the suspension damper mounting axis. Cylinder ŚR (5) represents the swing arm CFRP pivot area surface. Each Cylinder has its axis coordinates: x, y, z as well as the axis. Angle inclination: A – angle in term of axis x, B – angle in term of axis y, C – angle in term of axis z. Conducted measurements showed that the axle of the swingarm pivot (Cylinder ŚR (3)) was not parallel to surrounded CFRP (Cylinder ŚR (5)) in which it was bonded. In x dimension is 0,353 mm and in y it is 0.991 mm different. The angle of the axle location according to the base was also warped. The axle of suspension damper mounting (Cylinder ŚR (4)) was not parallel as well as angle measurements state. Axle of Cylinder ŚR (2) was not parallel to Cylinder ŚR (3) axis. Axle of Cylinder ŚR (1) was not parallel to Cylinder ŚR (3) axis.

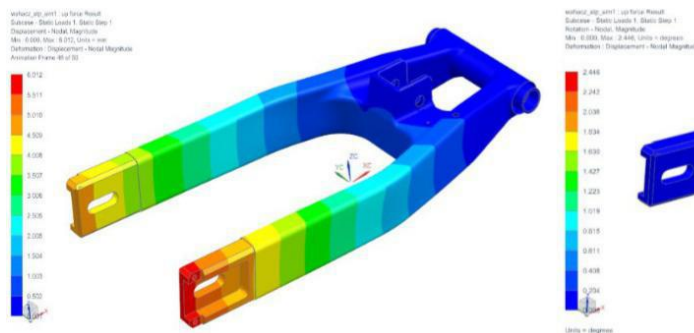
Figure 4: Displacement analysis: first load case

The displacement of the first load case is shown in Fig. 4. The maximum displacement is 6.012 mm, distinct color of both beams' ends indicates that the displacement is not equal. For the left beam, it was about 0.5mm smaller than for the right one.

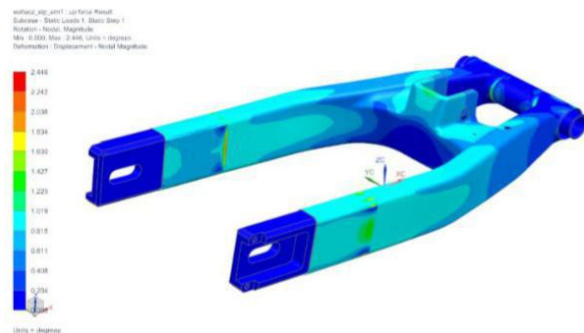
Figure 5: Displacement analysis: inserts rotation

Inserts rotation analysis shows maximum angle rotation of 2.446 degrees on the end of the

installed inserts (see Fig. 5). This may be the place of the stress concentration due to much higher stiffness of insert compared to CFRP laminate.

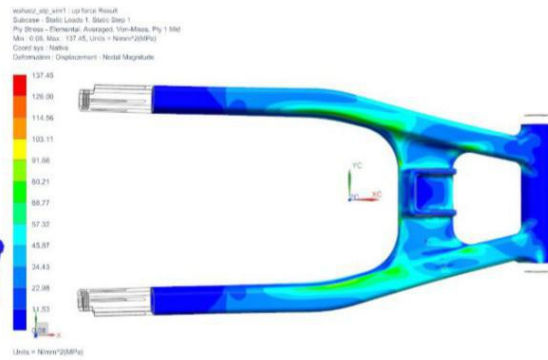
Figure 7: Von Mises stress: top view of the laminate

Stress analysis of CFRP laminate (Fig. 7) showed that the maximum value of 137.45 MPa appears on the downside of the swing arm due to the hole used to mount the chain slide (see Fig. 8-9).

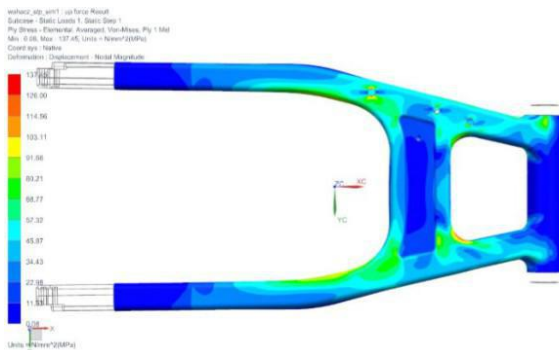
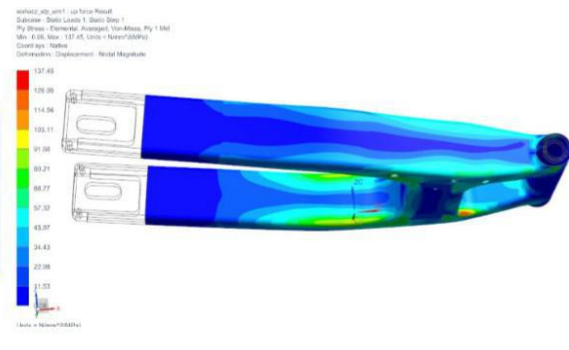
As it is shown, the higher stress values appear on the top and bottom wall of the swing arm beam. This means that the hole in its current position works as a notch and should be considered as a design flaw. Chain slide instead of bolted should be glued to swing arm surface.

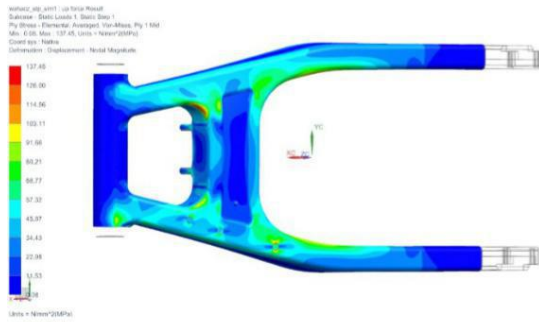
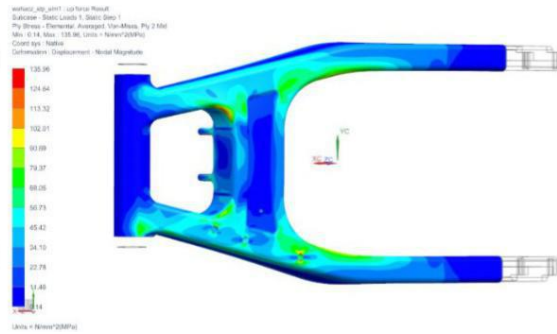
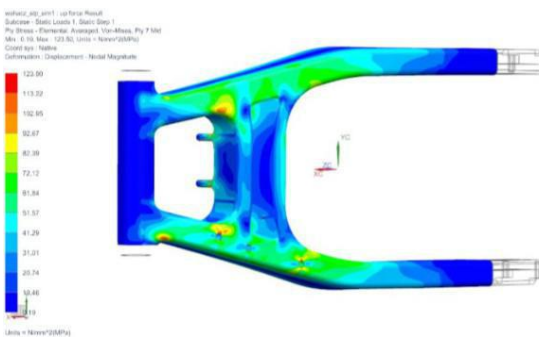
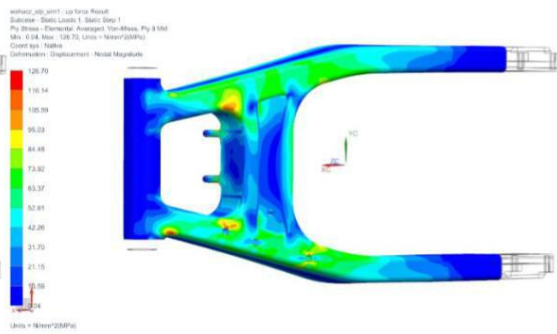
Stress in plies is presented in Fig. 10-13. The changes and transition of stress in plies can be observed. Starting from ply 1 where the highest stress occurs in the mounting hole, finishing on ply 8 where the high value of stress (698 MPa) appears in the first hole from the left side of the swingarm. An increase of stress can also be seen in the area of suspension damper mounting (Fig. 14-17). Though stress around the damper mounting area is within the acceptable limit, it shows that there is a possibility for design optimization.

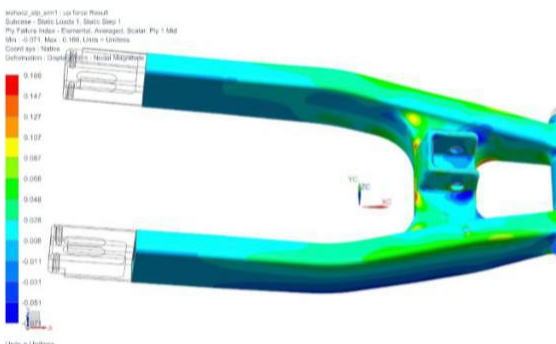
Figure 18: Laminate ply failure analysis

Laminate ply failure analysis results are shown in Fig. 18. A safe 0.3 rate of destruction was applied. As seen on summary analysis safe rate is not exceeded and is 0.166. The biggest difference in stress and what follow safe rate is between 3k, and 12k type prepreg fabric used to build laminate thickness (Fig. 19-21) This behavior proves proper calculation results as the stiffness of 12k two layers laminate with a summary thickness of 1.04mm is higher than 3k three layers of summary thickness of 0.6 mm. Therefore, such disparity may be the reason for delamination on the border between ply numbers 3 and 4, 5 and 6. By laminating stiffer fabric on the top (12k over 3k) where stress which came from the load is highest such difference in stress distribution across laminate composition could be avoided.

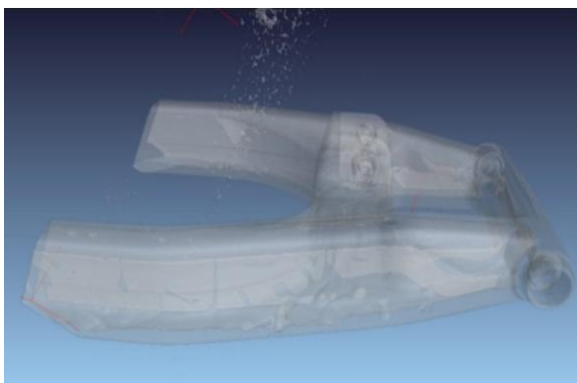
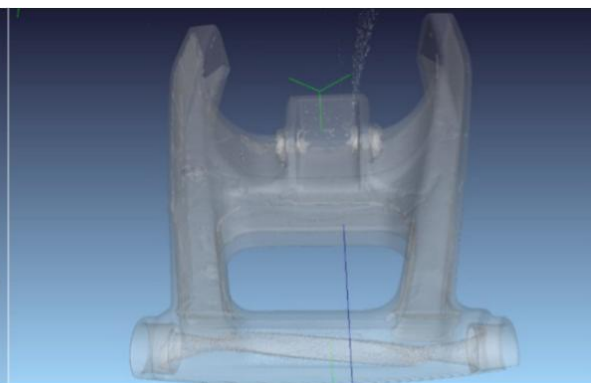
The analysis of the x-ray image is presented in Fig. 25 and 26. As seen in the figure, voids occurred in swing arm components on the right side of the beam, and around the swingarm pivot. The size of the defects and their impact on mechanical properties is unacceptable.

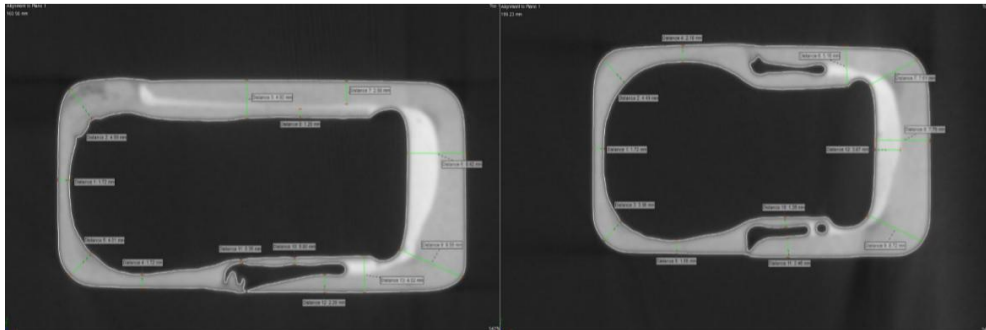
Figure 27: Cross-sections of LH beam

In Fig. 27, the cross-sections of the LH swing arm beam are shown. Uneven thickness of laminate, voids, and glue residue was discovered. The following laminate arranged was used according to manufacturer datasheet: 3 layers of TR3523 381 GMX twill 2x2 of 0.2 mm thickness each, 2 layers of TRK510 321GMP twill 2x2 of 0.57 mm thickness each, 3 layers of TR3523 381 GMX twill 2x2 of 0.2 mm thickness each. The total thickness sum is 2.34 mm. As figures showed, the thickness differs depend not only on location in a single cross-section but also on the length of the beam (see Fig. 27).

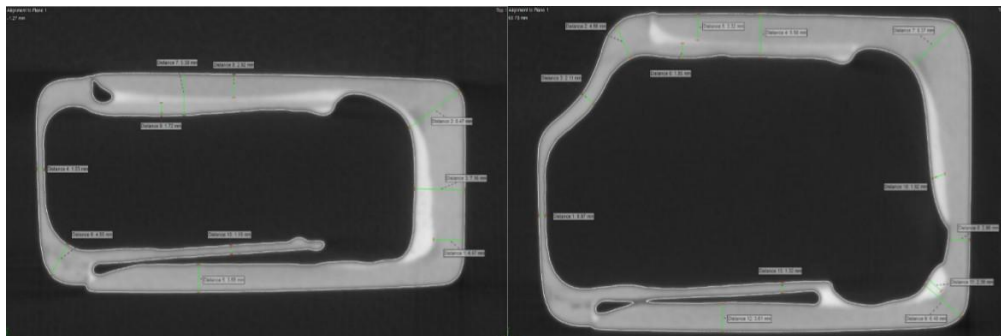
Figure 28: Cross-sections of LH beam

The RH beam cross-section is shown also in Fig. 28. Even more intense defects are discovered in RH beam, not only voids are presented but also unglued overlap surfaces.

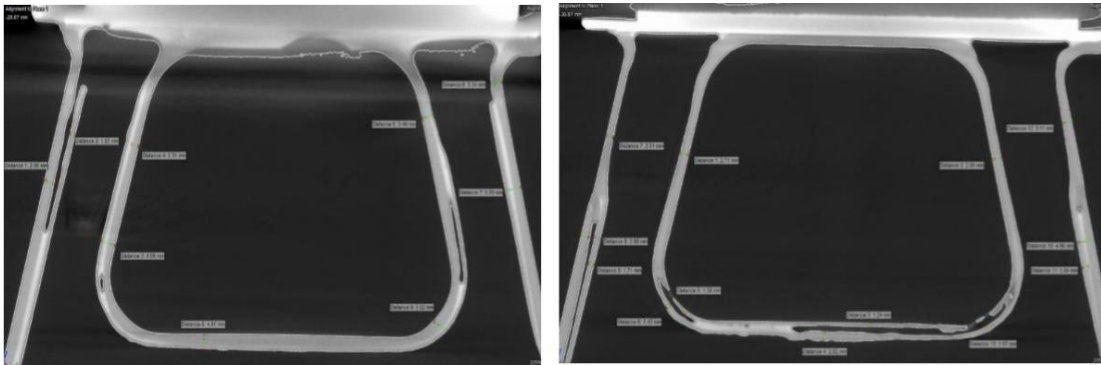
Figure 29: Cross-sections of the swingarm

A cross-section of the member of the swing arm is shown in Fig. 29. Large glued joint defects are visible with voids and uneven laminate thickness. A cross-section analysis of the suspension damper mounting area is shown in Fig. 30. The voids of the high content of the resin and prepreg fabric wrinkles can be observed.

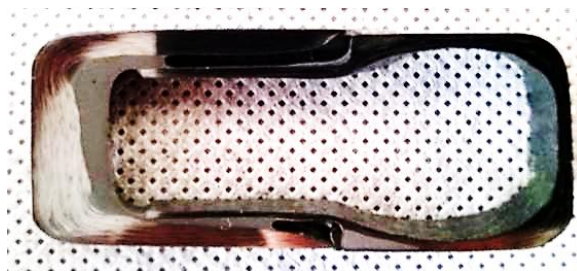
Figure 31: Composite material test sample of swing arm left beam cross-sections

In Fig. 31 internal defects are visible. Not only a lack of bond between two swing arm parts but also the difference in laminate thickness can be noticed. The lower part which

embraces overlap is thicker on the bottom and thinner on the sides. The upper part is made with the use of fewer layers of fabric which causes a thinner cross-section. A big residue of the bond was found on the bottom of the swingarm beam. To finishing the assembly of the product, two types of bond are used, first, to glue swingarm parts together, the second one to cover the gap which remains after the joining process. The microstructure view of the lower part of the swingarm (element embracing overlap) is presented in Fig. 32.

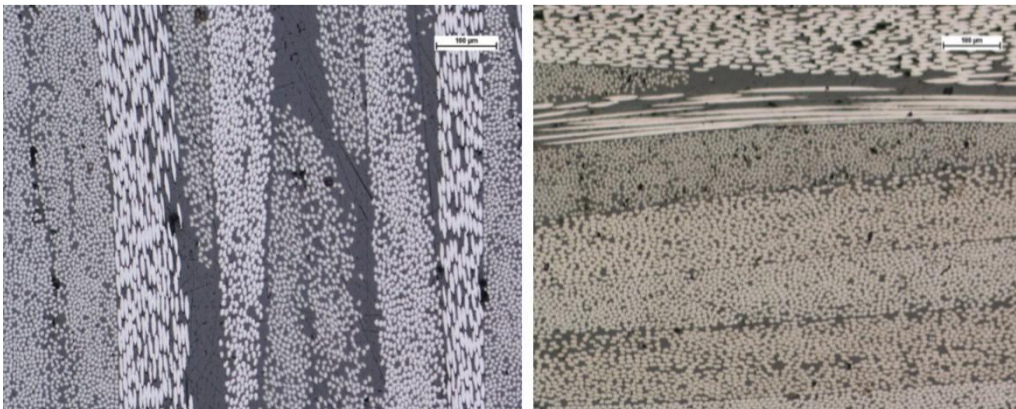
Figure 32: Microscopic analysis (x100)

In Fig. 32, the CFRP laminate with a cross-section of fabric fibers is shown. Large distances between fibers adversely affect mechanical properties. Higher resin to fiber ratio is the effect of chaotic laminate composition and insufficient vacuum bag pressure on laminate. Sidewalls of the same element where laminate scheduled are orderly placed, we can see the more tight arrangement of fabric and lower resin to fiber proportion (see Fig. 33). Furthermore, no internal defects of laminate were detected. The microstructure of glued joint is presented in Fig. 34. No cracks were detected on the aluminum to CFRP bond border. Some defects (pores) were noticed in the glued structure which has a negative impact on the mechanical properties of the joint itself.
