THE RESTORATION OF THE MEDIEVAL WALLS OF SAN GINESIO: A DEDICATED STUDY FOR THE CONSERVATION, REPAIR AND ENHANCEMENT OF AN IMPORTANT MILITARY FORTIFICATION

M. SARACCO^{1*}, F. MARIANO², A. A. GIULIANO²,
L. PETETTA² AND F. PICCININI²

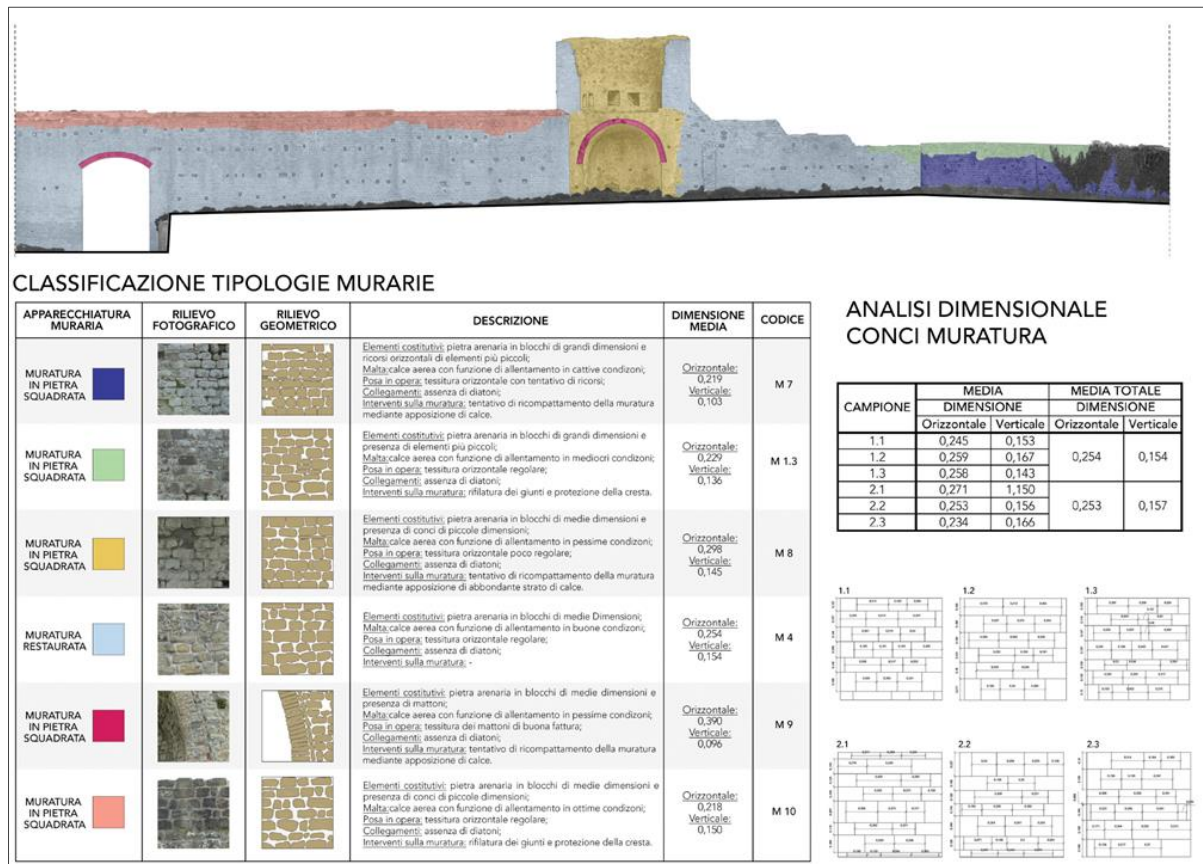
Figure 5: Datasheet for the classification of masonry types. In columns from left to right: type of wall texture, photographic survey of the sample, geometric survey of the sample, description of significant parameters, (constitutive elements, type of mortar, type of laying in work, cross connections) average block size, identification code. On the right, the block size survey and the average size estimate.

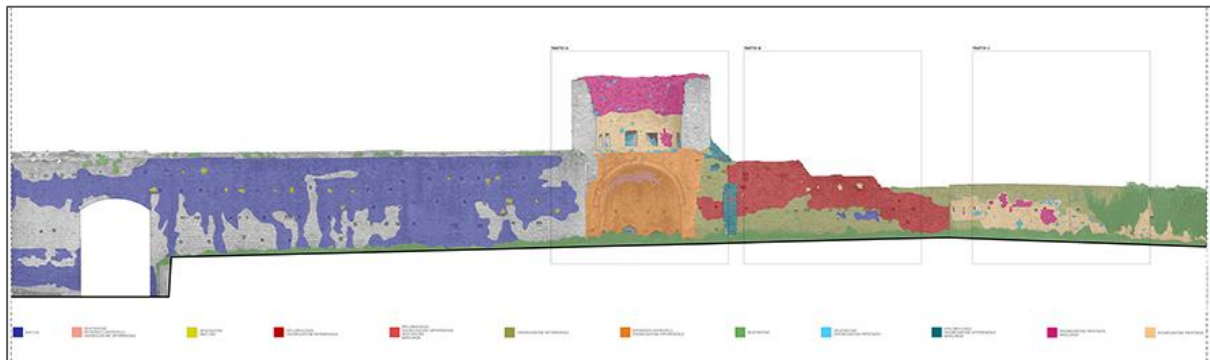
Since the degradation of the materials present in a structure, represents a process of pathological alteration, capable of compromising the chemical and physical-mechanical characteristics of the same, determining the state of preservation of the elements in work, it was essential to assess the strength characteristics of the masonry. It is also important to remember that the IQM calculation method uses qualitative assessment parameters of the conservation status of the mortar and building blocks of the masonry, therefore related to the possible presence of pathological alterations. The analysis of the degradation was carried out, at this stage, through a logical deductive path that, starting from the macroscopic alteration phenomena of the analyzed elements, derived the causes and mechanisms of degradation. The observations made, as indicated, were of a macroscopic type and therefore aimed at identifying forms of pathological alteration that obviously compromise the physical and mechanical characteristics of stone elements and mortar. In this analysis process, the *Lexicon of macroscopic alterations of natural and artificial stone materials* was used, collected in the UNI standard 11182:2006. The classification of the identified degradations, was transferred to the survey papers through a symbolism consisting of alphanumeric codes and colors. The recording of the forms of degradation was completed with the survey of the cracking framework and its interpretation, indicating static failures and the main mechanisms of damage related to dynamic stresses. The main forms of degradation identified, were: the erosion and hurling of the sandstone that constitutes the blocks of masonry and the pulverization of the mortars. These phenomena have been detected in numerous portions of the wall curtain and with particular severity in the base areas and ridges of the masonry. The cracking framework detected, has highlighted portions of masonry affected by rotations out of plane and structural injuries attributable to efforts in the plan, derived from the seismic stresses of 2016.

Figure 6: inside front, Block 2. A false-color representation of the main forms of degradation and their extent

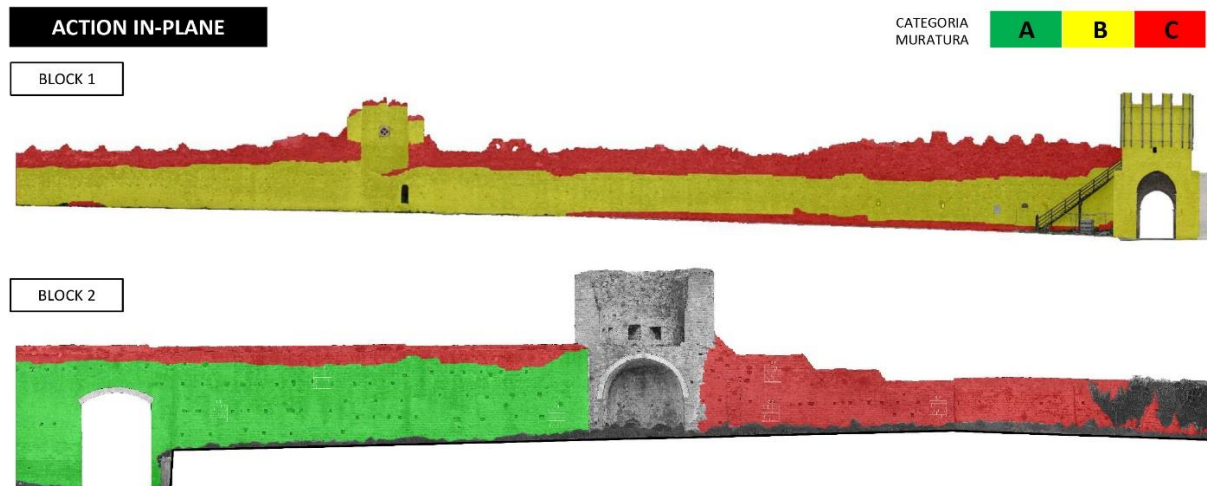
The calculation of IQM was carried out on all masonry samples surveyed, (so in three samples for each type of masonry) to obtain representative average values. The results showed low and medium, masonry quality indices in block 1, both for vertical loads, both for those horizontal in-plane and out of plane, while the situation in blocks 2 and 3 was appeared better, since only a single section has obtained a low masonry quality index for all expected loads (vertical, horizontal out of the plane, horizontal in the plane).

Figure 9: IQM identification of masonry categories
