FAILURE ANALYSIS OF THE ARECIBO OBSERVATORY M4N AUXILIARY CABLE¹

Gregory J. Harrigan,² Vinay K. Goyal,³ Pavel F. Babuska,⁴ Nathan Trepal⁵

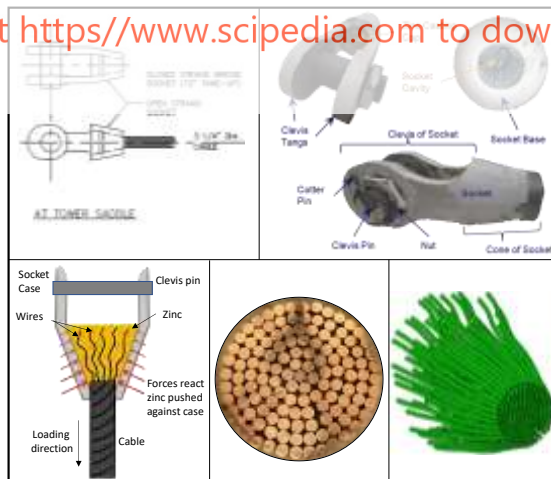
Figure 1: Clockwise starting on the top left: Open spelter socket drawing, socket terminology, Aux M4N broomed wire reconstruction, 1 x 127 structural strand cross section, and cable-socket interface detail sketch.

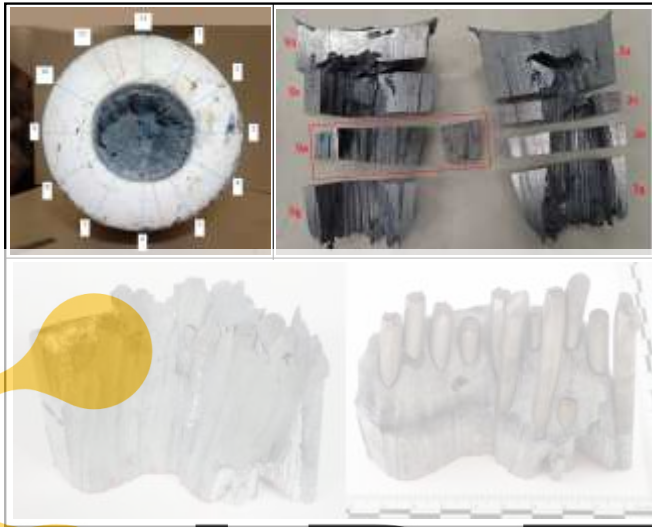
The socket was dissected, first longitudinally into left and right halves, followed by transverse cuts in each half starting from the casting cap side of the socket halves and moving toward the wire fractures near the socket base, Figure 2. During the sectioning process, areas of interest were analyzed and/or sectioned off for further microscopy. The zinc casting was analyzed by metallography, and the wire fractures were extracted from the zinc for fractography. Lastly, material testing was performed on socket and virgin material to characterize mechanical and metallurgical properties.

Figure 2: Sectioning plan for the socket (top left), sectioned zinc (top right), section of zinc with encased wires before (bottom left) and after (bottom right) removal of zinc via dissolution in acid.

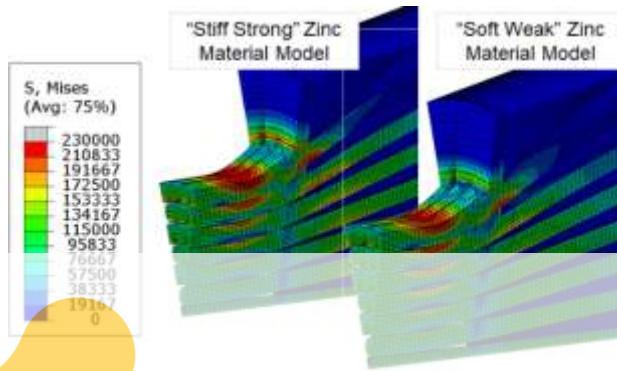
Insufficient Design Criteria: FE analyses predicted significant yielding of outer wires and negative structural margins using the maximum predicted cable loads of 720 kips predicted by WJE. Even using an applied load of 600 kips, outer wire stress predictions were in the 220 - 230 ksi range based on a range of zinc material models. With a factor of safety of unity, this corresponded to structural margins ranging from +15% to -4% when considering a range of wire ultimate strengths of 220 to 250 ksi. In aerospace applications, structures are analyzed and compared not only against the breaking strength of the joint but also for constituent stresses against their respective material strengths.

Figure 5: Outer wire stresses were near capacity regardless of zinc material model at design loads.

Based on loads alone, the effective design factor of safety was calculated as 1.83, which is lower than typical industry standards. The design upgrades involving the failed socket joint predated ASCE 19-96 (Reference 5), which was the requirements document governing the design of steel cables for buildings. ASCE 19-96 was superseded by ASCE 19-10 (Reference 6). While the inapplicability of ASCE 19-10 to the failed socket design is recognized, it was found that the effective design factor in this application fell short of the 2.2 specified in that standard and even those specified in international standards (Reference 7). The ASCE standard also states the minimum breaking strength of cables shall always be at least twice the maximum cable design loads, including the envelope of loading combinations of cable self-weight, structure dead load, cable pre-stress forces, and live load and environmental load combinations. Consequently, given the negative structural margins and insufficient factor of safety, insufficient design criterion was identified as significant contributor to the failure event.

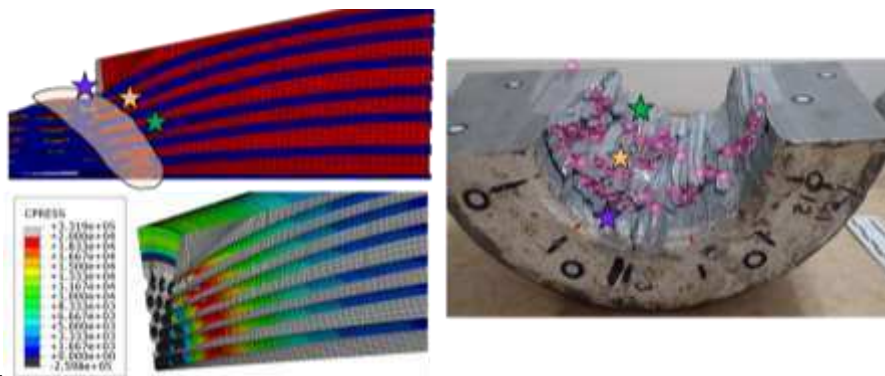
The highest stresses were not predicted to be planar from wire to wire, rather the failure surface followed the surface of a rough spheroid, matching the stepped pattern of wire fracture locations within the socket seen from forensic examination (Figure 8). The outer wires were predicted to fail closer to the socket base cable outlet region, while the inner wires failed slightly inboard to the socket, as seen in the forensic evidence. The stress field suggested that the wires failed adjacent to the greatest confining pressure within the zinc. The zinc plastic flow and the shape of the socket create a region of confining pressure in the shape

of a half spheroid, which causes the highest wire stresses adjacent to the boundary of the highest confining pressure. The red output, showing interface contact pressure (“CPRESS”) in Figure 8, reflects the area of highest confining pressure at the zinc/wire interface, which would squeeze the individual wires and suggest the fracture location to be ahead of this region. Regions of colored stars show the different "steps" of failure in the socket. Note that the yellow shading in the top left figure in Figure 8 and the red high stress zones in the lower left figure match the shape of the failure surfaces in the right figure. Model predictions were qualitatively consistent with the observed wire failure modes from the Aux M4N socket. Forensics identified that most wires failed in cup-cone fracture, although a select number of outer wires failed in shear. Analysis shows that the inner wires are under significant confining pressure, thus increasing elongation capability and resulting in a “ductile” cup-cone failure mode.

Figure 8: Highest stresses were not predicted to be planar; failure surface followed a spheroid shape, matching stepped patterns seen in forensic evidence.

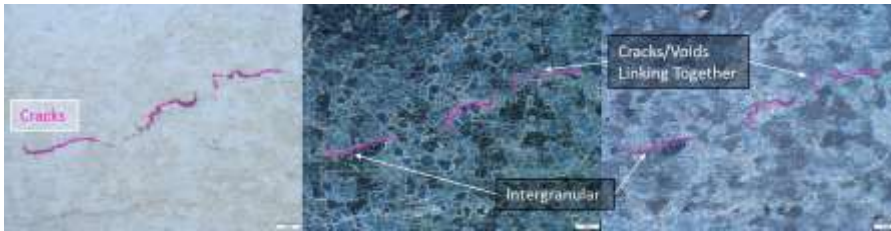
Cumulative Damage: Creep was found to be a major contributor to the failure for the following reasons: (1) Forensic analysis showed clear evidence of creep within the zinc (Figure 9). Zinc microstructure nearest the cable/zinc boundary was fully recrystallized with a predominance of grain boundaries aligned 45° to the shear stress, as expected for creep in pure zinc at ambient temperatures. The zinc nearest the socket base, adjacent to the cable/zinc boundary, was determined to be in the late secondary or tertiary stage of creep. Small, non-connected cracks are present within the fully recrystallized grain region near the cable/zinc boundary (Figure 9), running parallel with the cable-end section. These cracks are either from the tertiary stage or cavitation/voids that were squeezed closed due to continued confining pressure imposed by the cable tension and socket wall. High-magnification image of non-connected cracks in different illuminations after tint etching showed predominantly intergranular cracks, which are associated with slower creep mechanisms. Zinc microstructure nearest the socket casing was partially recrystallized with evidence of highly strained zinc (e.g., twinning / slip bands). (2) Loads analysis also supports a higher percentage of deadloads compared to transient loads. (3) Finite element analysis predicted high stresses within the zinc caused by sustained loading, and as the zinc crept the outer wire stresses were predicted to increase. The negative structural margins further deteriorated over time due to the creep setting within the zinc, until wire and zinc failure occurred.

Figure 9: Intergranular cracks present adjacent to cable/zinc slug boundary as seen in brightfield, dark field, and cross-polarized illumination. Klemm's 1 Reagent tint etch at 500X magnification.
