## FAILURE ANALYSIS OF THE ARECIBO OBSERVATORY M4N AUXILIARY CABLE<sup>1</sup>

Gregory J. Harrigan,<sup>2</sup> Vinay K. Goyal,<sup>3</sup> Pavel F. Babuska,<sup>4</sup> Nathan Trepal<sup>5</sup>

**ABSTRACT:** Structural and forensic analysis concluded that the Arecibo Observatory M4N socket joint failure in August 2020 was due to a socket joint design with insufficient design criteria that did not explicitly consider socket constituent stress margins or time-dependent damage mechanisms. The socket attachment design was found to have an initially low structural margin with a finite service life, notably in the outer socket wires, which degraded primarily due to long-term zinc creep effects that were activated by long-term sustained loading and exacerbated by cyclic loading. Additionally, HAC and wire defects were found in a few outer wires that may also have contributed to initial outer wire failures. The design did not explicitly consider the time-dependent effects of creep and cyclic loading on design capability, account for a worst-case build condition traceable to in-service inspection of features (e.g., zinc creep/extrusion), specify an end-of-life capability requirement ass

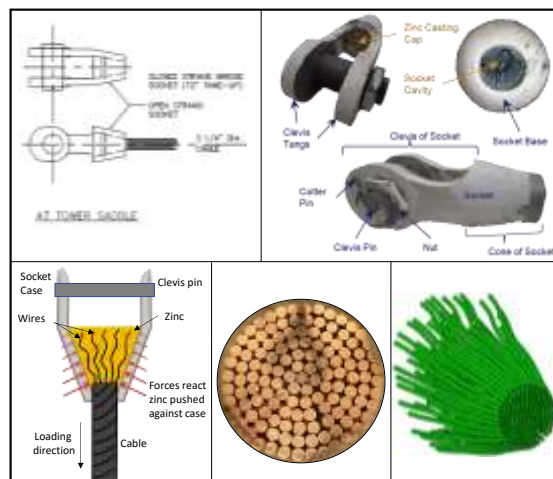
**Figure 1: Clockwise starting on the top left: Open spelter socket drawing, socket terminology, Aux M4N broomed wire reconstruction, 1 × 127 structural strand cross section, and cable-socket interface detail sketch.**

*Insufficient Acceptance Criteria and Inspections:* While the drawing did not specify acceptance criteria or characteristics for wire brooming, forensic reconstruction of the brooming (Figure 1) was found to be in-family to other socket builds. Nondestructive evaluation of the socket joint was not performed prior to service, but forensic examination of the failed socket showed dimensions to be within specifications. Defects (e.g., voids/cracks) within the zinc such as gas bubbles toward the socket back side were found (Figure 6), but analytical models with representative void geometries predicted negligible effects on the outer wire stresses near the termination. This is because the most highly stressed wires occur near the socket base and remain unaffected by the existence of voids a substantial distance away in the zinc. Further, a separate model simulated the existence of a cavity tear near the casting cap, but no changes in critical wire stress levels resulted as termination capacity is influenced significantly by the zinc in the narrow side of the conical volume but is largely unaffected by the zinc at the open end of the socket.

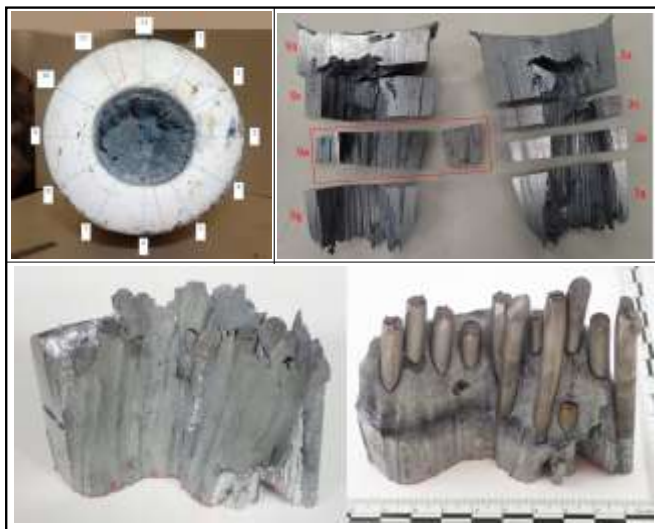
The socket was dissected, first longitudinally into left and right halves, followed by transverse cuts in each half starting from the casting cap side of the socket halves and moving toward the wire fractures near the socket base, Figure 2. During the sectioning process, areas of interest were analyzed and/or sectioned off for further microscopy. The zinc casting was analyzed by metallography, and the wire fractures were extracted from the zinc for fractography. Lastly, material testing was performed on socket and virgin material to characterize mechanical and metallurgical properties.

**Figure 2: Sectioning plan for the socket (top left), sectioned zinc (top right), section of zinc with encased wires before (bottom left) and after (bottom right) removal of zinc via dissolution in acid.**

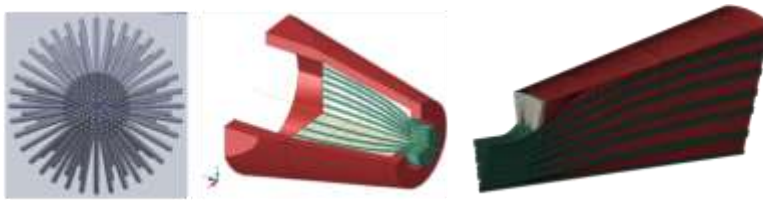
High-fidelity three-dimensional FE models of the cable termination into the M4N socket were developed using Abaqus to investigate the individual wire, zinc, and steel socket mechanics and to support the failure investigation. The models enabled sensitivity studies to understand the effects of various parameters including the degree of wire brooming, zinc material properties, and metallurgic examinations. Multiple model configurations were constructed, each containing varying levels of wire brooming, one of which represented the as-built/as-failed wire brooming specific to Aux M4N. The interfaces between the wires and zinc were modeled with a nearly infinite stiffness contact condition to enable extracting interface shear and pressure stresses. Contact modeling with friction was implemented between the zinc and the socket casing to allow for zinc “seating” within the socket. Material nonlinearity was included for the steel wires and the zinc spelter to predict the post-yield material response. Examples of the idealized wire brooming, simplified socket model, and wedge model mesh density are shown in Figure 3.

Figure 3: FE model included conical socket housing, cast zinc, and individual wires.

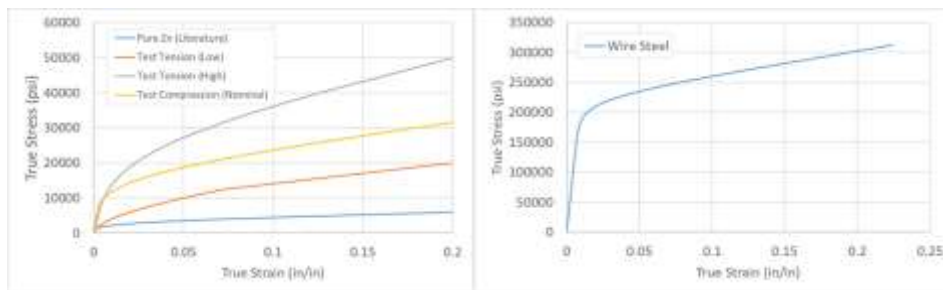
True stress-strain curves were generated and incorporated into the models based on NASA testing of the steel wire and the zinc. Stress-strain curves for the various material systems were approximated using the Ramberg-Osgood method. Pure zinc in structural socket terminations has low tension and high compression strengths, and grain sizes vary based on manufactured method and rates of cooling during casting. A high-confidence material model that accurately reflects both tension and compression response or attempts to model progressive damage is challenging. Zinc properties from material testing also exhibited significant dispersions. Different zinc nonlinear models were used in sensitivity studies to predict socket termination capability to address the uncertainty in the zinc mechanical behavior.

Figure 4: True Stress-Strain Curves for the Range of Zinc Material Properties (left) and Baseline Steel Material Property (right).

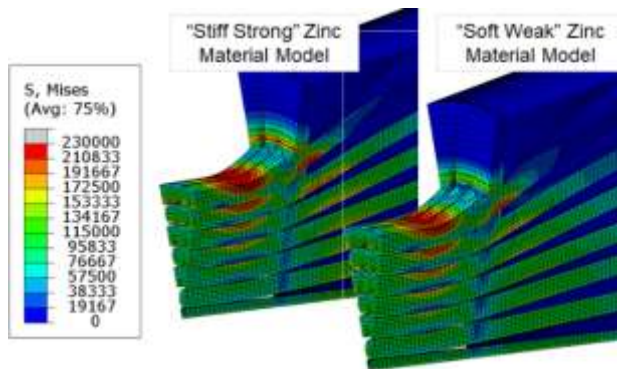
*Insufficient Design Criteria:* FE analyses predicted significant yielding of outer wires and negative structural margins using the maximum predicted cable loads of 720 kips predicted by WJE. Even using an applied load of 600 kips, outer wire stress predictions were in the 220 - 230 ksi range based on a range of zinc material models. With a factor of safety of unity, this corresponded to structural margins ranging from +15% to -4% when considering a range of wire ultimate strengths of 220 to 250 ksi. In aerospace applications, structures are analyzed and compared not only against the breaking strength of the joint but also for constituent stresses against their respective material strengths.

**Figure 5:** Outer wire stresses were near capacity regardless of zinc material model at design loads.

Based on loads alone, the effective design factor of safety was calculated as 1.83, which is lower than typical industry standards. The design upgrades involving the failed socket joint predated ASCE 19-96 (Reference 5), which was the requirements document governing the design of steel cables for buildings. ASCE 19-96 was superseded by ASCE 19-10 (Reference 6). While the inapplicability of ASCE 19-10 to the failed socket design is recognized, it was found that the effective design factor in this application fell short of the 2.2 specified in that standard and even those specified in international standards (Reference 7). The ASCE standard also states the minimum breaking strength of cables shall always be at least twice the maximum cable design loads, including the envelope of loading combinations of cable self-weight, structure dead load, cable pre-stress forces, and live load and environmental load combinations. Consequently, given the negative structural margins and insufficient factor of safety, insufficient design criterion was identified as significant contributor to the failure event.

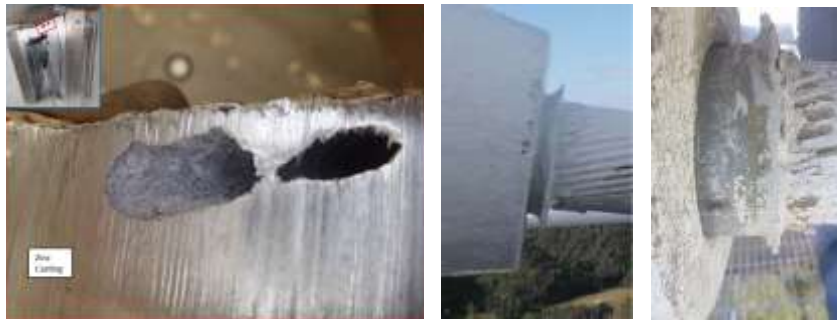
failure analysis showed that corrosion mitigations were employed, and that the zinc extruded progressively between 2003 (0.5 inch) and 2019 (1 3/8 inches). Although no pass/fail criteria were known to exist, AASHTO M277-06 states that seating extrusion should be less than one-sixth of the cable diameter, or less than 0.6 inch for the Auxiliary M4N cable that failed (Figure 6). The inspection process did not couple the qualification/design process to a pass/fail criterion to trigger a replacement.

Figure 6. Close-up view of a single gas bubble in zinc casting (left); 2003 photo of a Aux M4N (left) showing ~0.5-inch zinc seating extrusion (middle); and 2019 photo (right) showing ~1 3/8-inches Extrusion. (Ref. 4)

1. Socket joint constituents should be verified to have positive structural margins for strength, fatigue, and creep failure modes for the service life of the socket for all design load combinations.
2. Periodic visual inspection of socket joints should include pass/fail criteria for zinc extrusion tied to a structural qualification test program that verifies the creep failure mode.
3. Qualified processes such as cable replacement and socket joint refurbishment should then be defined to restore joint capacity in the event of failed inspection.

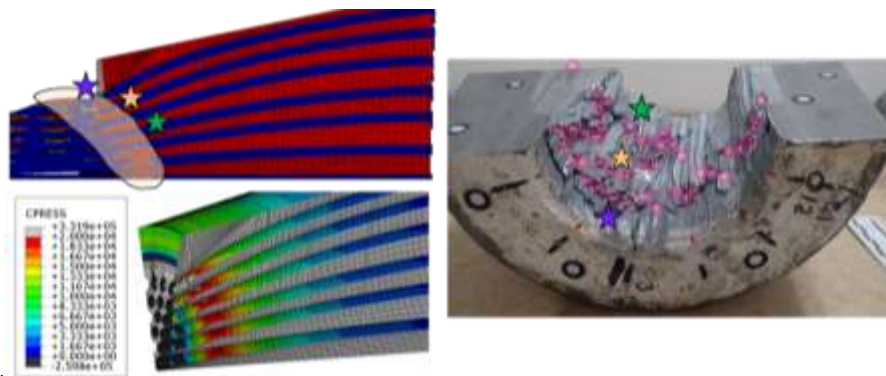
The highest stresses were not predicted to be planar from wire to wire, rather the failure surface followed the surface of a rough spheroid, matching the stepped pattern of wire fracture locations within the socket seen from forensic examination (Figure 8). The outer wires were predicted to fail closer to the socket base cable outlet region, while the inner wires failed slightly inboard to the socket, as seen in the forensic evidence. The stress field suggested that the wires failed adjacent to the greatest confining pressure within the zinc. The zinc plastic flow and the shape of the socket create a region of confining pressure in the shape

of a half spheroid, which causes the highest wire stresses adjacent to the boundary of the highest confining pressure. The red output, showing interface contact pressure ("CPRESS") in Figure 8, reflects the area of highest confining pressure at the zinc/wire interface, which would squeeze the individual wires and suggest the fracture location to be ahead of this region. Regions of colored stars show the different "steps" of failure in the socket. Note that the yellow shading in the top left figure in Figure 8 and the red high stress zones in the lower left figure match the shape of the failure surfaces in the right figure. Model predictions were qualitatively consistent with the observed wire failure modes from the Aux M4N socket. Forensics identified that most wires failed in cup-cone fracture, although a select number of outer wires failed in shear. Analysis shows that the inner wires are under significant confining pressure, thus increasing elongation capability and resulting in a "ductile" cup-cone failure mode.

**Figure 8:** Highest stresses were not predicted to be planar; failure surface followed a spheroid shape, matching stepped patterns seen in forensic evidence.

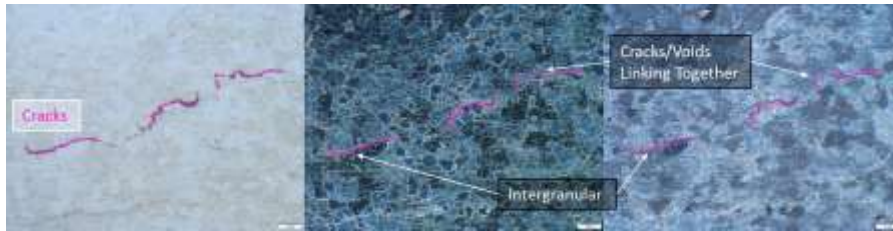
**Cumulative Damage:** Creep was found to be a major contributor to the failure for the following reasons: (1) Forensic analysis showed clear evidence of creep within the zinc (Figure 9). Zinc microstructure nearest the cable/zinc boundary was fully recrystallized with a predominance of grain boundaries aligned 45° to the shear stress, as expected for creep in pure zinc at ambient temperatures. The zinc nearest the socket base, adjacent to the cable/zinc boundary, was determined to be in the late secondary or tertiary stage of creep. Small, non-connected cracks are present within the fully recrystallized grain region near the cable/zinc boundary (Figure 9), running parallel with the cable-end section. These cracks are either from the tertiary stage or cavitation/voids that were squeezed closed due to continued confining pressure imposed by the cable tension and socket wall. High-magnification image of non-connected cracks in different illuminations after tint etching showed predominantly intergranular cracks, which are associated with slower creep mechanisms. Zinc microstructure nearest the socket casing was partially recrystallized with evidence of highly strained zinc (e.g., twinning / slip bands). (2) Loads analysis also supports a higher percentage of deadloads compared to transient loads. (3) Finite element analysis predicted high stresses within the zinc caused by sustained loading, and as the zinc crept the outer wire stresses were predicted to increase. The negative structural margins further deteriorated over time due to the creep setting within the zinc, until wire and zinc failure occurred.

**Figure 9:** Intergranular cracks present adjacent to cable/zinc slug boundary as seen in brightfield, dark field, and cross-polarized illumination. Klemm's 1 Reagent tint etch at 500X magnification.
