HISTORICAL TIMBER STRUCTURES IN ADANA-TEPEBAĞ SETTLEMENT AND CONSOLIDATION APPROACH WITH MODERN TIMBER PREFABRICATED SYSTEMS

KERİMCAN APAK ¹

¹Adana Alparslan Türkeş Science and Technology University

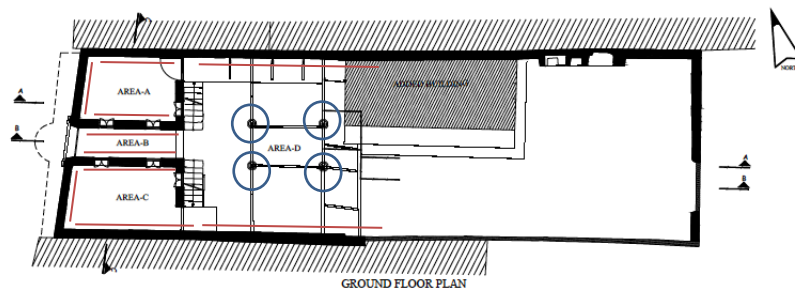
Figure 4: Adana-Tepebağ case study house ground floor plan [1].

On the ground floor, two rooms are designed on the sides of the plan. The thickness of the masonry walls of the rooms is 40cm thick, constructed with mixed brickwork with timber tie-beam support. There is no structural damage to the load-bearing walls. The ceiling is constructed with a timber structure. Primary timber beams are placed parallel to each other with 3,40cm. distance. Secondary beams that are placed above and perpendicular to the primary beams are constructed 25cm parallel to each other. In initial inspection, there is not decadence on the primary and secondary timber beams. However, there is a considerable humidity exposure inside the structure. Therefore, it could be some decay on the corners of the timber beams which are inside of the masonry walls. Also, on the surface of the floor timber finishing material, there had some decay related to humidity. In areas A, B, C, and D, which is marked with red lines, there is decay on the surface of the masonry walls related to humidity. Also, in area D, which is marked with blue circular lines, four poles connection detail with ground floor had some decay related to humidity (Figure 4-8). Inside the courtyard, there is a reinforced concrete structure that is built afterward of the historical building [1].

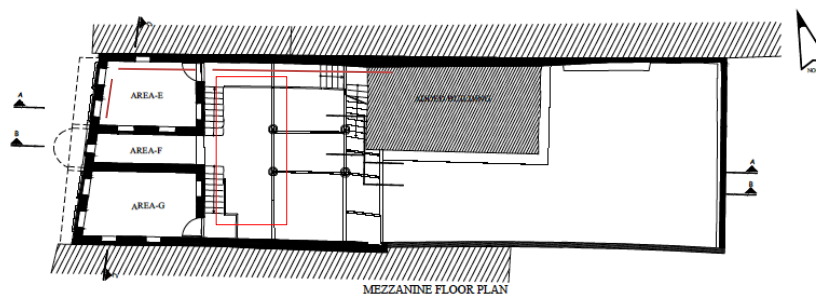
Figure 5: Adana-Tepebağ case study house mezzanine floor plan [1].

On the mezzanine floor, there are cracks and decay on the plasters of the walls, which is marked with red lines. Besides, above the windows and the doors, some deep cracks are related to the load-bearing structure.

The cracks on mezzanine floor are related to the forces which are come in sight with horizontal loads such as seismic activity. Most of the staircases, which are connected ground

and mezzanine floor, had a considerable decay. Therefore, it needs to be renewed. The timber floor of the courtyard had decay related to humidity, which is marked with a red rectangle [1].

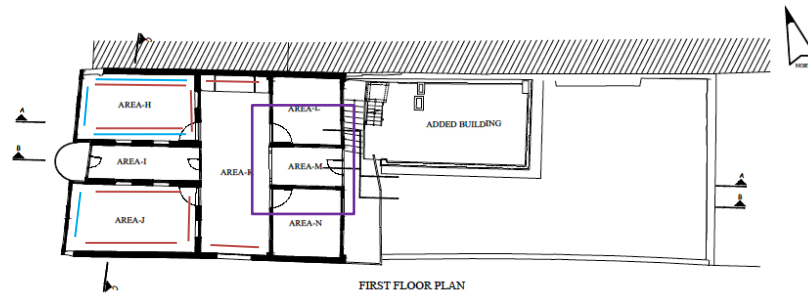
Figure 6: Adana-Tepebağ case study house first-floor plan [1].

The first-floor slab is supported with timber posts that are located inside of the courtyard. These posts are started from the ground floor and continue to the beneath of first-floor slab timber primarily beams. On the first floor, two brick masonry walls are rested on a timber slab, and there is a critical bending that happened on those beams, which are shown in a purple rectangle (Figure 6-8). The walls which are marked with the light blue line have deep cracks and partially collapsed (Figure 6). There are cracks and decay on the plasters of the walls, which is marked with red lines (Figure 6-7) [1].

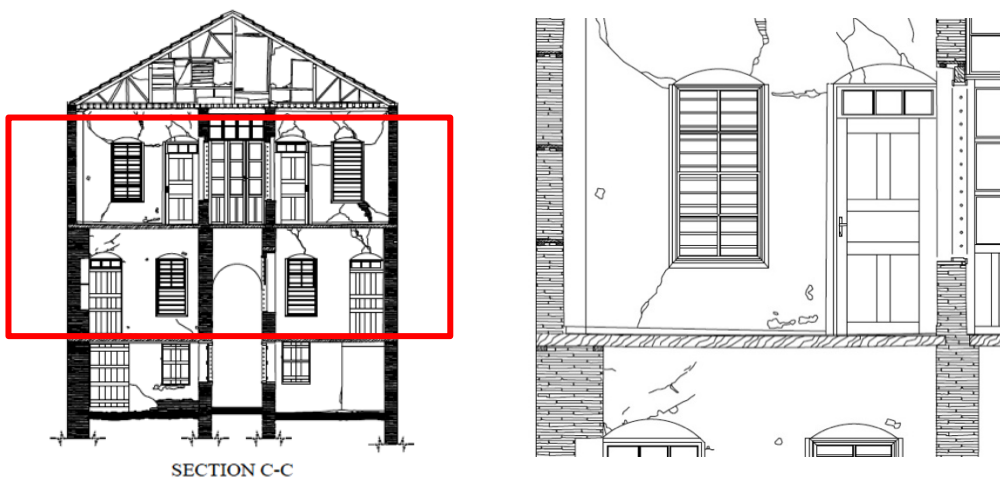
Figure 7: Adana-Tepebağ case study house: On the right section C-C and the left, timber slab, and load-bearing wall joint detail are shown [1].

On the ground floor, three spaces that are surrounded by masonry walls had some cracks. Those cracks are on the plaster, and they are not getting inside of the load-bearing structural system. However, the masonry walls, which are located on the first floor, especially the north wall, had deep cracks. Those cracks are affected the stability and bearing capacity of the first-floor load-bearing system (Figure 6). The north wall and the side walls are separated from each other, and it caused instability of the structure. These cracks and separations are occurred by seismic activity. Nevertheless, against the seismic forces, diagonal timber beams are used on the north loadbearing brick masonry wall (Figure 2) [1].

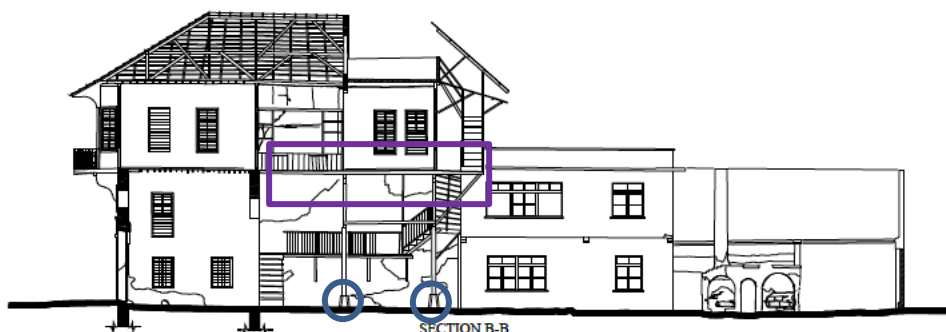
Figure 8: Adana-Tepebağ case study house: On the right section C-C (Adana endowment office) and the left timber slab and load-bearing wall joint detail are shown [1].

The structural timber elements of the roof were decayed as a result of water, humidity, and solar radiation. The water on the roof is not drained adequately and get out of the building. Therefore, the whole structure, especially timber, is under the effect of corrosion [1].
