Restoration of Historic Windows: Methodology and Case Studies

Edward A. Gerns¹ and Sarah K. Van Domelen²

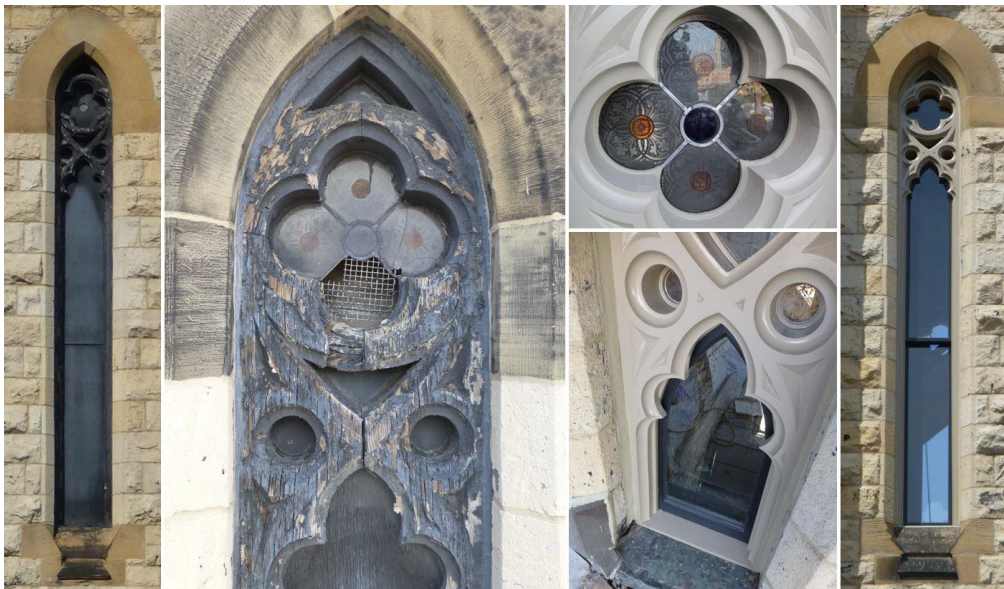
Figure 1. Typical window conditions before (left) and after restoration (right).

The exterior evaluation of the windows was performed from an aerial lift, which allowed access to all of the tower windows. The surfaces were probed with an awl, but no investigative openings were created. On the interior, access was limited based on the proximity of an interior stair. Conditions included wood decay at various exterior locations including sills, the base of jambs, and at decorative tracery. Several of the sash were missing, and the frames had been boarded up. Portions of the leaded art glass were broken or missing. Since the windows were likely built on site during construction, no original drawings or specifications existed.

Based on the owner's inability to ensure that resources could be dedicated to future maintenance of the windows, a comprehensive restoration approach was selected to maximize service life. Repairs included complete removal of existing coatings using a chemical stripper, replacement of deteriorated sills and tracery, dutchman repairs at the lower portions of jambs, replacement of sash, hardware, and weather-stripping, removal and restoration of the art glass, interior and exterior painting, and perimeter sealant replacement (Figure 2). The replacement sash were fabricated to match the profiles of the limited sash that remained. Although the original sash were likely glazed with leaded glass based on historic photos, the new sash were glazed with clear laminated glass due to budgetary constraints. The decision was also made to seal the perimeter of the glass with silicone sealant, rather than traditional glazing putty, to reduce the overall maintenance cycle. Based on the location of these windows, the substitution is not visually apparent. Finally, the colors of the new exterior coatings were selected based on paint analysis performed on other windows at the church and the historic photos.

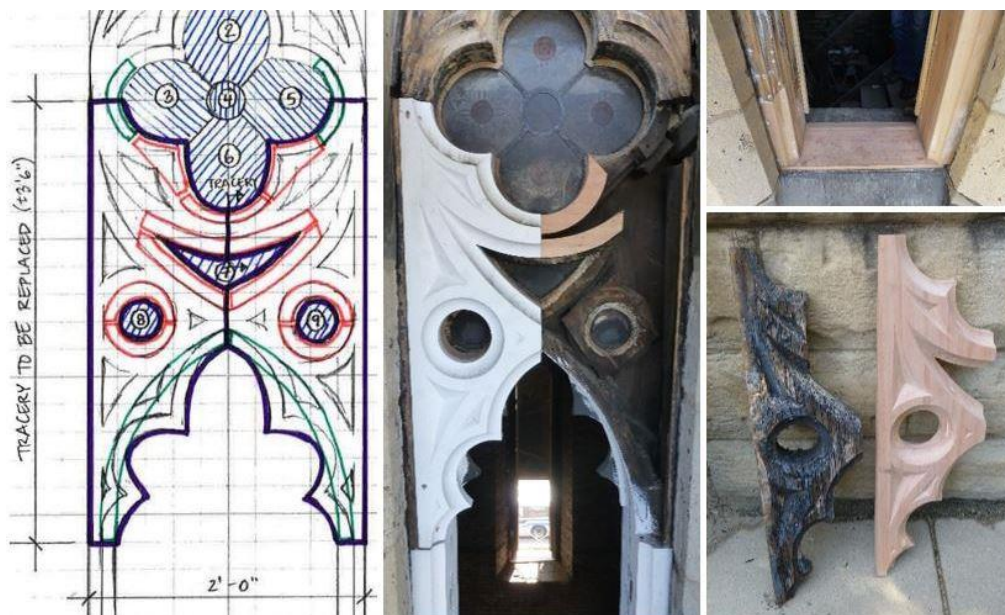
Figure 2. Sill replacement and jamb dutchmen (upper right) and tracery replacement.

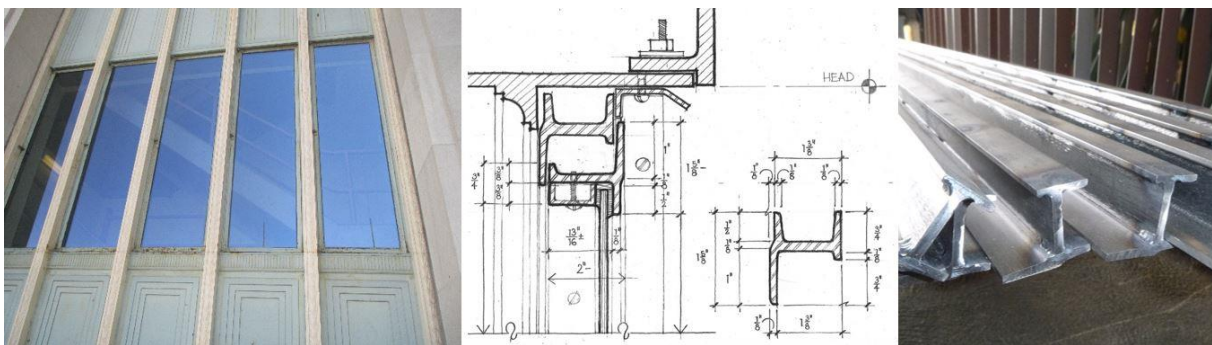
Figure 3. Cast iron curtain wall and steel casement windows (left and center); built up dutchman sections (right).

Our investigation revealed that limited repairs and intervention could extend the service life of the system, but a more comprehensive restoration could provide a significantly longer service life and limited maintenance schedule that were more in line with the owner's goals. Detailing and profiles were found to be generally consistent throughout the station, but window sizes varied. The original manufacturer of the windows was determined through archival research, and product data, including original profiles, was located in historic product literature.

A comprehensive facade restoration program, including the stone masonry facade, steel frame windows, and cast iron curtain wall, began in 2012. The restoration scope included off-site restoration of the steel sash and frames, including comprehensive glass replacement, and in-situ restoration of the cast iron curtain wall. Coating removal was accomplished by abrasive blasting with a garnet media to achieve SSPC-SP10 (near white metal blast with a surface profile between 1 and 2 mils). Where necessary, dutchmen were created by building up steel plates and stitch welding them to mimic the original profile. The original steel was tested for weldability and a weld procedure was provided. A high performance coating system was applied to the blasted surface, consisting of a zinc-rich primer, epoxy intermediate coat, and fluoropolymer top coat. Finally, a blast and solar protection film was applied to the new glass prior to being glazed into the restored sash. To improve the overall thermal performance of the building, custom fabricated aluminum storm windows were installed on the interior of the building at office locations.

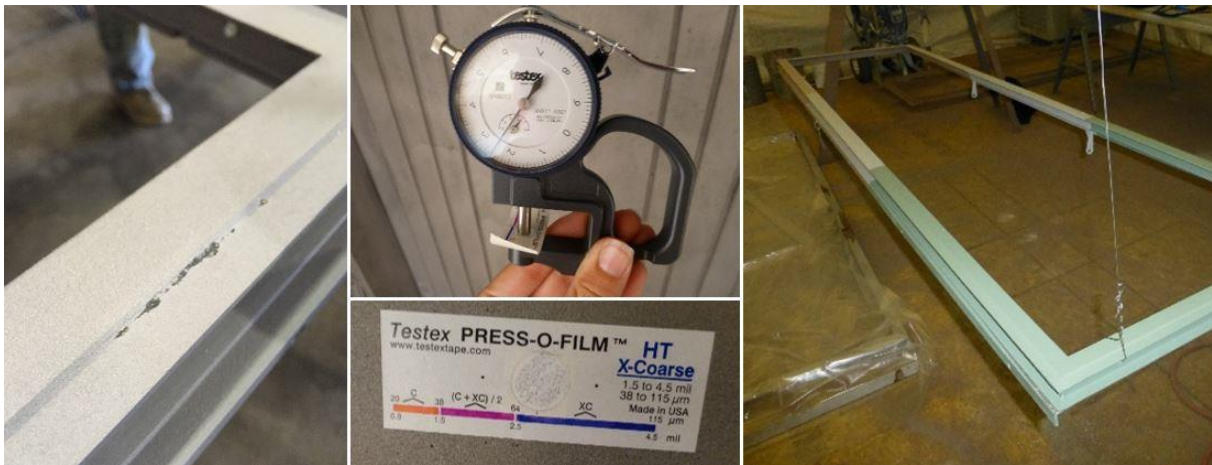
Figure 4. Steel frame blasting and surface profile measurement (left and center); coating mockup (right).

Several challenges were encountered at the beginning of the project that had to be resolved. Hazardous materials were found in concealed portions of the window assembly that required remediation. In addition, the weather-stripping had to be custom fabricated, as an off-the-shelf product replicating the profile could not be located by the contractor. A comprehensive quality control and quality assurance program was also established that included inspection and surface profile measurements of the window frames following blasting, and coating thickness measurements following each layer of coating application.
