SEISMIC RETROFITTING OF HISTORICAL MASONRY HERITAGE STRUCTURES: A CASE STUDY OF AN ADOBE MASONRY BUILDING IN LIMA, PERU

TIAGO MARTINS^{1*}, JULIA GARCÍA¹, ALEJANDRO FERRÁNDEZ¹, NICOLA
TARQUE² AND JAIME FERNÁNDEZ¹

2.3. Damage survey

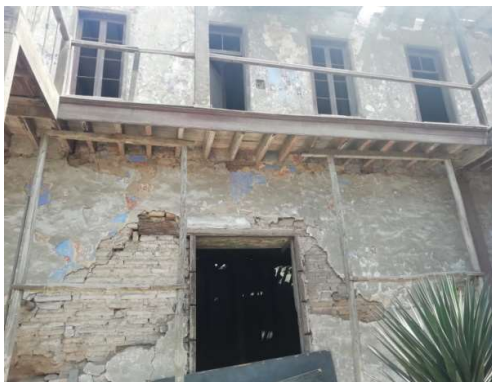
Beginning with the first floor, the most notable damage to the facades are multiple fractures generally followed by detachment of the exterior cladding and partial demolition of parts of the masonry walls, with material expulsion. The latter happening specially in the vicinity of the openings that serve as windows (Figure 5: a) and at the joints of the first and second floor walls, as well as at the corners (Figure 5: b.).

a. Cracks, cladding detachment and partial of walls

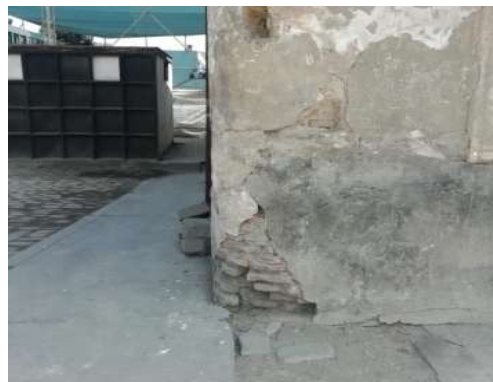
b. Partial demolition with material expulsion in corner

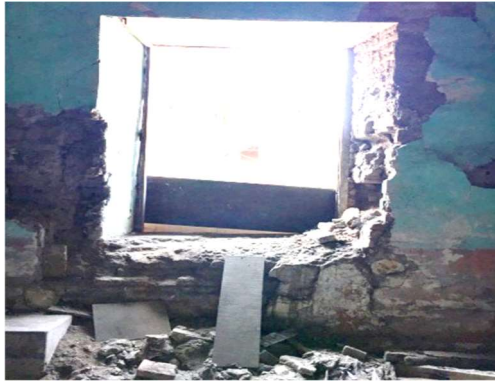
Inside this level, it also takes place detachments of material on the walls (Figure 6: a.). One of them, which served to separate a small room from the main one, has collapsed (Figure 6: b.). In addition, the presence of vertical cracks extends throughout all the load-bearing walls (Figure 6: c.), causing disconnection of all the edges between adobe masonry walls, making them work separately and not allowing a box effect (Figure 6: d.). Other important damages are those related

a. Partial demolition with material expulsion

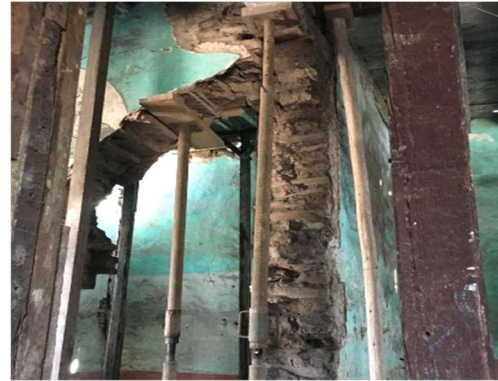
b. Collapsed wall sustained by props

Adobe walls will be reconstructed (for those which already collapsed) or repaired. The damaged sections of the walls will be torn down and rebuilt employing similar adobe bricks to the original ones.

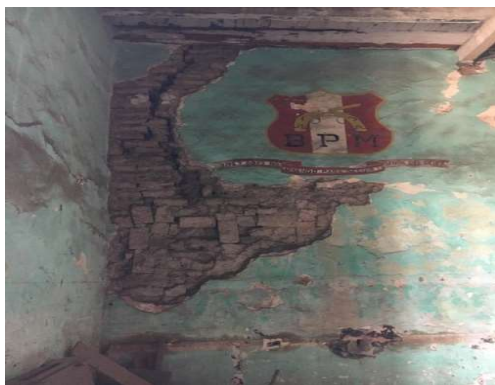
c. Vertical cracks

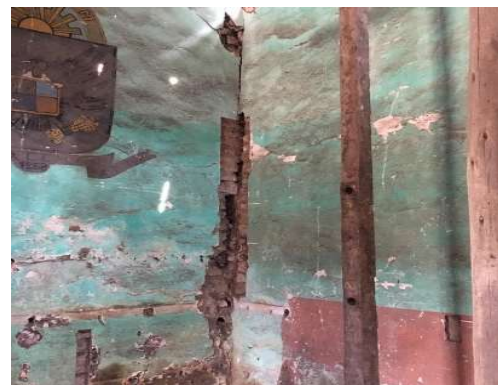
d. Disconnection of the edges

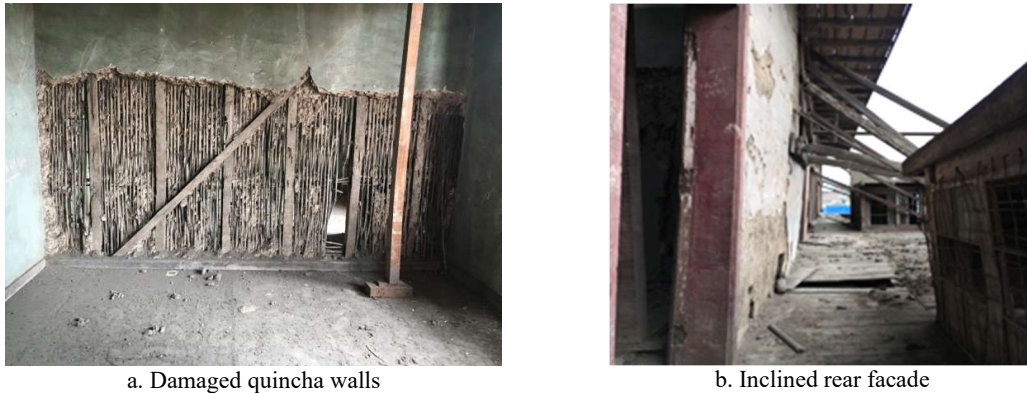
Figure 7. Second floor damages.

The analysis continues on the second floor. The only access to it is by a wooden stairway in a high state of deterioration. The quinchas walls used as separation elements for the sixteen departments that conform the second floor have damages generated by the attack of xylophages. This causes the need to rebuild the quinchas walls (Figure 7: a.) and the girders from the wooden slab as well because of their high deterioration. Finally, it can be seen how the walls of the rear facade, are inclined, making it necessary to support them with braces (Figure 7: b.).

In its current state the building can only stand thanks to a series of wooden and steel braces all around the main space, which support the main and secondary girders and avoid imminent collapse. Therefore, the retrofitting must begin with a reconstruction to provide the building its original mechanical properties.
