**Initial Building Investigations at Aberdeen
Proving Ground, Maryland: Building E5375**

ANL/ESD/TM-56

by K.L. Brubaker, J.M. Dougherty, and C. Tome

June 1993

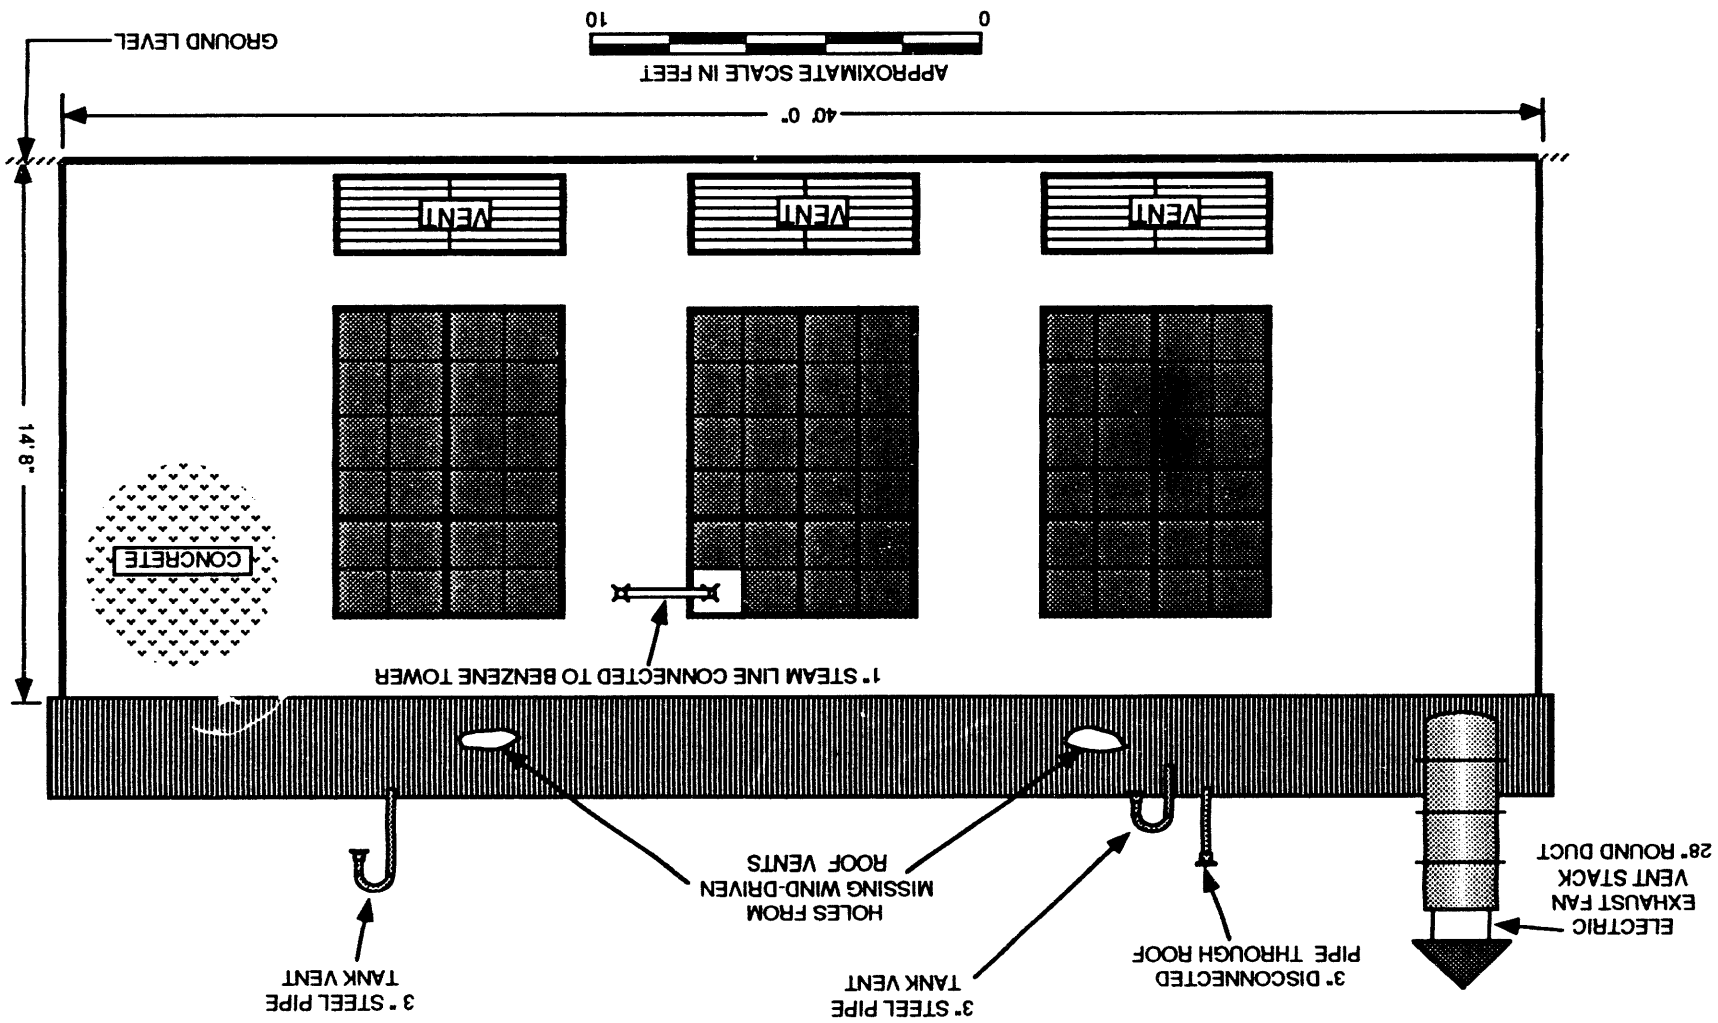
FIGURE 5 Building E5375 North Exterior Elevation

The north elevation of Building E5375 measures 14 ft 8 in. tall × 40 ft wide (Figure 5).

The overall condition of this elevation of the building is good. All of the components that constitute this elevation remain in place at the time of this investigation.

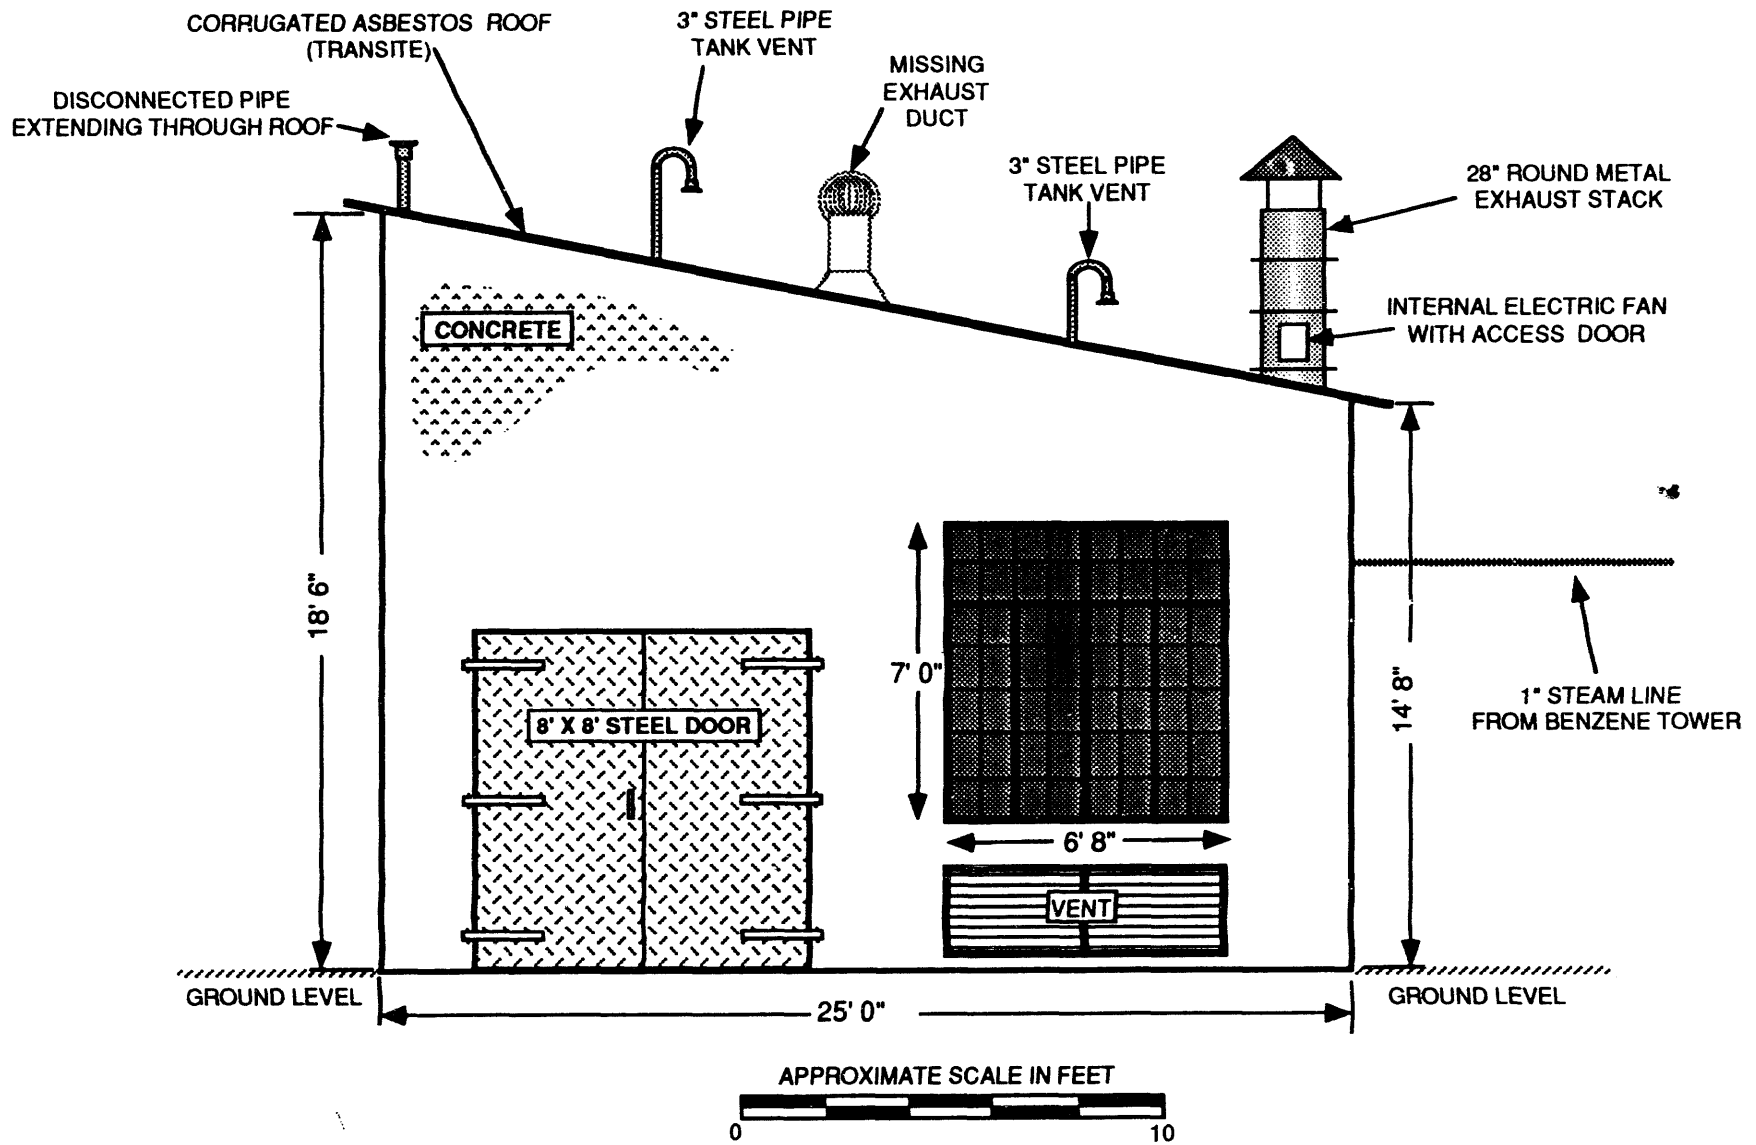
FIGURE 6 Building E5375 East Exterior Elevation

The overall condition of this elevation of the building is good. All of the components that constitute this elevation remain in place at the time of this investigation.

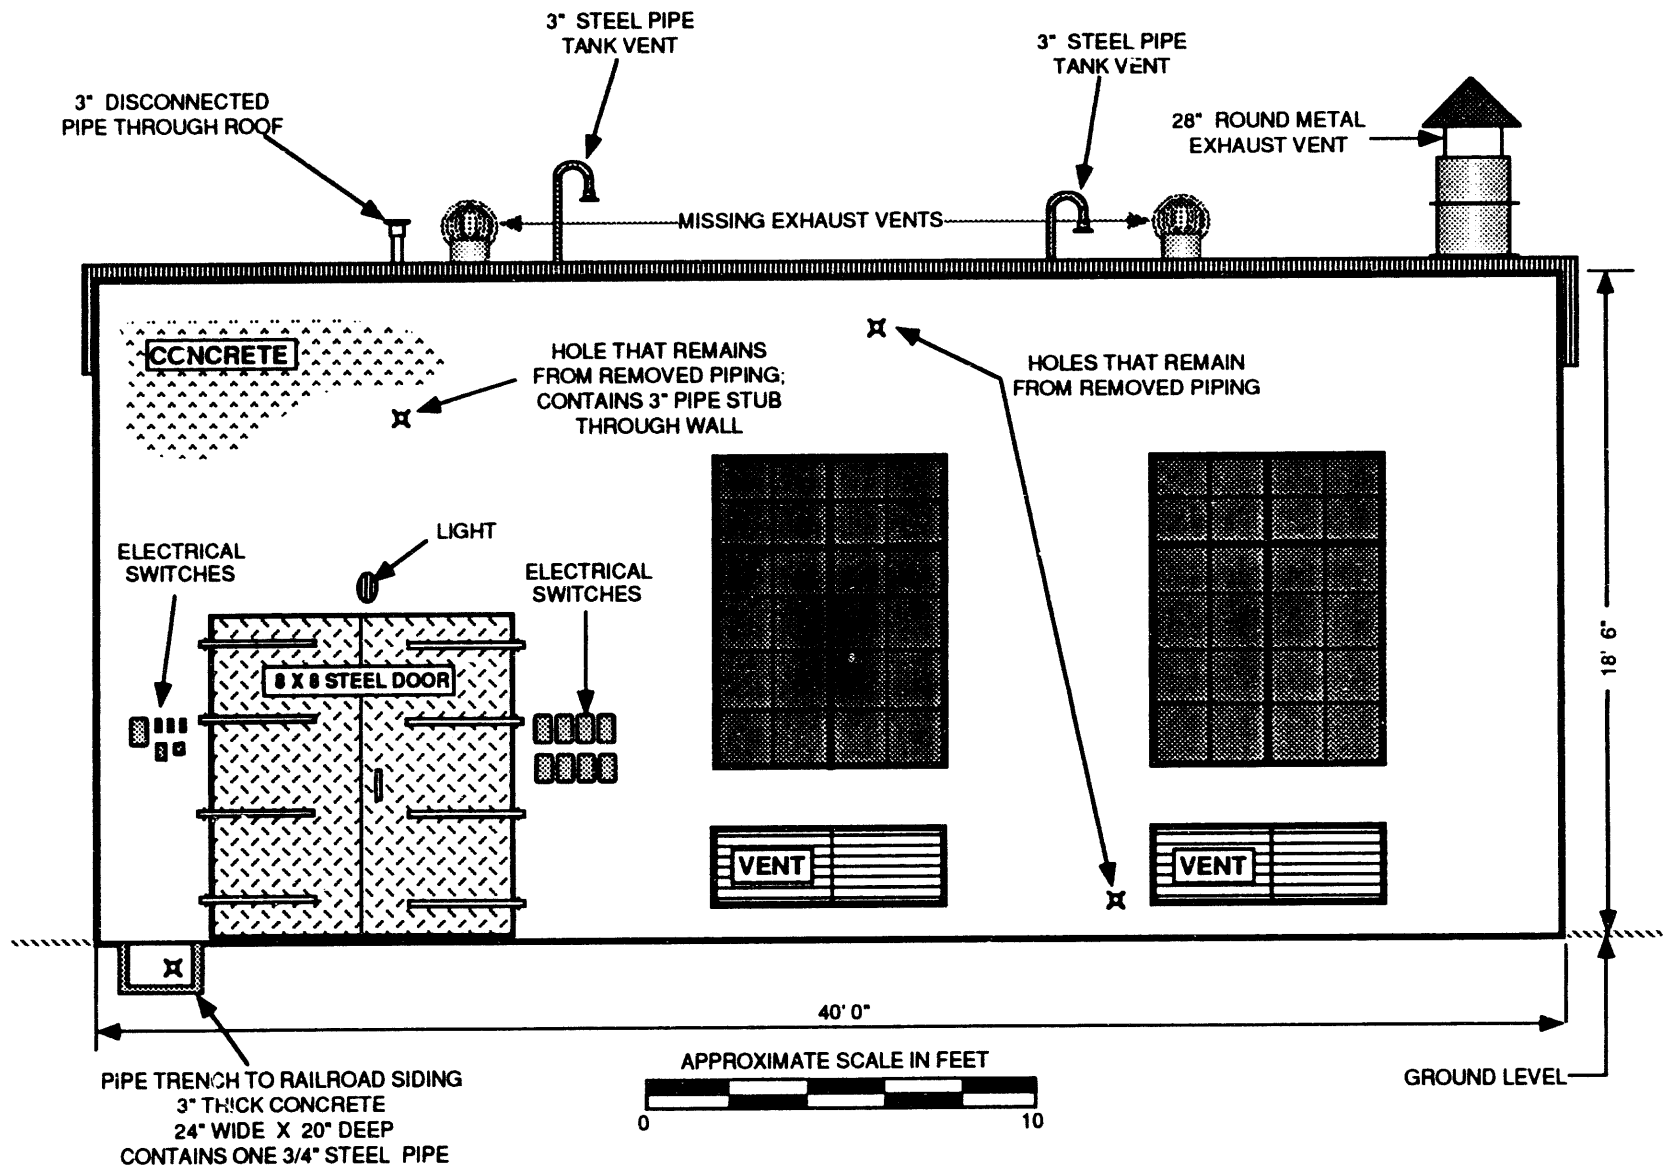
FIGURE 7 Building E5375 South Exterior Elevation

This elevation of Building E5375 is currently devoid of any exterior piping, but evidence of former pipe connections in this elevation remains in the form of holes through the exterior walls of the building (Figure 7).

The pipe trench that connected Building E5375 with the railroad siding to the south of the building (Figures 4 and 7) exits at the southwest corner.

The overall condition of this elevation of the building is good. All of the components that constitute this elevation remain in place at the time of this investigation.

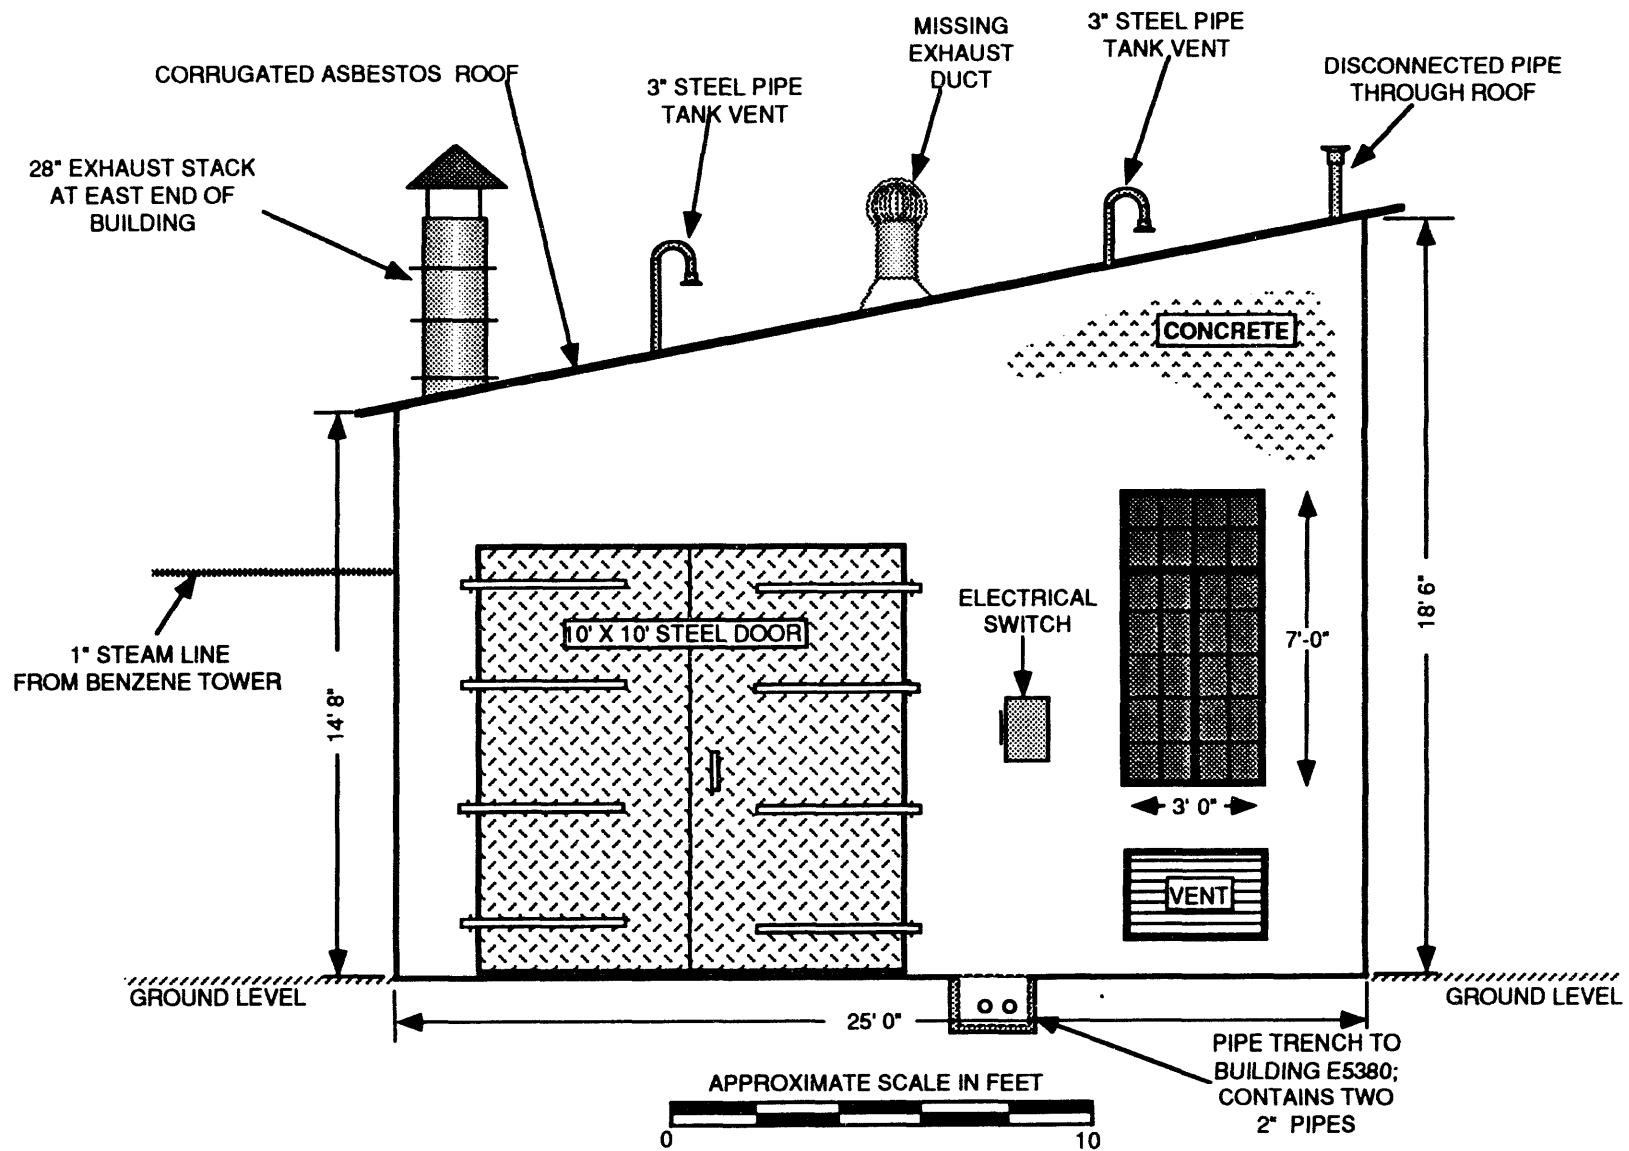
FIGURE 8 Building E5375 West Exterior Elevation

The overall condition of this elevation of the building is good. All of the components that constitute this elevation remain in place at the time of this investigation.

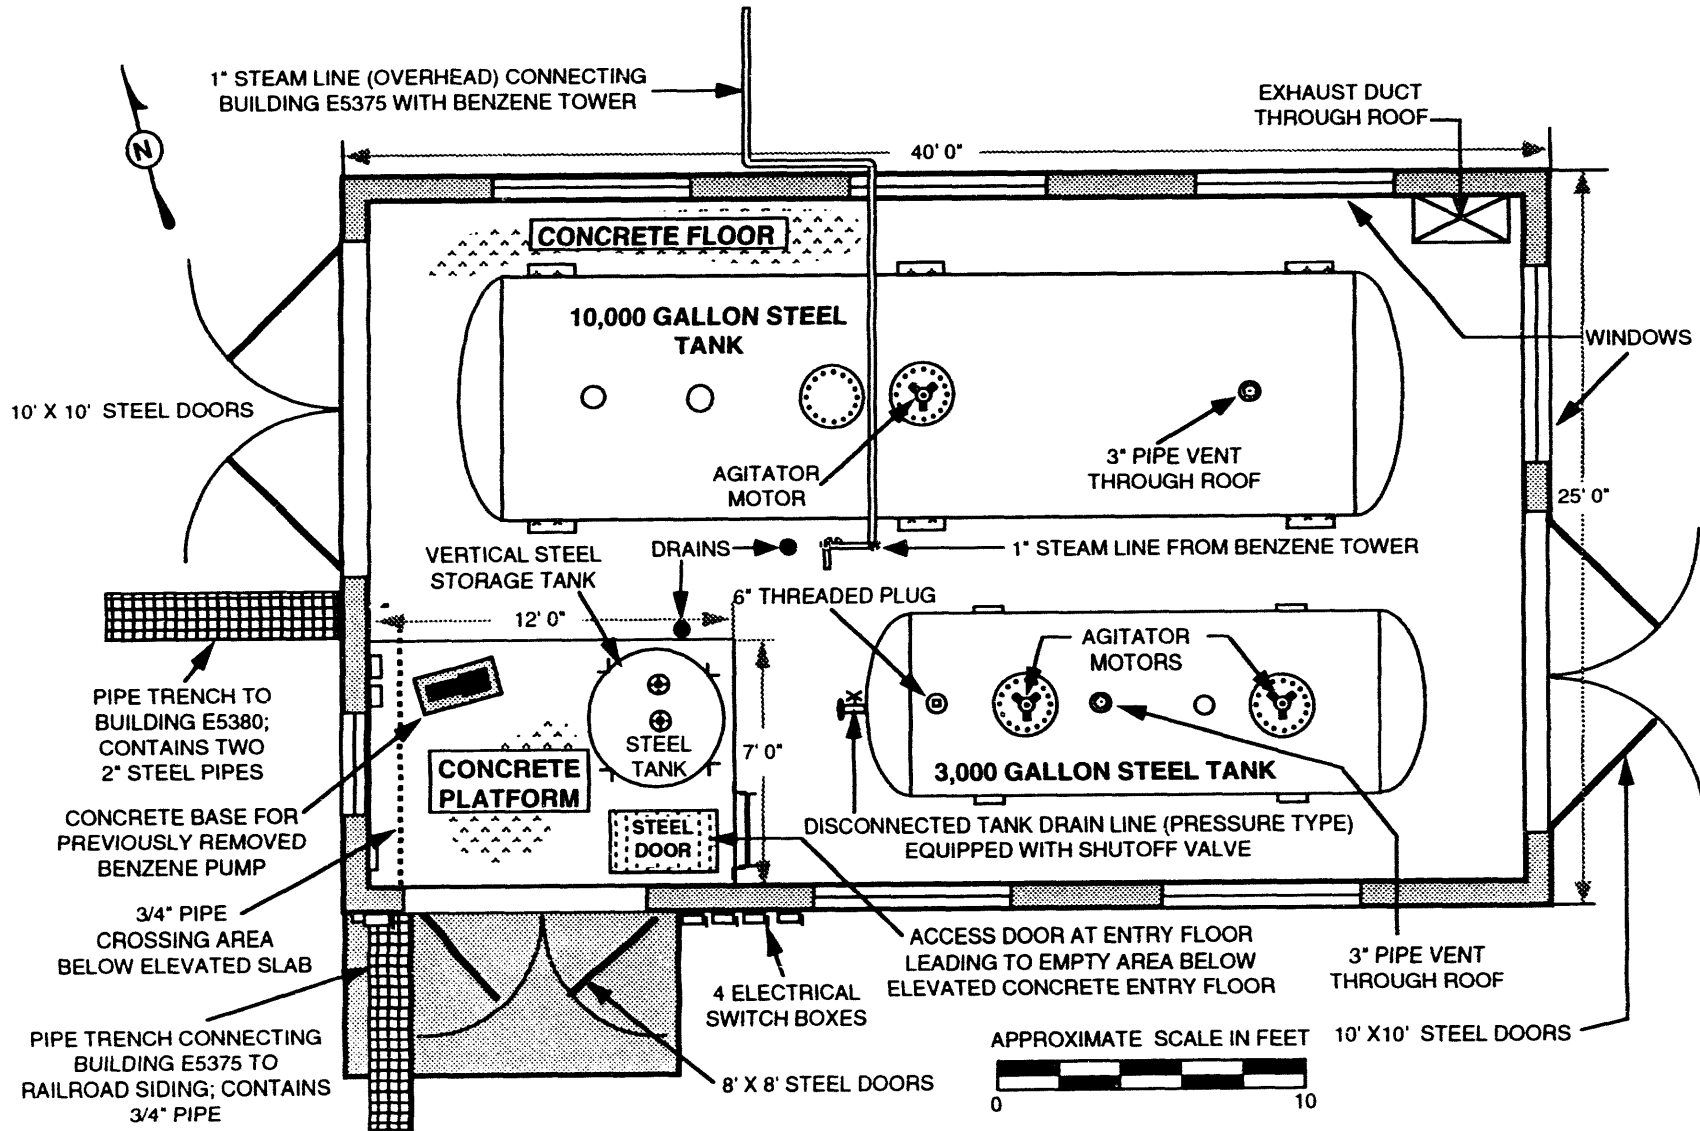
FIGURE 9 Building E5375 Floor Plan

Building E5375 has a 1-ft-thick, cast-in-place, concrete floor installed 4 ft below the surrounding exterior grade of the building. The floor is intact and in good condition for its age.

There is no evidence to suggest that the floor was modified in any way. No major cracks were identified.

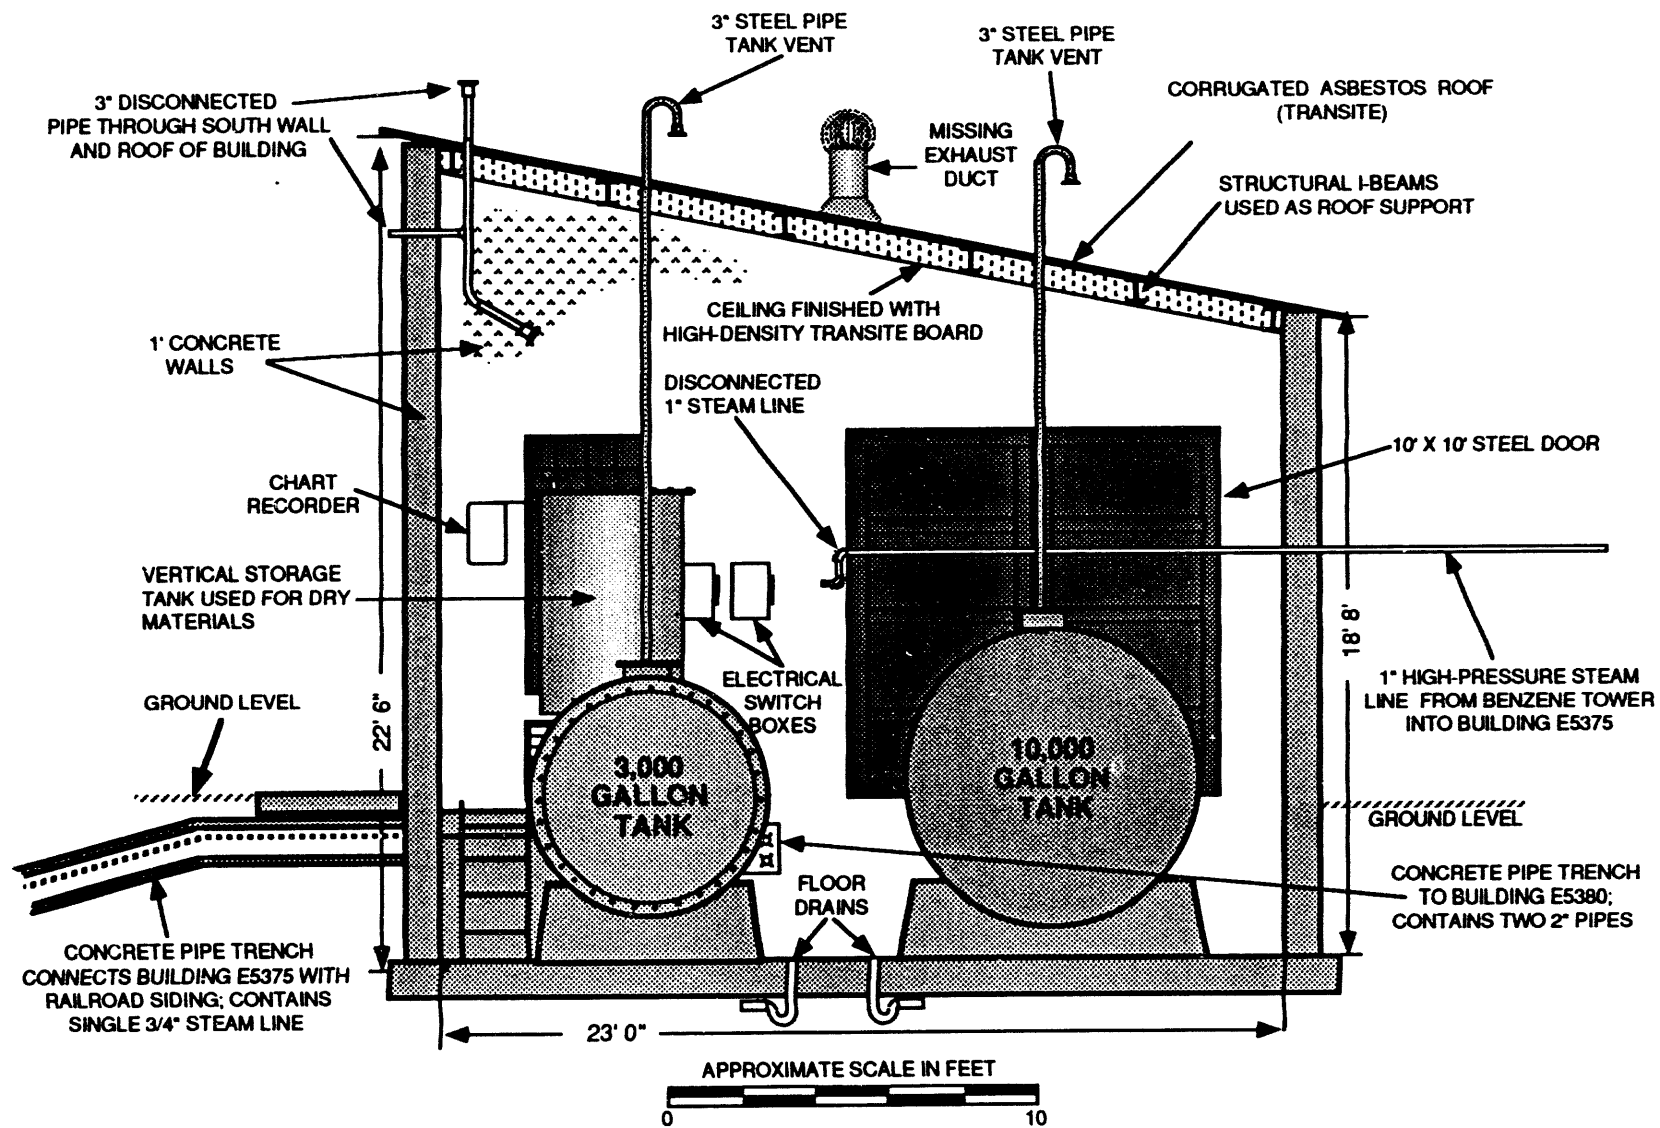
FIGURE 13 Building E5375 West Interior Elevation

Located at the west interior wall is the opening for the in-ground pipe trench connecting Buildings E5375 and E5380. This trench contains two 2-in. metal pipes. No other piping is found in this elevation (Figure 13).

The ceiling of Building E5375 is constructed of Transite panels (Figure 13). There are two large holes in the ceiling remaining from the removal of wind-driven vents that were once mounted on the roof of the building. Currently, rain may enter the building through these holes, which has resulted in an accelerated deterioration of the ceiling and the potential transport of any

contaminants present via the floor-drain system. Large sections of the ceiling finish are in danger of falling because of the deterioration.
