SHM SYSTEM FOR BONDING LINE MONITORING OF COMPOSITE WING BOX SKIN-SPAR CAP DURING MANUFACTURING

Summary: *The CFRP wing box section under investigation is a stringer less wing-box (develop within the OPTICOMS research project) and consists of two portions: an upper part, made of co-cured spars and a top skin panel, and a bottom cured skin panel. The two portions are joined with a bonding process, giving rise to the final wing-box. During that final assembly step, distributed fibre optics were embedded between the spar caps and the bottom skin panel along the bonding lines. The embedded FO consists of six distributed fibres running within the bonding layer for about 1 m along the span direction. An irregular damage map was defined, by simulating the presence of manufacturing bonding defects by the intersection of teflon patches, different for width and length, to check an SHM system capabilities in detecting such flaws. The SHM system was tested after the final bonding process, by exploring the info contained within the “residual strains” data of the unloaded structure. Results obtained by post processing data for each fibre optic, are reported. The damage index associated to the e

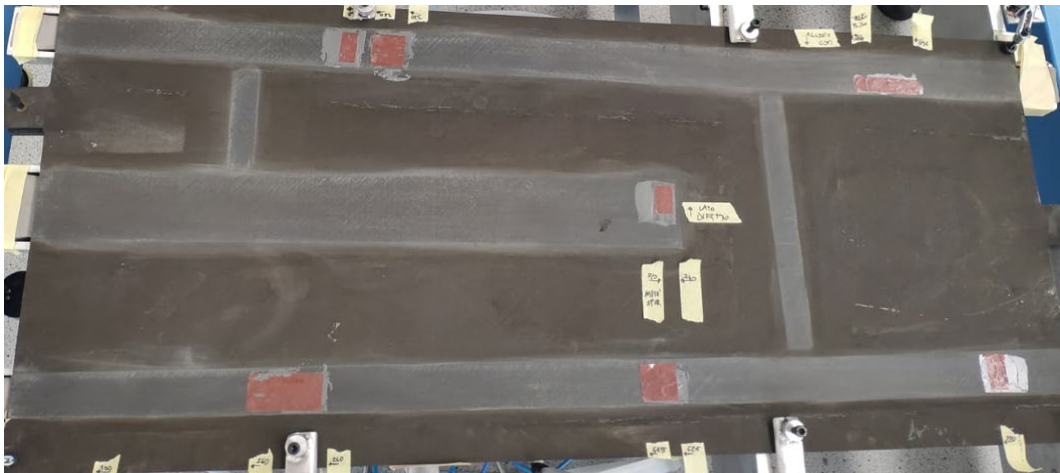
The damage map is visible in Figure 2, corresponding to the areas where Teflon patches were placed within selected areas on the spar caps. The main idea was to simulate the presence of disbanded areas, therefore characterized by a lower mechanical strength.

Figure 2: The lower skin with the Teflon tape simulating a disbanded area.

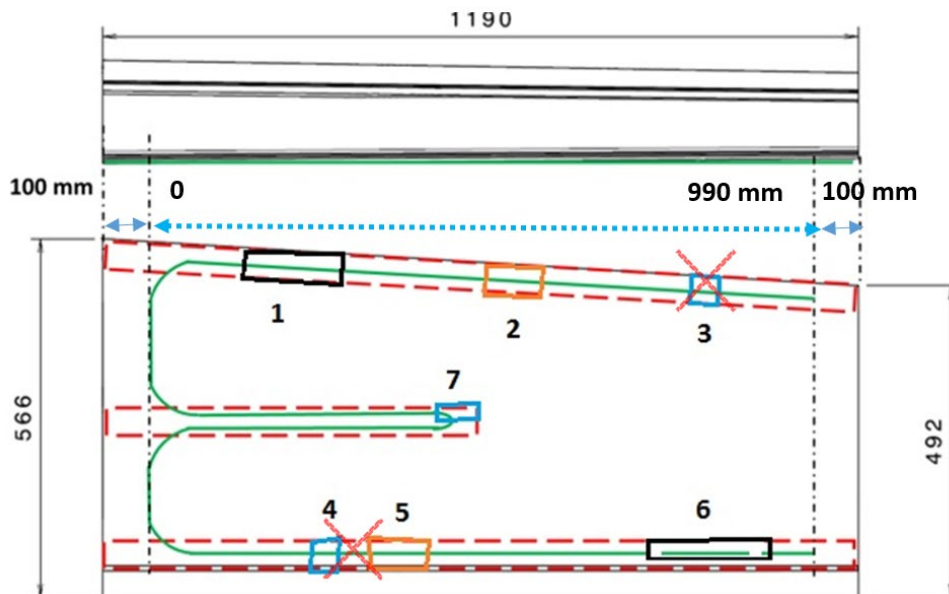
Figure 4: The sketch of a possible distributed fibre optic route layout on the investigated structural component and the defined damage map. The dotted rectangle indicates the region of interest far from the cradle area. In addition, there are two flags on damage 3 and damage 4-5. The reason is that damage 3 was discovered to be bonded out of the region of interest, while damage 4-5 were merged due to the resin squeezing post assembly.

A first consideration must be done about the manufacturing process. It arose that the damage ID.4 and ID.5 were barely distinguished by the SHM system. The gap of 20 mm between them was probably uncovered by the adhesive during the assembly, for the excessive proximity of the two faults.

Another consideration must be done for the damage ID.3, that was scarcely revealed by the SHM system, even if a certain alert points distribution was detected; however, such a map was considered insufficient for a reasonable determination of the fault size. The partial visibility of the flaw may be associated to the fact, confirmed by the C-Scan, that the Teflon was actually arranged out of the region of interest (Figure 4).

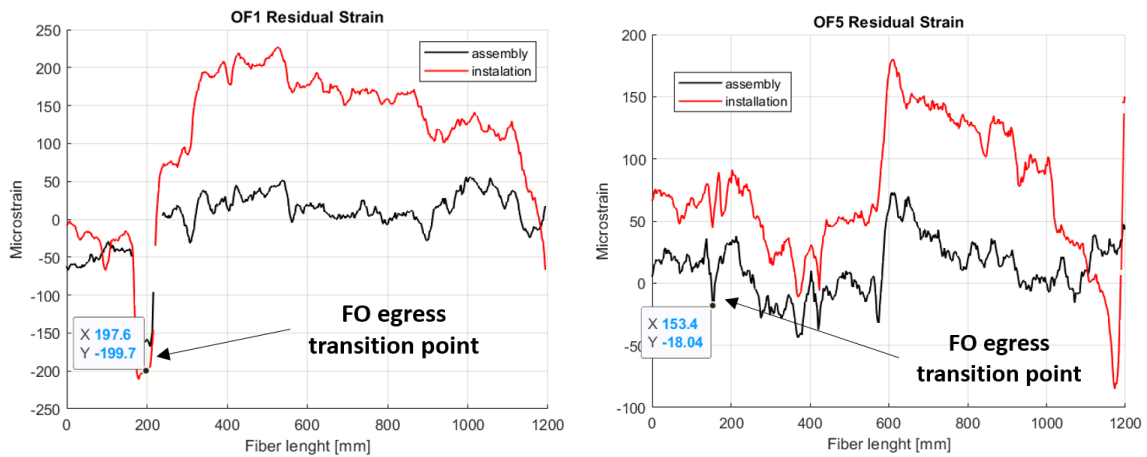
A non-zero strain map is revealed, much more evident after the installation on the test rig. Indeed, the cantilever beam-like configuration on the test rig added a gravity load over the span of the box providing a strain shift of the overall signal. In addition, the strain distribution also showed a clear compression effect in the area of the cradle (indicated by a red arrow). Finally, the effective length of the fibre optic along the spar is retrieved, by marking the abscissa (black arrows) corresponding to the egress point on the connector side.

Figure 8: The residual strain after assembly (black line) and after installation on the test rig (red line).

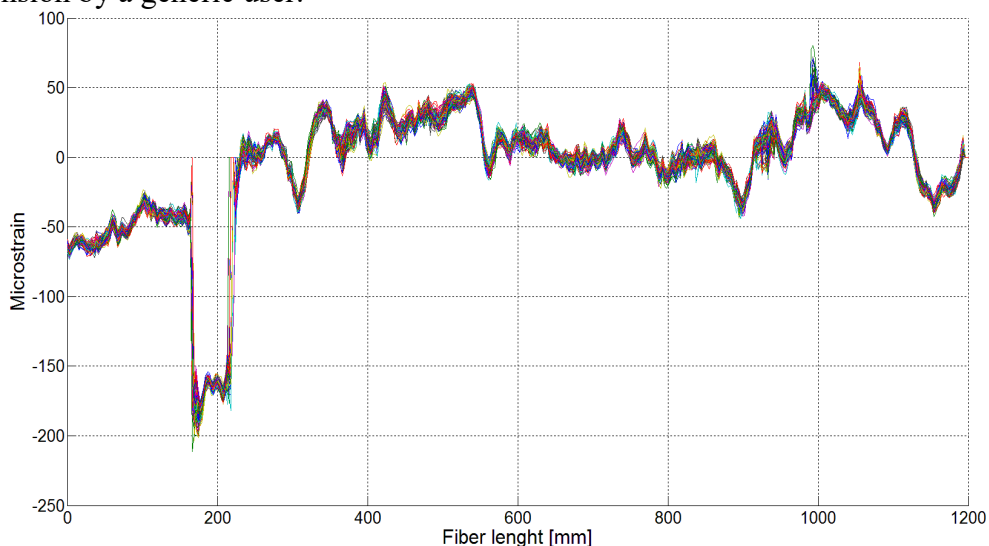
Figure 9: The residual strain after assembly for OF1 on the rear spar

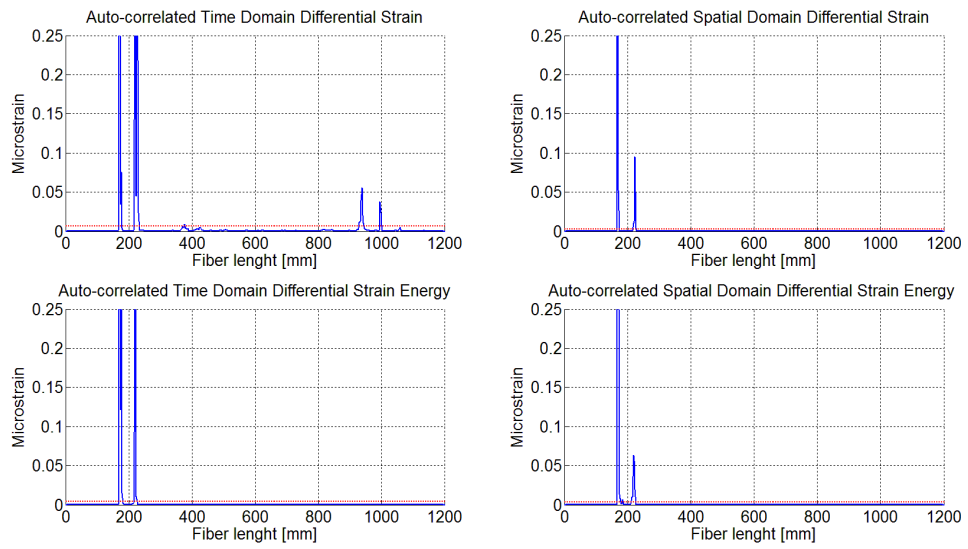
From these pictures, it does seem that the most remarkable edge is revealed at the egress point of the fibre; however, at a more accurate view, other minor peaks can be revealed. Now, the former ones are a known characteristic of the system, and can be neglected. The others, shall be further analysed by the LHEO algorithm to provide an expected indication of the damage presence. In fact, In the next Figure 11, the cumulative damage index (CDI) is shown all along the fibre length.

Figure 10: The cross-correlation features extracted by the strain map (phase 2, flowchart in figure 7)

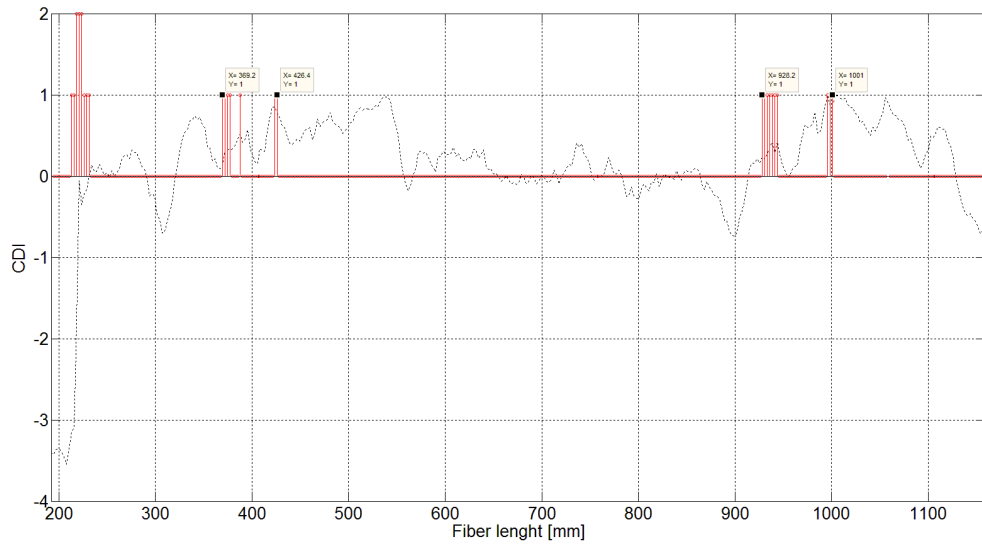
Therein, the strain signal is reported with the aim of providing a reference to the reader. As it can be seen, the egress region is clearly indicated, and other points do also emerge as indication of what the SHM code recognised as significant discontinuities. It is relevant to remind that the code aims at revealing the edges of the fault areas, and therefore it is expected that the points more easily pointed out will be their boundaries. The final picture, Figure 12, reports the same data of Figure 11, but deployed on the physical representation of the bottom skin panel to help discern the revealed points. This may be an excellent tool for the immediate comprehension by a generic user.

Figure 11: The cumulative damage index CDI extracted by the features (phase 3, flowchart in figure 7)

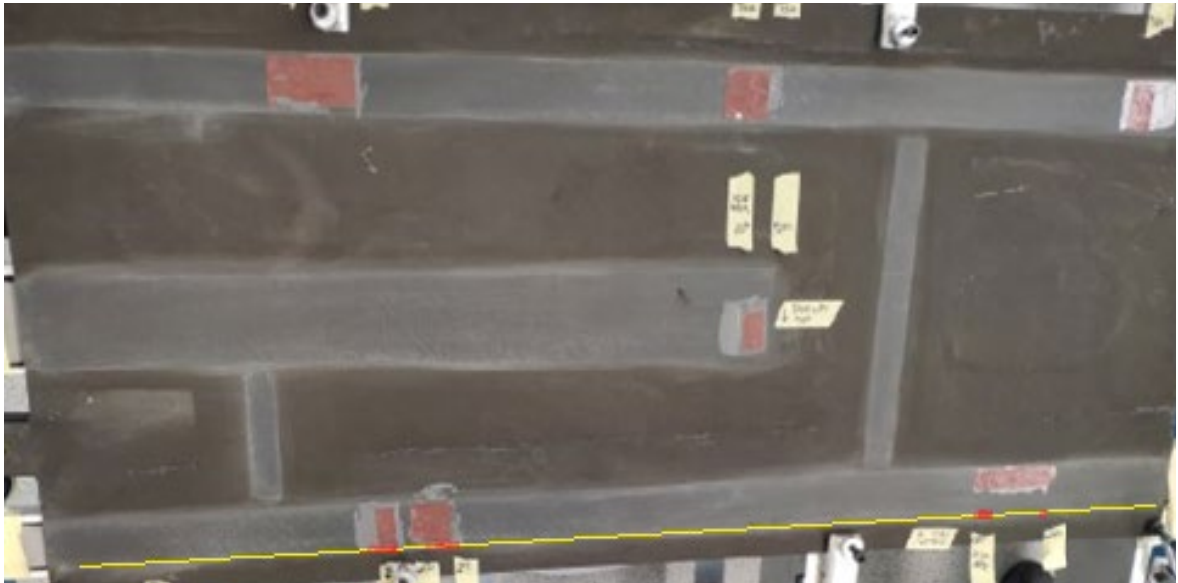
Figure 12: The graphical user interface with a representation of the fibre optic in yellow and the SHM sensors readouts indicating a damage in red

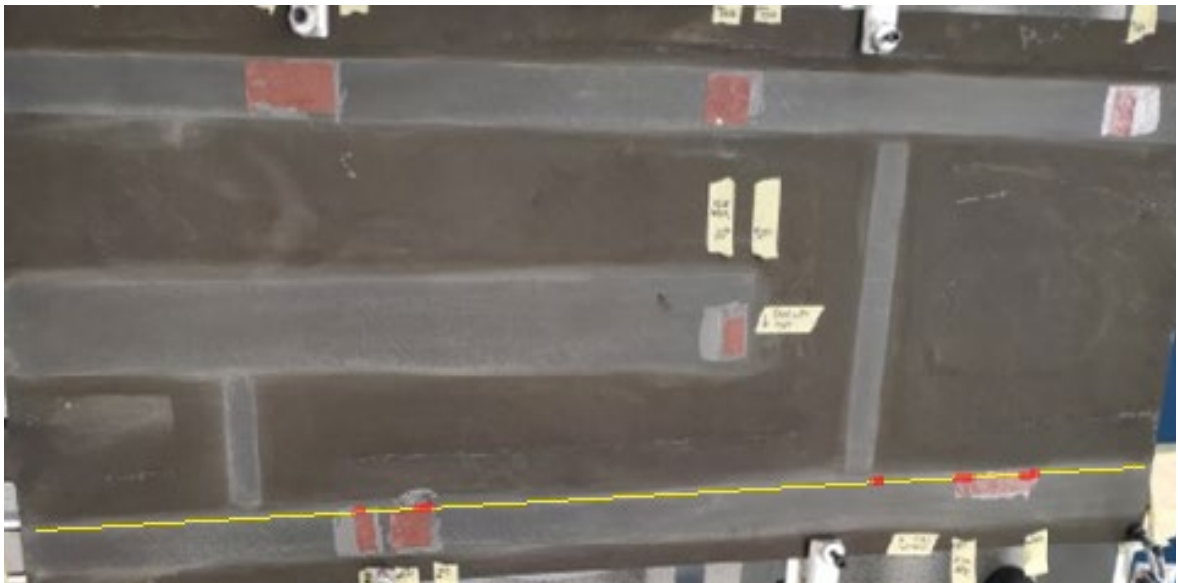
As anticipated, from this point on, it is chosen to report only the final outcomes of the data elaborations. The steps are the same, and the intermediate graphs would add only side information with respect to the algorithm capability in detecting the presence of the damage. In detail, a good proximity of the outcomes for the OF1 and OF2 may be appreciated by a comparison between Figure 12 and Figure 13. The positions of the imposed damage are clearly exhibited, and the specific prediction points are well matched. A minor discrepancy does appear at the very beginning of the fault ID.6 (Figure 4), maybe associated to a small local irregularity in the fibre deployment.

Figure 13: The graphical user interface with a representation of the fibre optic in yellow and the SHM sensors readouts indicating a damage in red

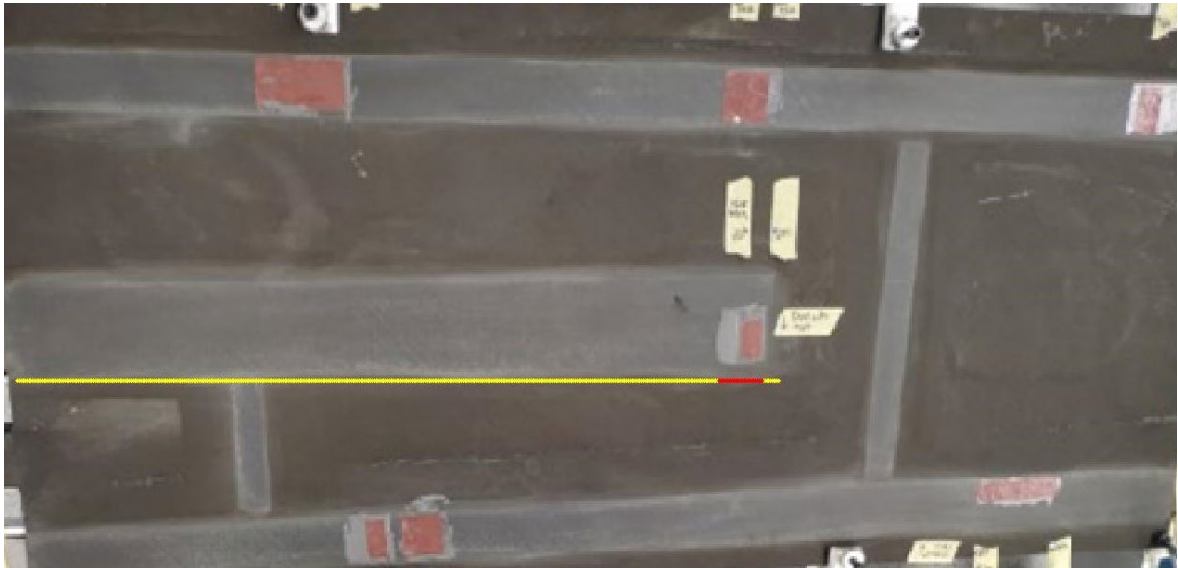
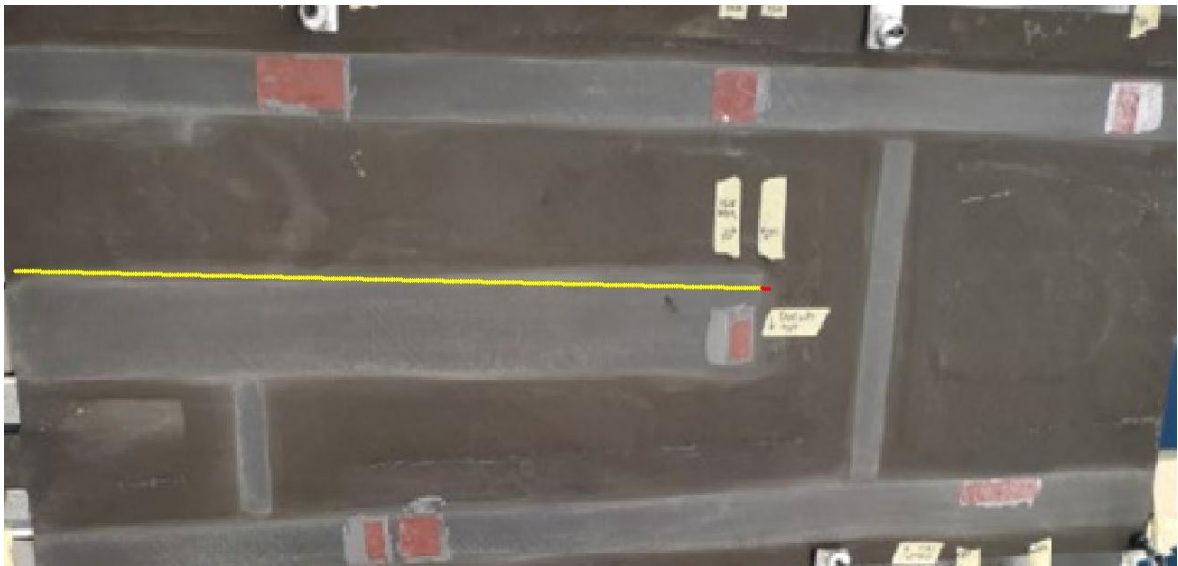
Continuing the aforementioned tracks, in the next Figure 14 and Figure 15, the outcomes associated to the fibres deployed along the middle spars are reported. These results are particularly significant from the algorithm capability verification standpoint, since the imposed damage interested a very limited area at the tip of the central spar. Therefore, it was natural to expect that the indications could be very slight. Nevertheless, the algorithm proved to be very sensitive in this case, either, by recognizing the existence of a structural irregularity in the region of interest. This does appear very clear for the fibre OF3, while the detection for the fibre OF4 is only marginal, but nevertheless occurring at the fault edge.

Figure 14: The graphical user interface with a representation of the fibre optic in yellow and the SHM sensors readouts indicating a damage in red

Figure 15: The graphical user interface with a representation of the fibre optic in yellow and the SHM sensors readouts indicating a damage in red

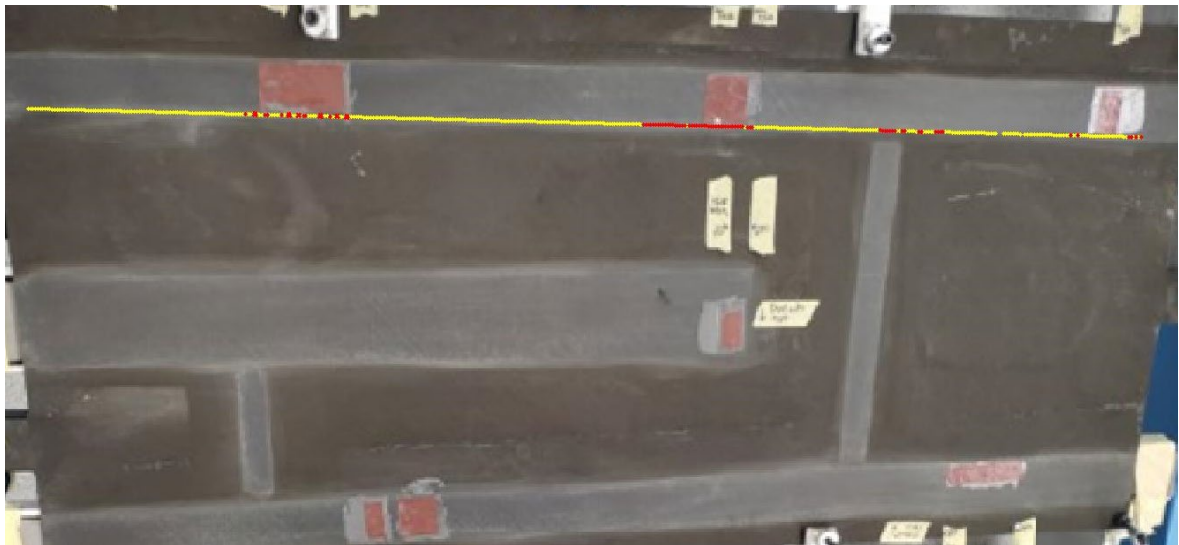
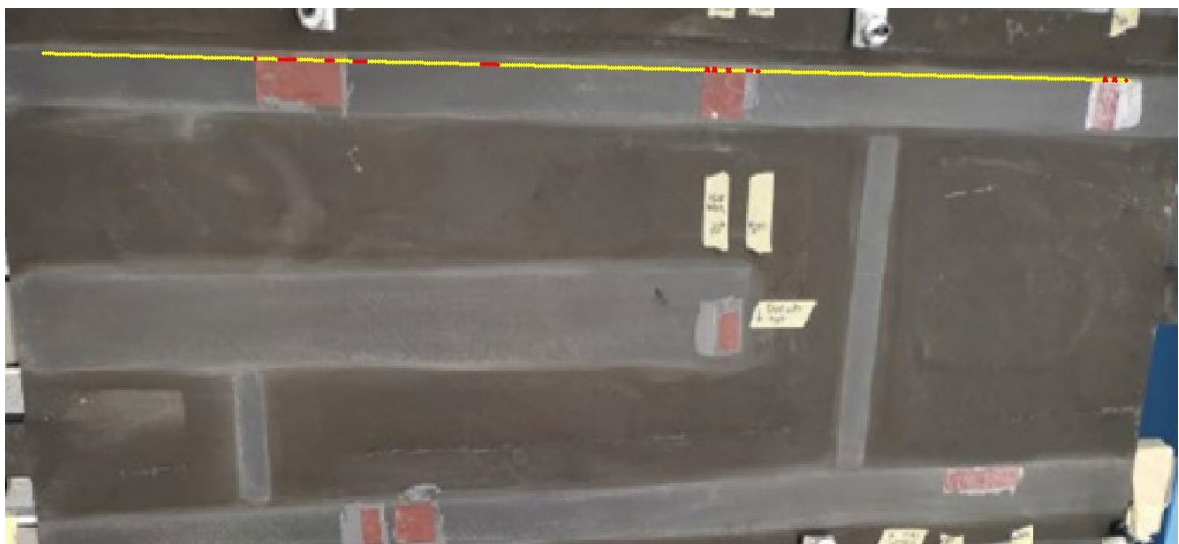
Finally, the outcomes for the front spar are reported. Even in this case, the OF5 and OF6 are reported. The damage presence is always revealed, with a clear resolution with respect to the fibre segments that are not interested by disbonding regions; disbonding areas are always highlighted by a remarkable and homogeneous quantity of warning points. As in the other cases, few points do occur in regions nominally intact. Again, they can be explained by local irregularity in the fibre deployment or in further anomaly in the local bonding application. In the sole point of the fault ID.2, Figure 4, it could be supposed that the relevant alert shown by that sensors line, may be due to a sort of spill-over effect of the imposed damage, locally.

Figure 16: The graphical user interface with a representation of the fibre optic in yellow and the SHM sensors readouts indicating a damage in red.

Figure 17: The graphical user interface with a representation of the fibre optic in yellow and the SHM sensors readouts indicating a damage in red.
