Evaluation of Defects Incidence and Severity on Building Façade: A Case Study

In the scope of the study, one of the modern period buildings was constructed between 1955-1963 (Oktay, 1964) from Istanbul, Turkey – the Istanbul Esnaf Hospital was inspected and analyzed considering façade defects. The main objective of the study is to examine the defect incidence and severity of the building façade considering different parameters such as orientation of the façade, location on the façade, finishing material (i.e., rendered-painted and mosaic ceramic), and perceived causes. In this respect, the analysis method of the defects is explained first with brief information about the building and its environmental properties. Then, findings from field inspection are presented and discussed.

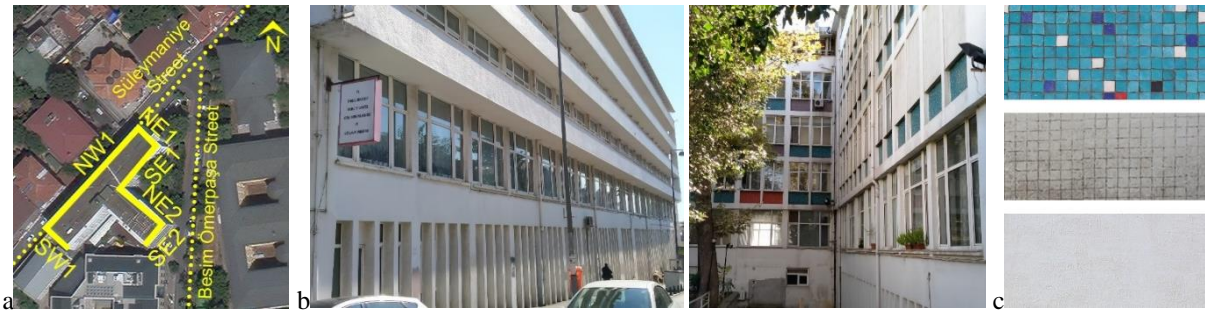
Figure 1: a) Close surrounding (straight lines represent examined façades and they have numbered according to its orientation and repetition) (URL-3), b) Views of the façade (Authors, n.d.); NW1, SE1 and NE2, c) Façade finishing materials (Authors, n.d.); colorful mosaic ceramic, mosaic ceramic-painted, and rendered-painted.

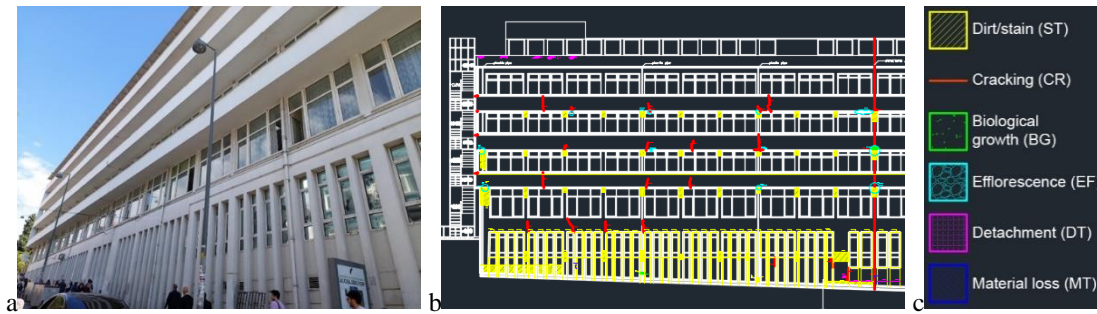
Figure 2: a) Part of the NW1 façade (Authors, n.d.), b) Defects marked on the NW1 façade (drawing taken from Istanbul University - Construction and Technical Department and adapted by authors), c) Main type of defects legend.

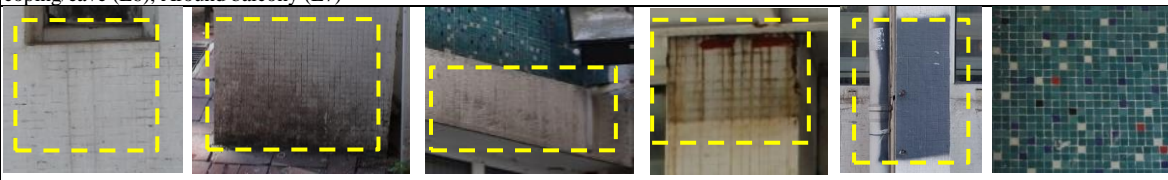
<p>C_ST1-L5 C_ST1-L3 R_ST1-L1 C_ST2-L6 C_ST4-L4 C_ST6-L4</p>
Cracking (CR)	<p>Defects on R: Cracking on paint (R_CR1), Cracking on render (R_CR2), Cracking and detachment in paint (R_CR3), Cracking and detachment in render (R_CR4). Defects on C: Cracking on paint (C_CR1), Cracking and detachment in paint (C_CR2), Cracking on outer layer (C_CR3), Cracking and detachment of outer layer (C_CR4), Cracking and detachment of system (C_CR5). Locations: On the projected area (L1), On continuous wall (L4), Under/around coping/eave (L6), Around balcony (L7), On/near structural system (L8), Around openings (L9)</p>

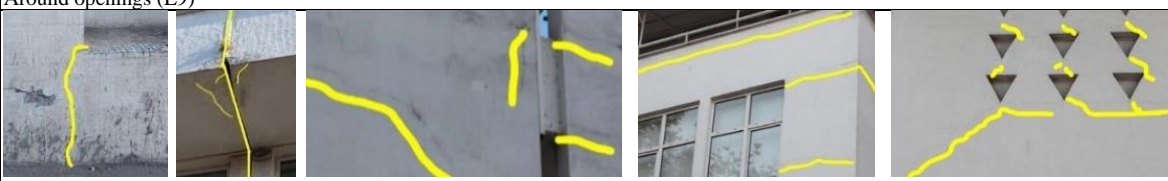
<p>C_CR1-L9 R_CR2-L8 R_CR2-L7 R_CR1-L9, R_CR2-L8/L6 C_CR1-L9</p>

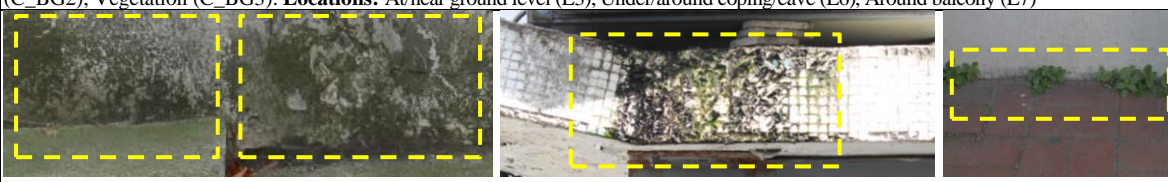
<p>C_BG1 (left side), R_BG1 (right side)-L3 C_BG2-L6 C_BG3-L3</p>
Efflorescence (EF)	<p>Defects on R: Color change (R_EF1), Blistering (R_EF2), Spalling - in small pieces (R_EF3), Blistering and crack (R_EF4), Flaking in large pieces (R_EF5). Defects on C: Color change (C_EF1), Blistering of paint (C_EF2), Flaking of paint (C_EF3), Efflorescence of outer layer (C_EF4), Efflorescence of system (C_EF5). Locations: On the projected area (L1), On continuous wall (L4), Under/around coping/eave (L6), Around balcony (L7), Around opening (L9)</p>

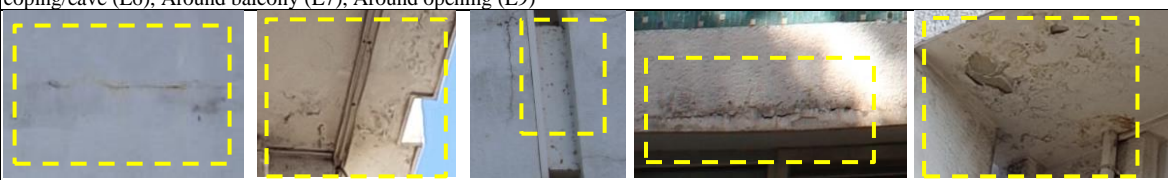
<p>R_EF1-L4 R_EF2-L7 R_EF3-L7 R_EF4-L1 R_EF5-L7</p>
Detach. (DT) and M. Loss(MT)	<p>Defects on R: Detachment of paint (R_DT1), Detachment of render (R_DT2), Material Loss (R_MT). Defects on C: Detachment of paint (C_DT1), Detachment of outer layer (C_DT2), Detachment of system (C_DT3), Material Loss (C_MT). Locations: On the projected area (L1), At/near ground level (L3), On continuous wall (L4), Under/around coping/eave (L6), On/near structural system (L8), Around opening (L9)</p>
