CLAUDIUS AQUEDUCT IN ROME - KINEMATIC ANALYSES AND EMPIRICAL EXPERIENCES FOR THE DEFINITION OF STRUCTURAL RESTORATION INTERVENTIONS

FABRIZIO DE CESARIS¹

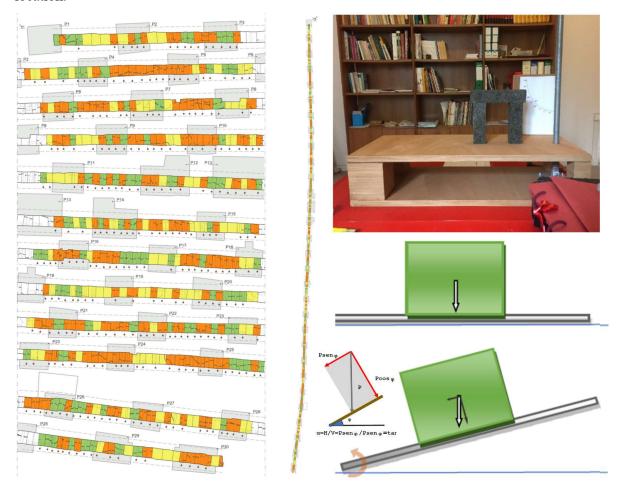
Figure 3: Survey of the state of cracking degradation in the different sections of the portion of Aqueduct analyzed, edited by Arch. P. Agrimi and re-elaborate by the author (left); inclinable plane used in the experimentation (kindly provided by DucaleRestauro S.r.l.) with the scheme adopted (right).

As can be seen in fig. 3, the fracturing of the lintels is widespread, but not homogeneous. Some elements appear intact (yellow) and others interrupted by the discontinuity that is sometimes positioned in the center (green) and often near one of the edges (orange). The presence of multiple fractures is rarely observed and sporadic is the case of an actual partial collapse; this temporary balance has recommended and allowed, in the past and at present, the insertion of the metallic supports to prevent a progression of deformation phenomena and possible collapses.

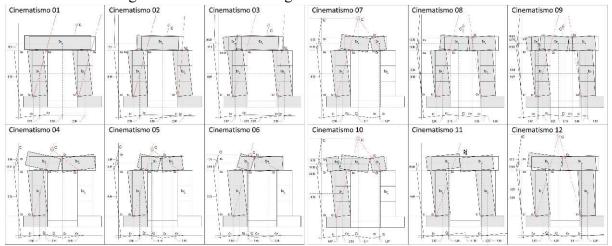
The following figures show the most significant and therefore considered schemes (fig. 4). The kinematic mechanisms analyzed are essentially based on the hypothesis of the formation of hinges in the absence of sliding, prevented by friction. Only in case study 11 it was possible to consider the sliding between bodies 3 and 4.

Figure 4: Synoptic framework of the kinematic mechanisms examined.

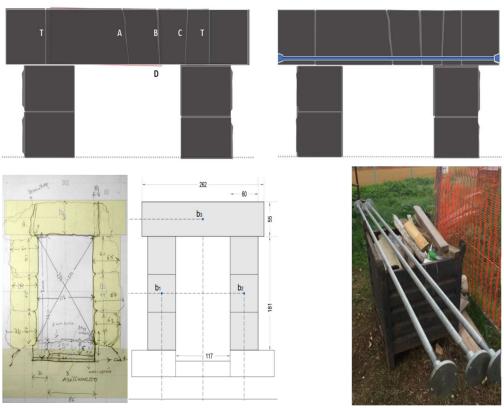
In summary: some lintels have preserved monolithic shapes, but largely show fractures passing through the entire thickness, with regular orientation or levels with different configurations. The scheme in fig. 5 shows fractures represented simultaneously but, in general, only one is present on the same element and the scheme must also be considered in the symmetrical version. The lesions are of type A, B, or C: in case B, a portion of the lintel takes on a larger size than the other - the center of gravity is within the gap between the walls), and normally give in D before finding an adequate contrast in the natural arch. Type C is the fracture with the greatest risks due to the very reduced support section and because the lesion is not visible. Therefore, the possible presence of these discontinuities is not appreciable in the performed survey, but it is only hypothesized during the study comparing other portions of the Aqueduct. The T cuts are sometimes original, but are not always present and symmetrical on both ends of the same slab; it is possible to observe them only in the sections in which the building has lost its continuity and, consequently, they do not appear in the survey carried out as they cannot be identified.

Figure 5: Representative scheme of the lintel and of the typologically repeated fractures (above, left); indication for the tie bars location (above, right); the survey and the used scheme (bottom, left); the tie bars proposed and already used in other sections of the aqueduct (right).

In conclusion, to obtain an improvement in capacity, can be inserted devices capable of supporting the roofing slab tracing the architrave back to its original monolithic nature. The measure can be implemented by inserting titanium bars - or stainless steel - which should exert a modest compressive force, sufficient to avoid rotations and also vertical translations in the fractured sections (fig. 5, above right). The failure due to shear force near the supports is, in fact, one of the most penalizing consequences of the structural deterioration for the wood. The proposed intervention could be a substitute for the internal supports and allow full suitability of the duct. The insertion of titanium bars would not be burdensome for the lithic material as it requires the execution of small diameter holes, which can be made without difficulties. This intervention certainly appears suggestive since it allows to find a structural stability close to the original one, because it doesn't introduce invasive elements in the cavity.

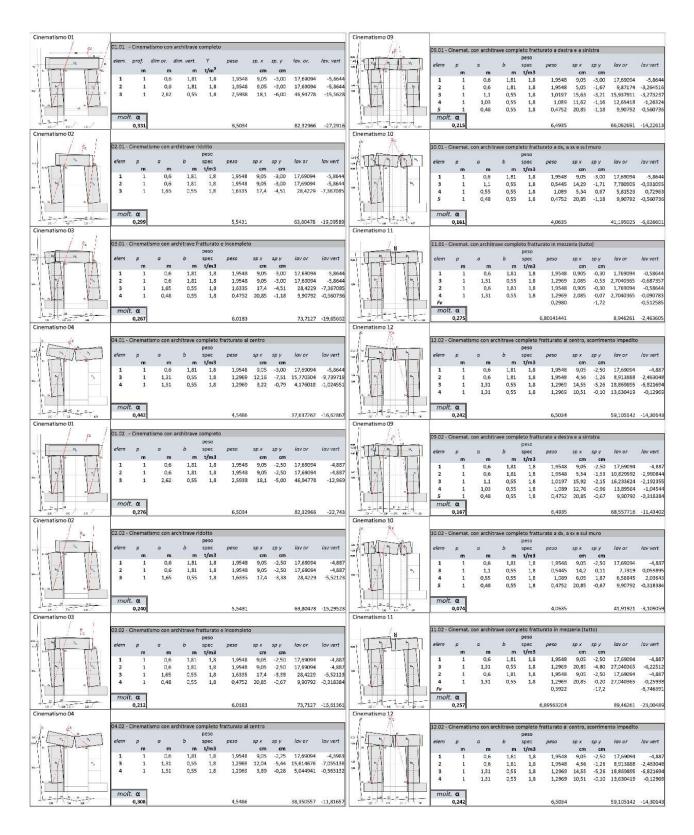
Figure 6 reports some of the results obtained with the study of the mechanisms in terms of load multiplier necessary for the activation of the mechanism; the values are obtained considering the activated hinges set back by 5 cm to give a general account of both the effects of the load concentrations and the degradation of the material. In the study, the homologous values were also calculated considering intact hinges, but for brevity they were not reported.

Figure 6: Summary of the expected results with activated retracted hinges.

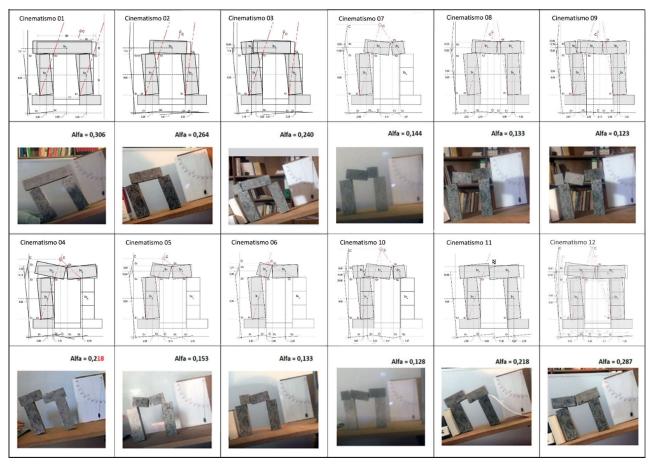
Figure 7 lists the results obtained empirically in the different cases already examined with numerical analysis. The photographs show the mechanism that occurred in the experiment.

Figure 7: Synthesis of experimental results with physical model.
