Pathologies of a Glass Building Envelope that Affect Durability and Comfort

Susana Santamaria-Fernandez¹, Arritokieta Eizaguirre-Iribar² and Xabier Olano-Azkune³

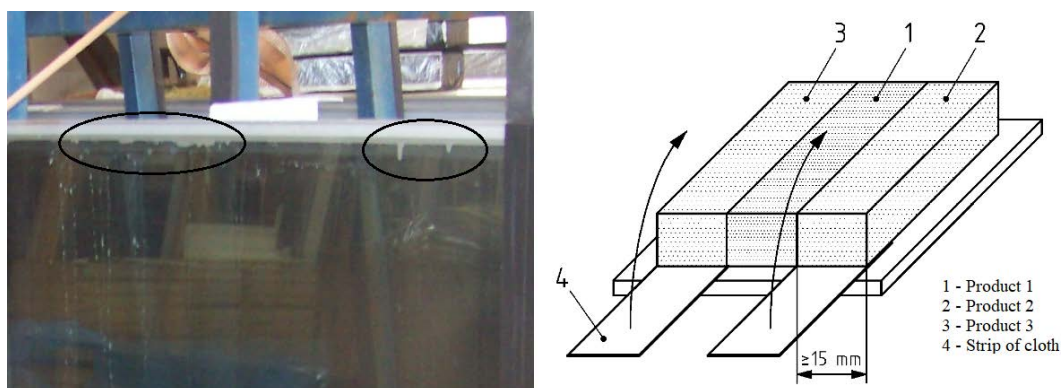
In this first case study, degradation in the form of a slump of one or both sealing barriers of a IGU is noted (Figure 1). This pathology occurs in an office building with a large glazed surface that is two years old. The construction of all the glazing in the building is unique, large-format double insulating glass units filled with argon gas formed both externally and internally by laminated glass.

Figure 1. Sealant flowing (left) and test specimen for the chemical incompatibility test (right).

Degradation is detected in discrete areas of some of the IGUs. The concern with this pathology is firstly, the possible detachment of the outer sheet and its subsequent fall and secondly, if the property of thermal insulation is still preserved.

Once the samples were received in the laboratory, one of them was disassembled. Both sheets of glass were separated, and it was verified that the sealant was the one attacked. In this case, the degraded sealant was that of the first sealing barrier.

After completing the compatibility test on the different combinations of adjacent materials, it was verified that the inner sealing barrier and the weathertightness gasket were highly incompatible.

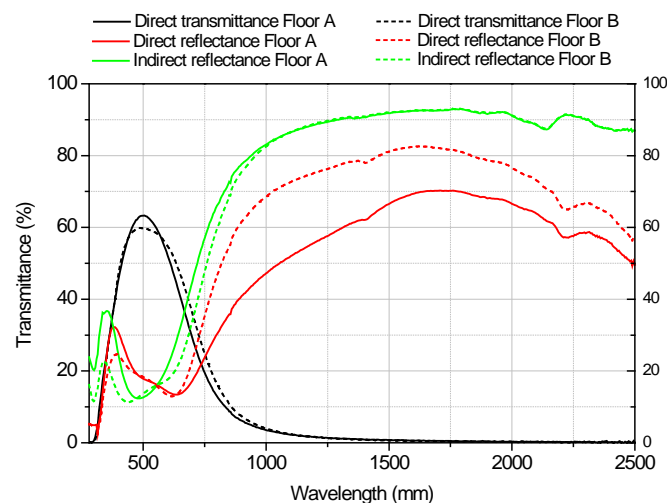
Figure 2. Transmittance and reflectance spectra of the coated glass.

After finishing the lab measurements, we noticed that laminated glass panes for both glazing units were the same but coated glass panes were not identical. Even though they were similar, differences were enough to be perceived by the human eye.

Considering manufacturing tolerances in the luminous/solar transmittance and/or reflectance, it could be concluded that both coated glass panes were not the same product.

With the described measurements and collaboration from the manufacturer, we reached the conclusion that there was a manufacturing error, meaning that a coating not designed for the thermal toughening process, had been tempered by mistake.
