## SEISMIC ASSESSMENT OF HERITAGE BUILDINGS IN BULGARIA

**Keywords:** Historical Structure, Seismic Assessment, Computer Modelling

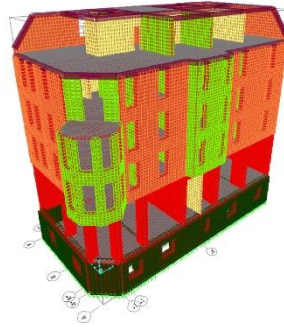
**Figure 3:** Numerical model in SAP2000 (Lege Palace) [5]

According to the standards in use, the checks for the displacements are basic for the assessment of the structural behaviour. Usually, for existing structures, the control of the damages as a result from excessive displacement are definitive for the behaviour. The results show that the displacements for the biggest part of the vertical elements (for the seismic combination) are not in the limits given in the standard. Analyzing the normal forces in the elements, it was found that the real value of the normal forces in the vertical elements also exceeds the maximum capacity of the elements.

In addition, analysis according to the actual Bulgarian regulations [8] is done. The same elements are checked. The results are similar but the safety according to EC8 [9] is lower than the safety according to the Bulgarian regulations [8]. The difference in the value of the modulus of elasticity of the bricks, defined in the two standards, leads to different stiffness of the walls. The ground floor has some previous interventions and after the site investigation was clear that some of the walls are removed in the past. This fact is related to the decreasing of the global stiffness of the structure. All changes in the first floor (produced on site without any specific design), representing removal of some brick walls, has unfavorable influence on the global seismic performance of the building. The actual conditions of the vertical elements after the on-site inspection shows that there are cracks and damages in them and they need special measures for strengthening.

The provided checks show that the building needs remedial measures for the damaged elements but any future changes in the structure will affect significantly the safety. It is not recommended to make any interventions without a special design for the strengthening. Special care is necessary for the foundations. The observed high level of moisture in the basement requires the execution of waterproofing insulation.

The results of the seismic assessment show that the bearing capacity of the vertical structural elements is reached and for some elements even exceed the limit. The displacements of the biggest part of the vertical elements are bigger than the prescribed limit value. That is the reason to recommend to the Investors to keep the structure without further changes and to strengthen the original structure using the results of the analysis.

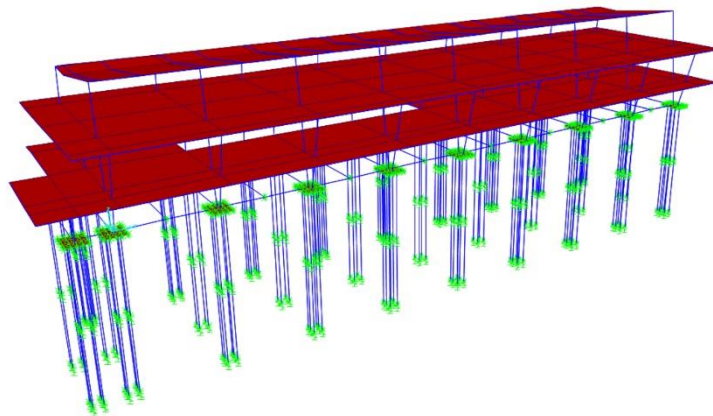
For the structural seismic assessment a few numerical models in SAP2000 (Figure 5) are analyzed, using finite elements. The first 3 modal periods according to EC8 and the Bulgarian standards are practically the same. The elastic story drifts exceed the prescribed limits. The comparison is done according to EC8 [9] and according to the actual Bulgarian regulations [8].

The main checks for the structural elements – columns, beams, slabs, etc. show that the available reinforcement in some sections is not according to the contemporary standard requirements. The detailing of the structure is also not according to the standards.

**Figure 5:** Numerical model in SAP2000 (Marine Station) [5]

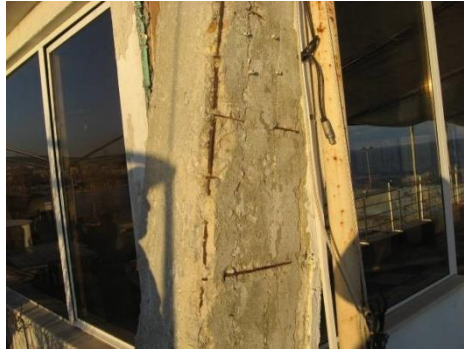
Despite the overall relatively good condition of the building, the structure is seriously endangered because of the very active processes of carbonization of the concrete and the reinforcement (Figures 6). The high level of carbonization results from the high humidity and the aerosol impact of seawater.

**Figure 6:** Actual condition of some structural elements [11]

It is believed, that the building has exhausted its bearing capacity on the basis of the currently applicable regulations for the design of reinforced concrete structures and future functional changes are possible after strengthening of the existing structure.

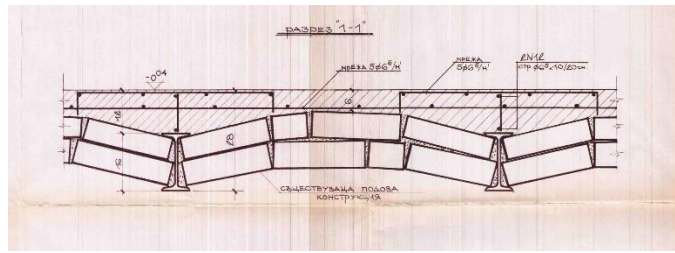
**Figure 8:** Strengthen floor structure “Prussian vault” (Serdica Building) [10]
