Aznalcóllar dam failure. Part 1: Field observations and material properties

E. E. ALONSO* and A. GENS*

The paper describes the failure of Aznalcóllar dam, in southern Spain, in April 1998. The rockfill dam slid forward and released a flow of acid-saturated tailings. The geology and geomorphology of the site are described. The results of a detailed laboratory testing programme on the tailings material and on the overconsolidated high-plasticity foundation clay are given. Special attention is paid to the identification of cementation of the tailings and to the strength and consolidation properties of the foundation clay. Failure features are interpreted on the basis of the field evidence, taking into account the measured geotechnical properties of the materials involved.

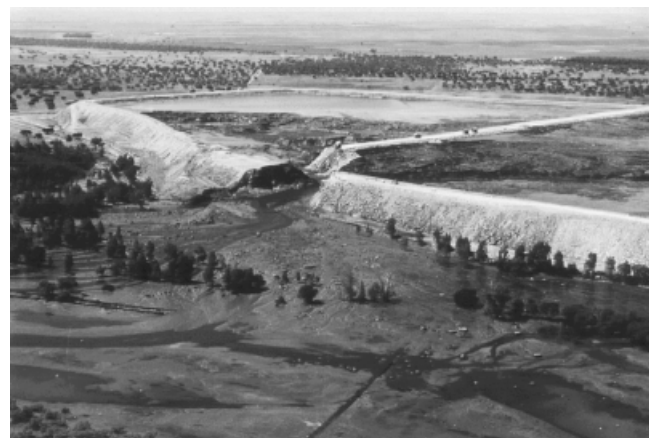
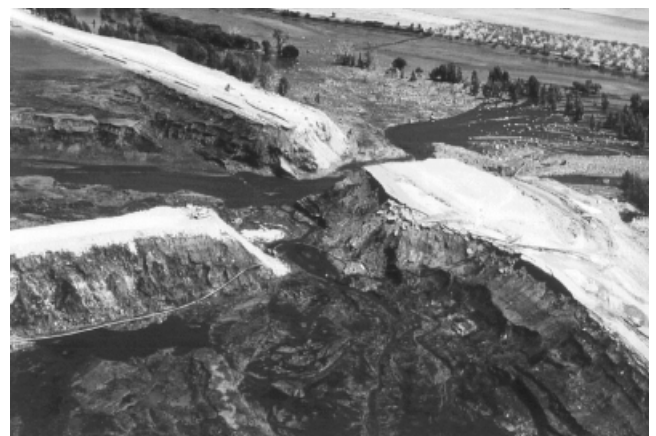
Fig. 4. Two aerial views of the breached dam a few hours after the failure: (a) view from the east; (b) detail of the breach

The orientation of the initial outflow is indicated by the depositional fans observed outside the breached embankment (Fig. 4(b)). The flow of tailings was directed initially in a NE direction, against the natural slope of the Agrío valley. Later, the progressive erosion of the breach allowed the outflow to change direction towards the east.

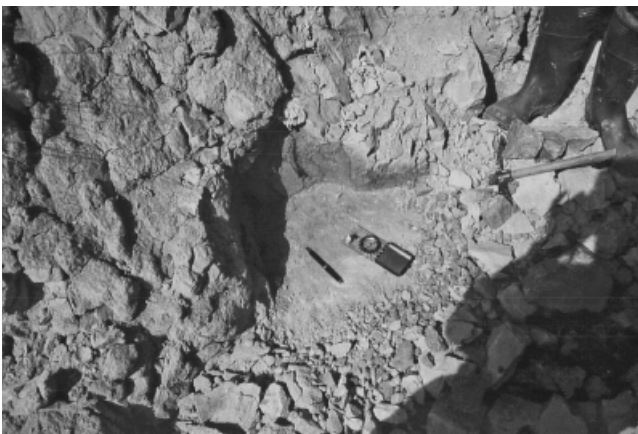
Fig. 9. Slickensides exposed on a bedding plane: river bank of Agrio river

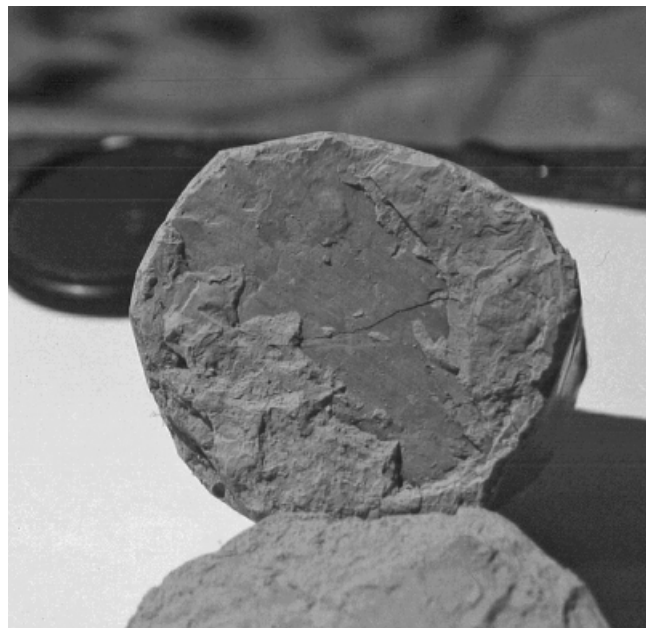
Fig. 10. Slickensides observed in core recovered in borehole S1-3 at 13.5 m depth

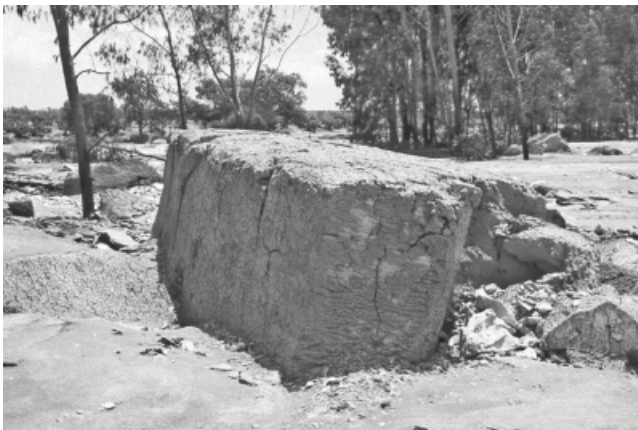
The violent mudflow that followed the breach of the embankment dragged out large blocks of the clay, which floated on the denser tailings mud. One of these blocks is shown in Fig. 12, a month after the failure. It has a remarkable shape, with sharp edges, consistent with the previous description of the clay structure. An oxidation patina is observed on some of the block faces. Despite the strong surface drying suffered by the block, the original water content (as measured in undisturbed core samples) was well preserved once a few outer centimetres of clay were removed. Block samples were recovered from some of these large blocks, which sometimes included distinct joints, for laboratory testing.

Fig. 12. Clay block 'floating' on tailings flow: photograph taken one month after failure

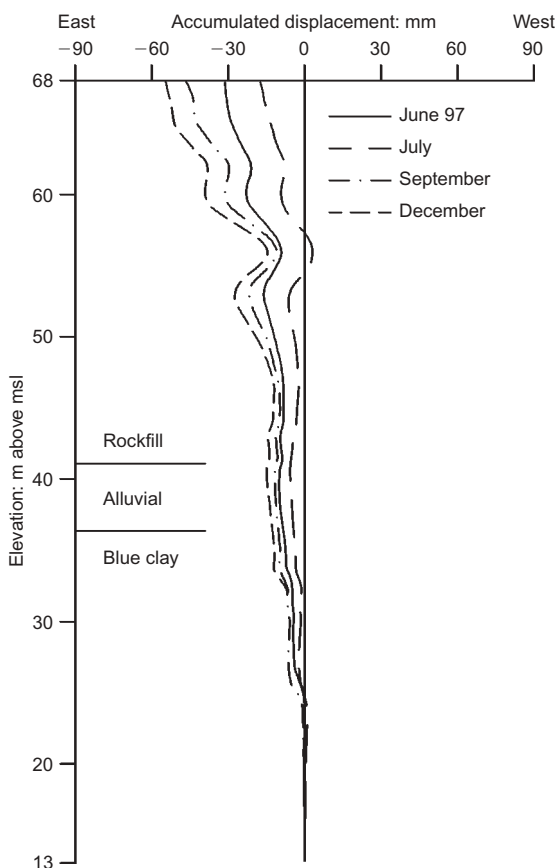
Inclinometer I-3 was located approximately at the centre of the section of the embankment that slid towards the river at the time of failure. A few readings were made during December 1996–December 1997. They are shown in Fig. 14. The locations of the rockfill/alluvial and alluvial/clay interfaces are shown in the figure. Unfortunately, the upper part of the inclinometer was damaged in January 1998, and no data for the months immediately preceding the failure are available. The displacements shown in Fig. 14 were not

interpreted, at the time of readings, as a sign of a possible deep sliding. It was later established, after the failure, that a sliding surface developed at elevation 26 m. Six millimetres of displacements accumulated at this elevation during the year 1997. Most of the observed displacements were recorded within the rockfill embankment, which was under construction.

Fig. 14. Readings in inclinometer I-3 in direction perpendicular to dam axis (towards the east)

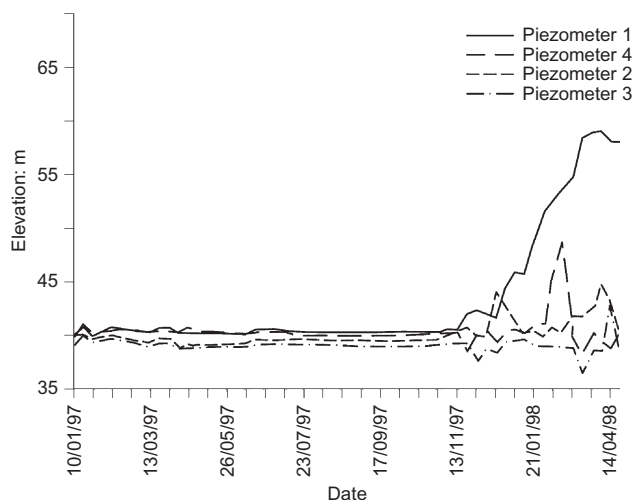
The recorded water heights of the open tube piezometers P-1, P-2, P-3 and P-4 are shown in Fig. 15. The behaviour is fairly regular during the first 10 months of 1997 and the

recorded water elevation (level 39 m) corresponds to the mid-point of the alluvial layer. After November 1997 the measurements show a more irregular pattern difficult to interpret. The last available readings, in April 1998, indicate that the water level was again within the limits of the pervious granular alluvium. No abnormal settlements were recorded. Horizontal displacements of the embankment, however, were not measured. The behaviour of the dam was always considered normal, and the regular monitoring reports did not express any special concern.

Fig. 15. Evolution of water elevation in piezometers P-1, P-2, P-3 and P-4

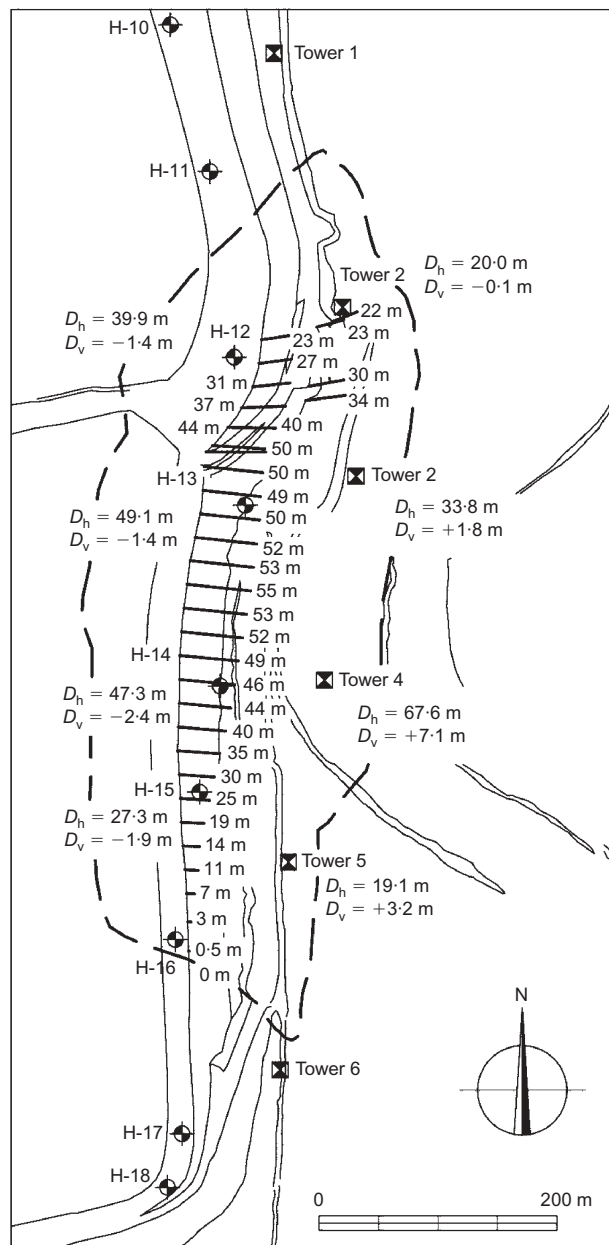
Fig. 16. Limits of the slide area and vectors indicating the displacement. Displacements were measured in topographic marks and electrical towers. D_h , horizontal displacement; D_v , vertical displacement (negative numbers indicate a drop in elevation)

The inclination ($1.5\text{--}2^\circ$) and planar nature of the basal sliding surface are a strong indication that it followed a bedding plane. The position of settlement plates, precisely located on the crest of the embankment before the slide, could be used also to determine the horizontal (D_h) and vertical (D_v) displacements experienced by those plates. The measured values are indicated in Fig. 16. The slope ($\arctan D_v/D_h$) is also consistent with a sliding surface dipping $2\text{--}3^\circ$ towards the east. A comparison of the topography before and after the failure also provides a good indication of the magnitude of horizontal displacements (Fig. 16).

The central part of the embankment moved 40–55 m towards the east (directions varied between 93° and 100° with respect to north). The magnitude of the displacement decreased to 20–22 m at the northern limit of the slide, at the position of the open breach. Towards the south, a more gradual decrease of displacements was observed. In total, a 600 m long portion of the south-eastern embankment of the lagoon was affected by the slide. North of the breach, no displacements of the embankment were detected.

The shape of the northern limit of the slide (Fig. 16) suggests that the failure surface crossing the embankment was controlled by the dominant orientation (NE–SW) of the vertical joints of the foundation clay. An interpretation of the original rupture breach is given in Fig. 23. The orientation of the embankment, its size, the direction and intensity of the sliding motion and the orientation of the rupture plane led to an initial breach width of 14 m. Note also that the two lips of the breach separated immediately, and therefore

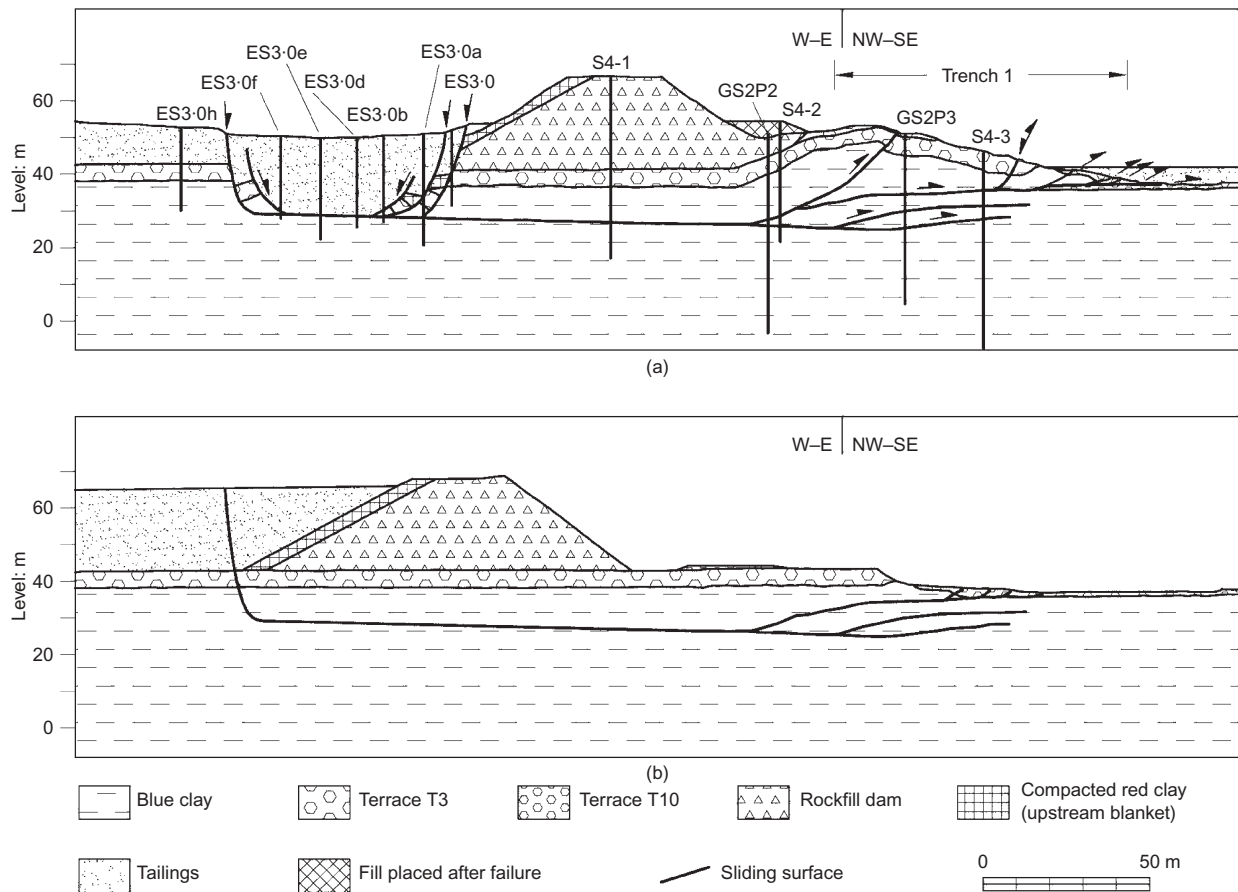
Fig. 17. Cross-section of slide at position of Profile 4: (a) geometry after the slide, as interpreted from borehole results and surface topography; (b) reconstruction of position of sliding surfaces before failure

found in direct contact with the clay in some of them (e.g. Boring ES3-0e in Fig. 17). In several boreholes it was also possible to identify the position of the sliding surface where a highly polished surface could be found. This is the case for the plane shown in Fig. 18.

Also indicated in Fig. 17(a) are the folded structures found at the foot of the downstream slope of the embankment. The interpretation given is based on zones of intense shearing found in boreholes and trenches. Upward displacements of the ground, close to 8 m, were measured at the position of the folded strata. Fig. 17(b) provides a reconstruction of the original position of the sliding surface before failure displacements. An interesting finding of this reconstruction is that the head scar of the slide was a near-vertical surface located at the original upstream toe of the embankment. This vertical scar was fairly well preserved even after the intense erosion of the tailings deposits that followed the uncontrolled flow out of the lagoon. This is shown in Fig. 19.

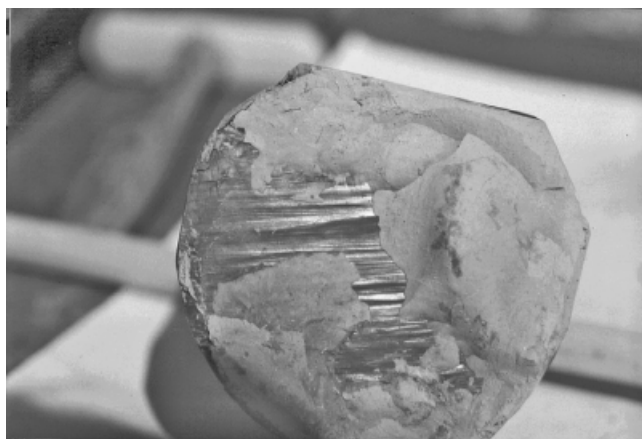
Fig. 18. Highly polished and striated shear plane that follows a bedding plane (S_0). Borehole 2-1 at 33.8 m depth. It was interpreted as belonging to the sliding surface

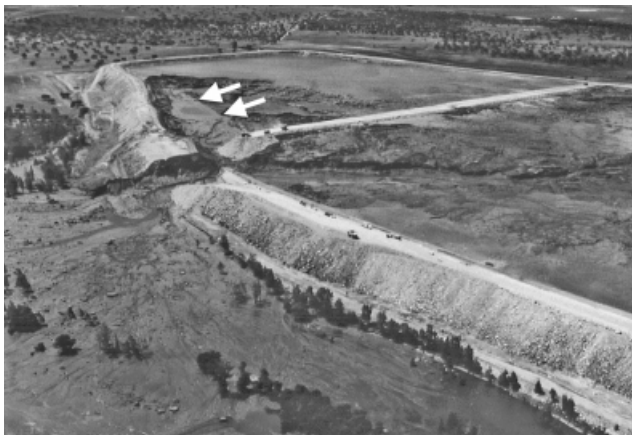
Fig. 19. The straight line, indicated by arrows, shows the position of the upstream scar of the slide

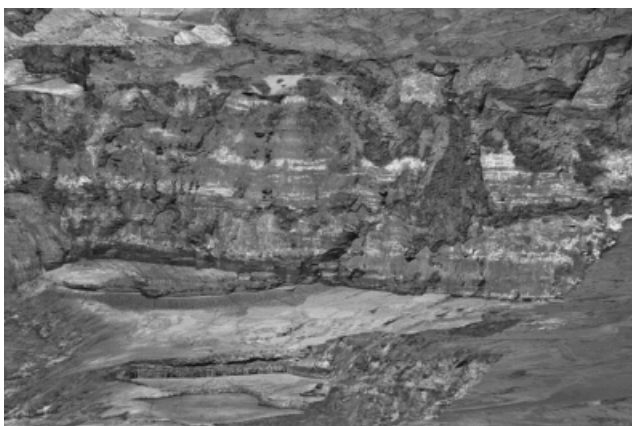
It was also observed that the tailings could maintain stable vertical cliffs 15–20 m high (Fig. 20). The position of the initial upstream vertical scar, as given by the reconstruction of the original profiles, is shown in Fig. 21. Also shown in this figure is the position of the scar, some months after the failure. It shows a small retrogression towards the lagoon as a consequence of (limited) sliding and erosion. The vertical jointing on the clay foundation is consistent with this interpretation of field observations as it explains the existence of a nearly vertical upstream limit of the slide, within the blue clay, which continued upwards within the tailings deposit.

Fig. 20. Vertical cliffs inside lagoon as observed a few weeks after failure

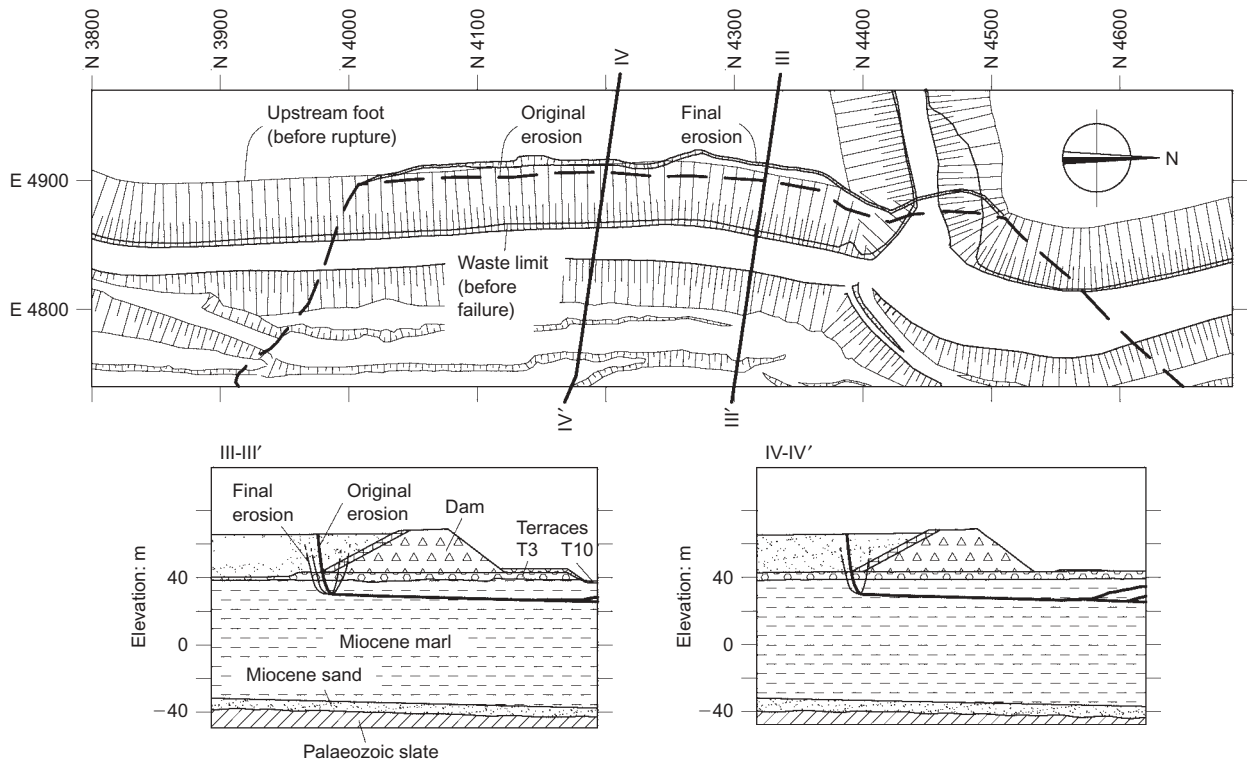
Fig. 21. Position of the upstream scar of the slide. The original scar retrogressed towards its final position owing to some sliding and erosion

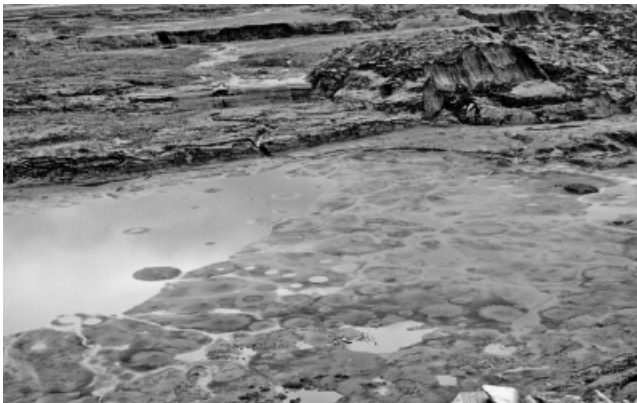
Observations made a few hours after the failure showed small mud volcanoes on the solidified tailings upstream of

the dam (Fig. 22). This was a clear indication of tailings liquefaction during the failure process.

Fig. 22. Mud volcanoes observed a few hours after failure on surface of depressed basin upstream of slid dam

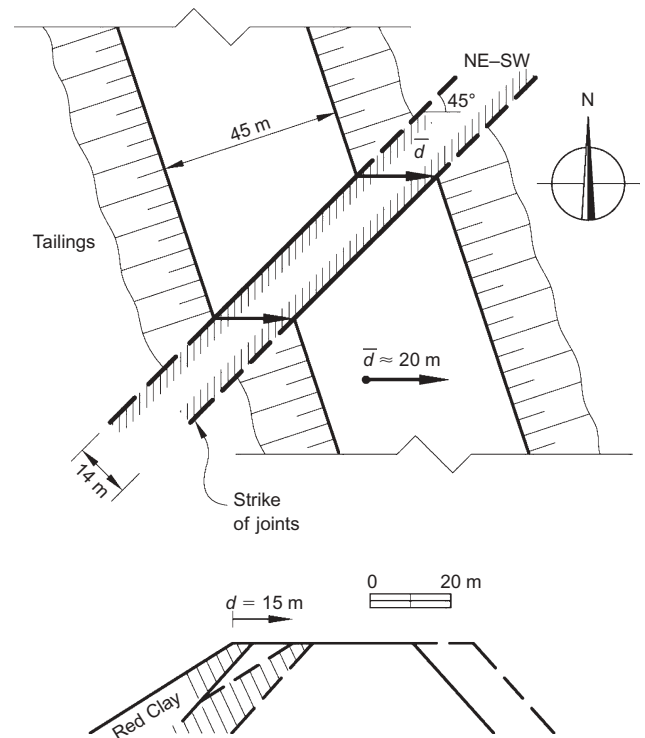
no shearing resistance was offered by the rockfill embankment. Given the width of the embankment at the position of the breach (crest width 45 m), a shear distortion amounting to 10 m of displacement could probably have been resisted by the embankment, avoiding the opening of a free outflow for the tailings.

Fig. 23. Geometry of rupture breach
