# PICTURE THIS: A NEW PERSPECTIVE ON TENSILE MEMBRANE DEGRADATION

**Key words:** Biological Growth, Membrane Degradation, PET-PVC Coated Fabrics

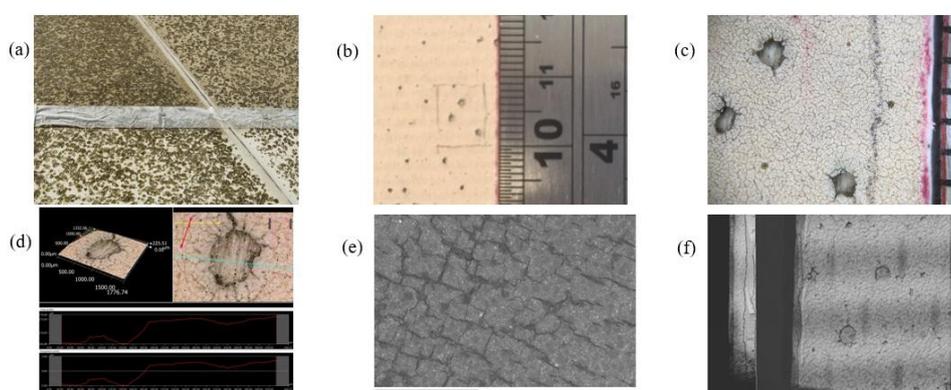
Typical output examples (**Figure 4**) provide a comparative view of the level of detail each method can achieve. All images relate to the same sample of PET-PVC taken from a coastal structure and aged at approximately 25 years. All the PVDF finish had been lost from natural weathering, as confirmed by energy-dispersive X-ray spectroscopy (EDX) analysis and scanning electron microscopy (SEM) imaging. Samples were noticeably stiff (inflexible) when handled compared to new material, and possessed crazed/cracked surfaces, evidencing significant loss of plasticiser. The loss of finish had increased the ability of biological growth to adhere to the surface which was removed before capturing the images in (b) to (f) enabling inspection of the membrane condition.

These and other pictures (images) gathered during the project confirmed that a basic visual inspection with the naked eye, or with photography at a distance, provides very little information on surface condition, despite it being the basis for many inspections. It also showed that ‘dirty’ surfaces conceal the true condition of the membrane finish and coating.

**Figure 4:** Results from different visual techniques on 25 year old PET-PVC (a) naked eye, biological growth (b) mobile camera phone, dark spots/pinholes (c) mobile microscope, visible yarns (d) 3D microscopy, visible yarns (e) scanning electron microscope (SEM), cracked PVC coating (f) CT model, through-construction imagery

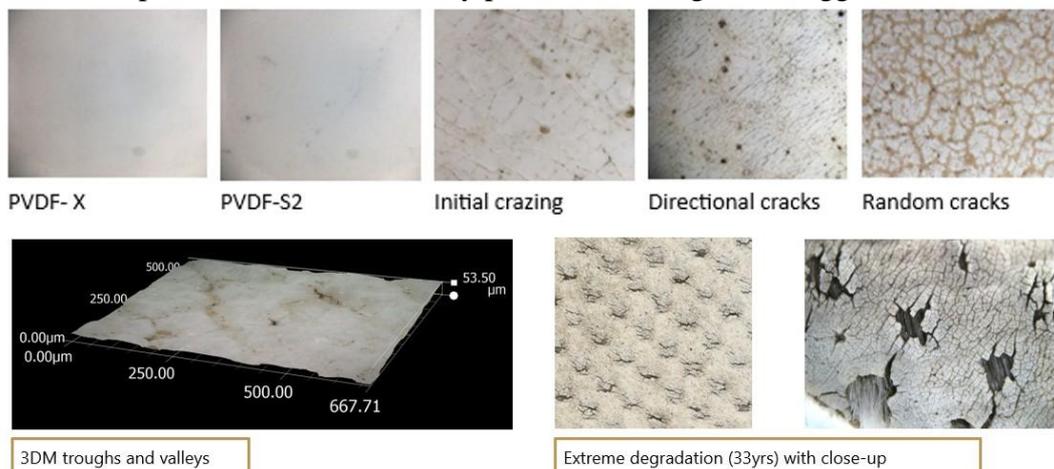
The images in **Figure 6** give an indication of how these stages appear under the microscope. Cracks and crazing can align to yarn directions but may also present as a random pattern. The 3DM image highlights the surface unevenness with the yarn layout plainly visible. The extreme degradation examples have been affected by pressure washing and an aggressive microclimate.

**Figure 6:** Visual examples of weathering degradation; top row: new PVDF coatings, crazing in the finish (21yrs but concealed under a clamp plate), spots and cracks in the coating (25yrs); bottom row: 3DM image showing fabric structure, extreme case (33yrs)

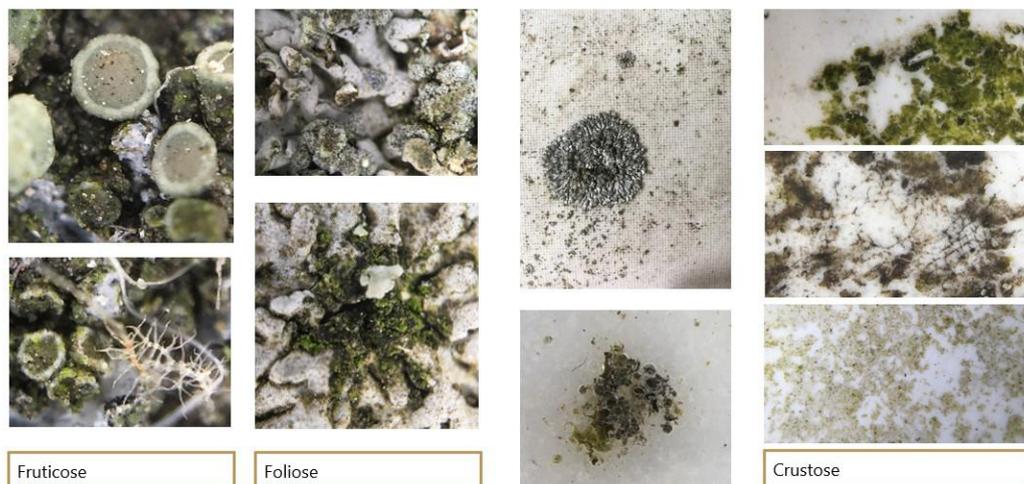
They thrive on a wide range of substrates, including coated membrane structures, and typically anchor themselves in surface irregularities such as holes, cracks, seam edges, or areas enriched by deposits like guano. Their growth is sustained by rainwater for moisture, sunlight for energy, and nutrient inputs from environmental deposits. Once established, rhizines (root-like tendrils) can penetrate beneath protective coatings, making removal difficult and accelerating localised deterioration. Colonisation also alters the membrane's performance, reducing light transmission and darkening the surface, thereby affecting both its functional and aesthetic properties.

**Figure 7:** Examples of lichen growth on membranes; PET-PVC (left and right) Glass-PTFE (centre)

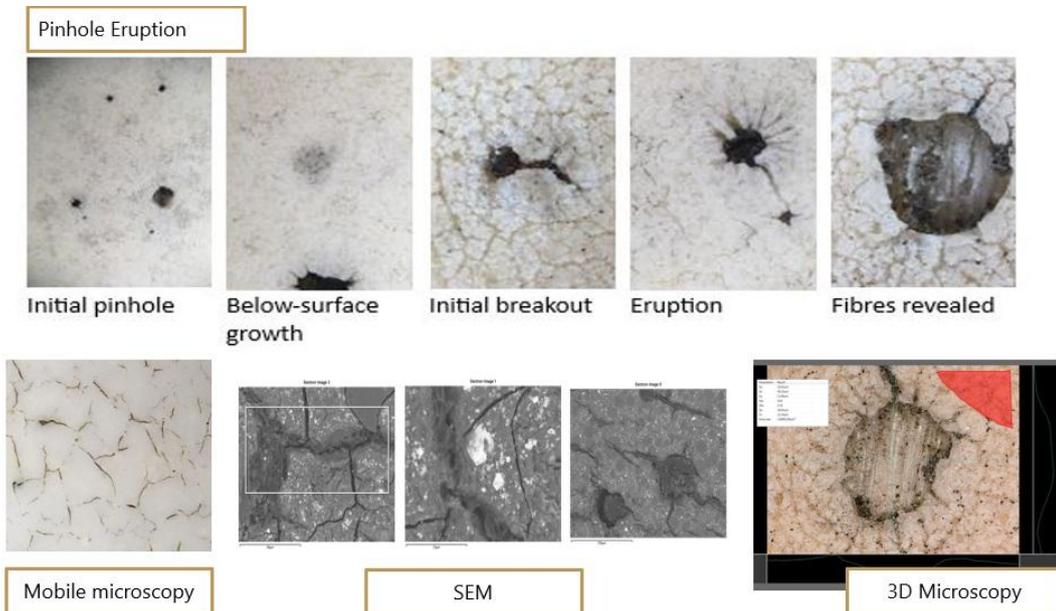
The top sequence of images in **Figure 9** highlight different stages of the formation of a hole in the coating due to lichen growth, often occurring at the high point of the weave where the coating is thinnest. The bottom row of images evidence residual organic matter present after cleaning. Samples were from various structures and locations demonstrating that this is not an unusual occurrence.

**Figure 9:** Visual examples of biological degradation; top row: lichen growth sequence creating a pinhole eruption and exposed yarns; bottom row: residual biological growth in surface crazing, SEM images of fungal remains, 3DM image confirming rhizines tendrils
