THE PLASTER CEILINGS OF BUCKINGHAM PALACE AND WINDSOR CASTLE: THEIR CONSTRUCTION, CONDITION AND CONSERVATION

Abstract. *Alan Conisbee & Associates and Richard Ireland were engaged by the Royal Household Property Section to inspect and assess the historic plaster ceilings and their supporting structure within Buckingham Palace and Windsor Castle. Following the partial collapse of the Apollo Theatre ceiling in London in 2013 great importance has been placed on the inspection and certification of all historic plaster ceilings throughout the United Kingdom. This paper presents the key challenges of the project included the facilitation of access to constrained spaces, asbestos removal and cleaning of delicate fabric, surveying, digital monitoring, structural and plaster defects. Furthermore we discuss the key project outcomes including lessons learnt and best practice methodologies and practicalities behind inspections of this kind. The paper concludes with an outline of significant discoveries and ongoing laboratory testing of undernailed historic timber connections.*

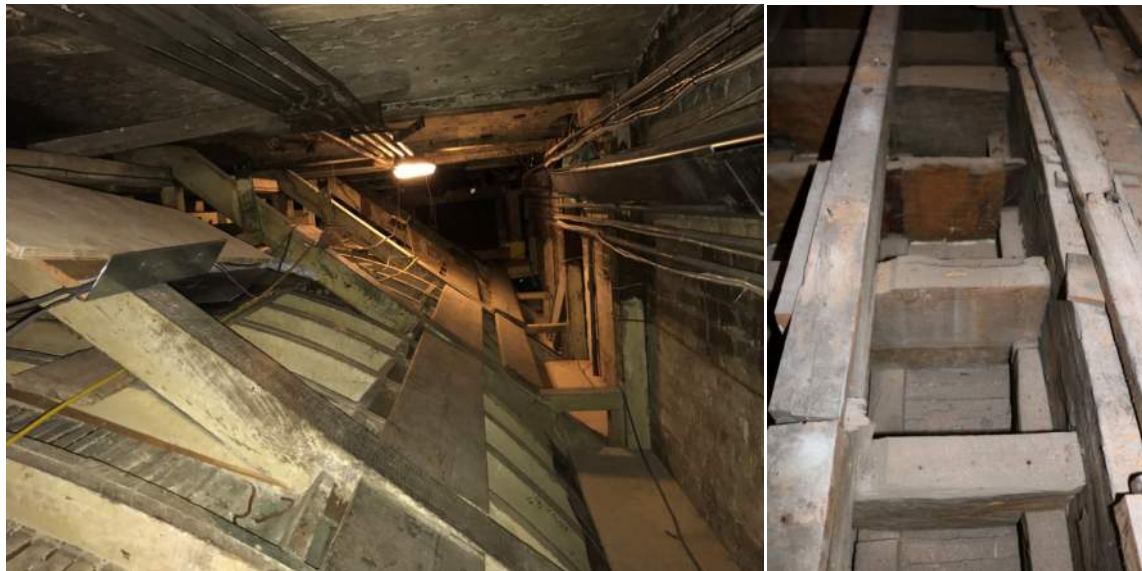
Figure 02: (Left) Internal view above the Blue Drawing Room ceiling, from within the void, highlighting the repeating timber primary beams and typical timber coving structure and back face of the ceiling laths. (Right) KCIIDR rear face, comprising timber floor joists and secondary ceiling members

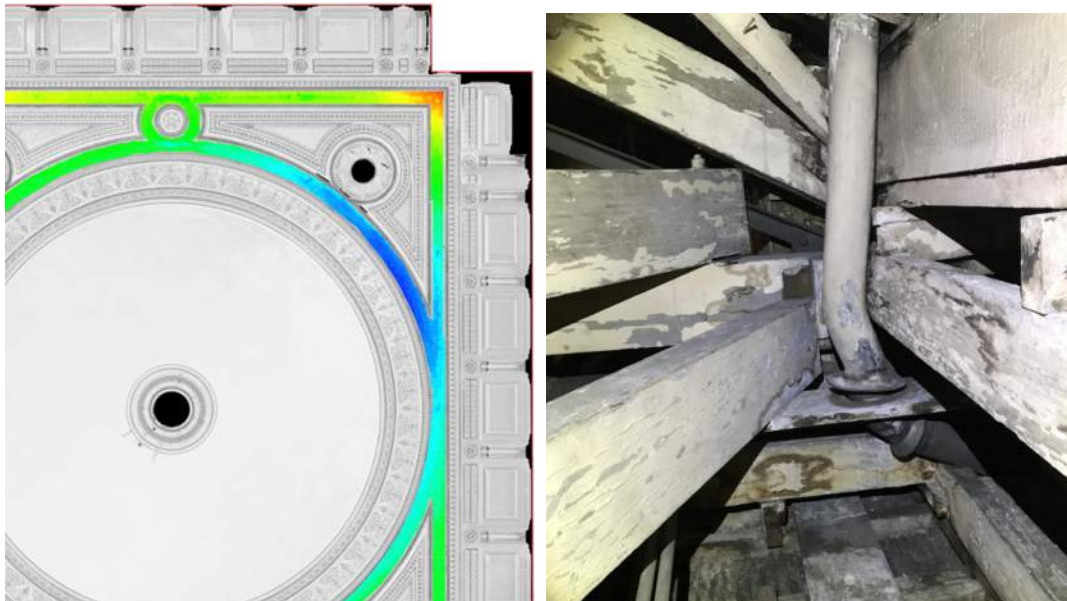
key areas such as those outlined in Figure 03. Local distortion of the Ball Supper Room ceiling aided discovery of a failed roof truss bearing which had caused the ceiling to distort, as captured within the scan, and a new stainless steel bracket was subsequently installed to remedy this. The complicated structural arrangement within the Ball Supper Room and its challenging access constraints would have otherwise made this process much more lengthy and challenging.

Figure 03: (Left) Distortion mapping of the soffit of the Ball Supper Room. (Right) Photograph of structural defect within the void above, located via the underside distortion. Dropped truss connection was resting on the floorboards and partially supported by a lead drainpipe which has since been repaired.

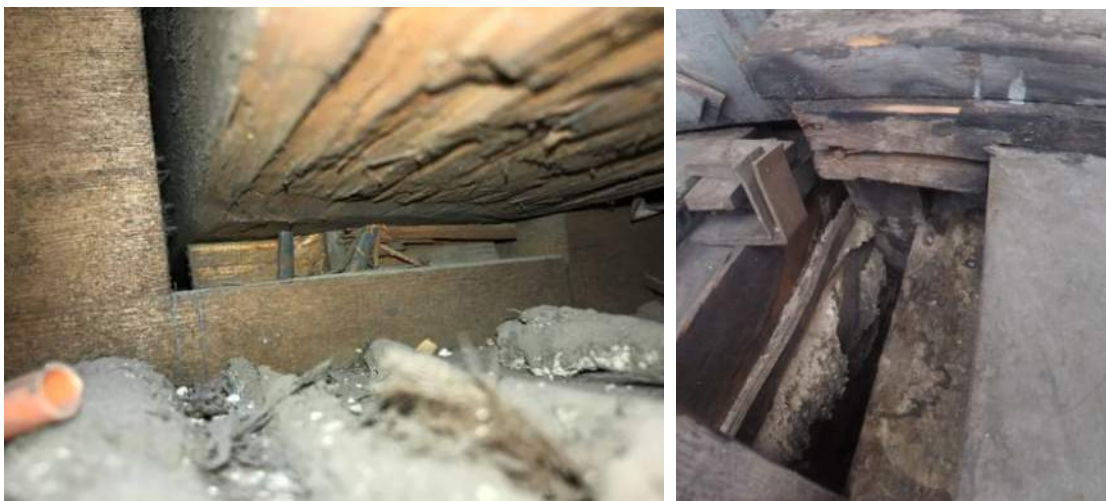
Individual vertical undernailed connections between timber members were commonly encountered, directly supporting the ceilings within both Buckingham Palace and Windsor Castle. This form of fixing would doubtless have proven quick and effective when installing the ceiling structure, however their prevalence generates some concerns regarding their structural integrity, specifically the quantified pull out resistance of historic square cross section wrought iron nails from the parent timber in which they are embedded and their ability to effectively withstand tensile loads, especially those applied dynamically.

Figure 05: (Left) Dropped underside nailed connection within Windsor. Similar defects are endemic throughout both the Windsor and Buckingham Palace estate. (Right) Nail sickness and splitting to timber elements in the East Drawing Room, likely accelerated by moisture ingress.

To date our assessment of the adequacy of such connections has been reasonably but wholly based on their historic performance in satisfactorily supporting the dead and imposed loads to which they have been subjected, however this may not accurately reflect their true load capacity. Owing to this, the paucity of relevant codified guidance and the wide variety of variables at play. Conisbee and the RHPS are currently collaborating with the Centre for Engineering Materials at the University of Surrey to undertake in-situ site testing of historic nails. These tests will empirically determine the influence of key variables – embedment, load magnitude and load type – on pull out resistance using original reclaimed historic nails recovered from the Palace and Castle void spaces. Preliminary results suggest that the pull out resistance of such nails is strongly influenced by the timber species, nail embedment and environmental conditions, and further research is in progress which will quantify these factors in detail.

In accordance with accepted conservation engineering principles structural repairs typically comprised reversible and distinct simple bolted stainless steel straps or bespoke traditional timber repairs where needed, usually to consolidate failing hangers or connections.

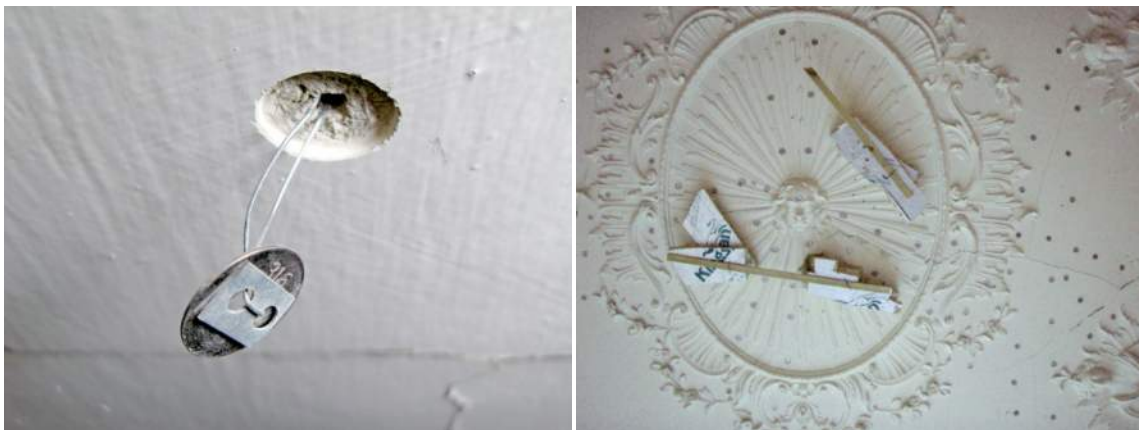
Figure 06: (Right) Ceiling restraint washers tied back to the timber support structure above via perforated metal band. (Left) Example restraint fixings to plaster ceiling.

The preferred method utilises stainless steel washers suspended by wire inserted through small holes drilled through the ceiling plaster and tied off to perforated galvanised band secured between the joists above[4]. The overall goal is to provide additional support to delaminating areas of historic plasterwork. A washer diameter of around 25mm provides a balance between effective support and minimising physical impact to the ceiling plaster. Restraint sites should form a flat seating to maximise washer contact and should be recessed no more than allows subsequent filling and covering. Where access from above is not possible, the use of screws becomes unavoidable. This is less ideal as it is more difficult to accurately determine the location of reliable supporting timber structure and can easily lead to the repeated drilling of the ceiling fabric to locate suitable structures for fixing to. Screws should be of the smallest diameter required with narrow parallel shafts of sufficient length to make a secure fixing in the selected timber. The technique is intended to be used locally in a spirit of minimum intervention and not intended for systematic thoughtless wholesale gridding and is the method being implemented on decorative plaster ceilings and heavy decorative plaster enrichment in both the Buckingham Palace and Windsor Castle where our investigations have identified defects and potential risk of loss.
