FAILURE ANALYSIS OF THE ARECIBO OBSERVATORY M4N AUXILIARY CABLE¹

Gregory J. Harrigan², Vinay K. Goyal³, Pavel F. Babuska⁴, Nathan Trepal⁵

ABSTRACT: Structural and forensic analysis concluded that the Arecibo Observatory M4N socket joint failure in August 2020 was due to a socket joint design with insufficient design criteria that did not explicitly consider socket constituent stress margins or time-dependent damage mechanisms. The socket attachment design was found to have an initially low structural margin with a finite service life, notably in the outer socket wires, which degraded primarily due to long-term zinc creep effects that were activated by long-term sustained loading and exacerbated by cyclic loading. Additionally, HAC and wire defects were found in a few outer wires that may also have contributed to initial outer wire failures. The design did not explicitly consider the time-dependent effects of creep and cyclic loading on design capability, account for a worst-case build condition traceable to in-service inspection of features (e.g., zinc creep/extrusion), specify an end-of-life capability requirement associated with service life degradation, or explicitly set servi

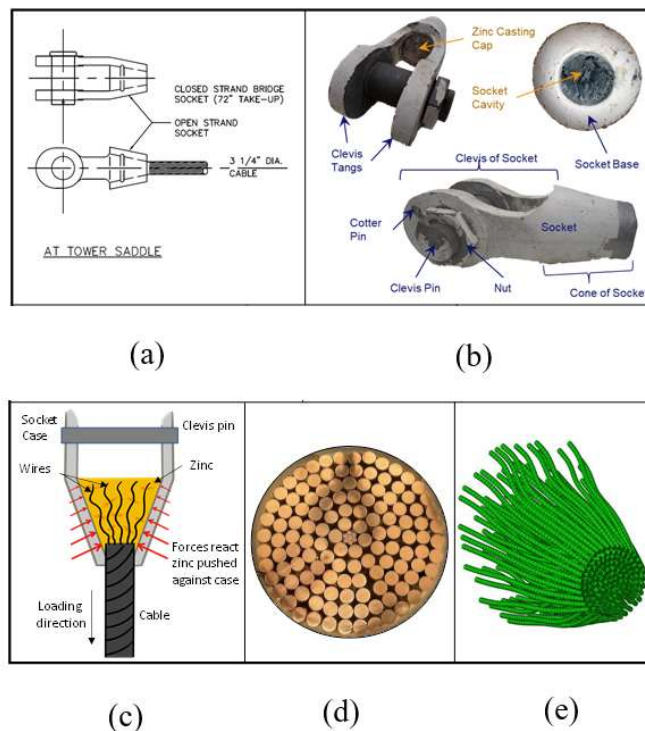
Figure 1: (a) Open spelter socket drawing, (b) socket terminology, (c) Aux M4N broomed wire reconstruction, (d) 1 × 127 structural strand cross section, and (e) cable-socket interface detail sketch.

Insufficient Acceptance Criteria and Inspections: While the drawing did not specify acceptance criteria or characteristics for wire brooming, forensic reconstruction of the brooming (Figure 1) was found to be infamily to other socket builds. Nondestructive evaluation of the socket joint was not performed prior to service, but forensic examination of the failed socket showed dimensions to be within specifications. Defects (e.g., voids/cracks) within the zinc such as gas bubbles toward the socket back side were found (Figure 6), but analytical models with representative void geometries predicted negligible effects on the outer wire stresses near the termination. This is because the most highly stressed wires occur near the socket base and remain unaffected by the existence of voids a substantial distance away in the zinc. Further, a separate model simulated the existence of a cavity tear near the casting cap, but no changes in critical wire stress levels resulted as termination capacity is influenced significantly by the zinc in the narrow side of the conical volume but is largely unaffected by the zinc at the open end of the socket.

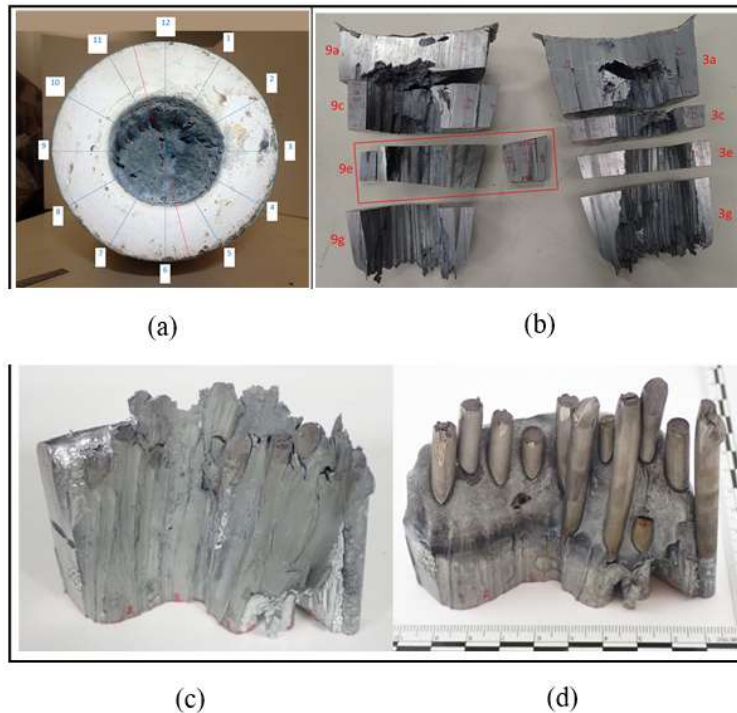
The socket was dissected, first longitudinally into left and right halves, followed by transverse cuts in each half starting from the casting cap side of the socket halves and moving toward the wire fractures near the socket base, Figure 2. During the sectioning process, areas of interest were analyzed and/or sectioned off for further microscopy. The zinc casting was analyzed by metallography, and the wire fractures were extracted from the zinc for fractography. Lastly, material testing was performed on socket and virgin material to characterize mechanical and metallurgical properties.

Figure 2: Sectioning plan for the socket (a), sectioned zinc (b), section of zinc with encased wires before (c) and after (d) removal of zinc via dissolution in acid.

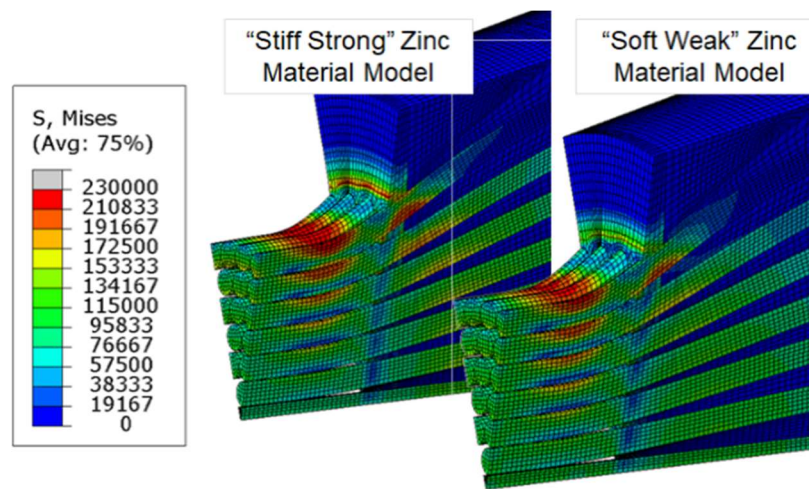
Insufficient Design Criteria: FE analyses predicted significant yielding of outer wires and negative structural margins using the maximum predicted cable loads of 720 kips predicted by WJE. Even using an applied load of 600 kips, outer wire stress predictions were in the 220 - 230 ksi range based on a range of zinc material models. With a factor of safety of unity, this corresponded to structural margins ranging from +15% to -4% when considering a range of wire ultimate strengths of 220 to 250 ksi. In aerospace applications, structures are analyzed and compared not only against the breaking strength of the joint but also for constituent stresses against their respective material strengths.

Figure 5: Outer wire stresses were near capacity regardless of zinc material model at design loads.

Based on loads alone, the effective design factor of safety was calculated as 1.83, which is lower than typical industry standards. The design upgrades involving the failed socket joint predated ASCE 19-96 (ASCE, 1996), which was the requirements document governing the design of steel cables for buildings. ASCE 19-96 was superseded by ASCE 19-10 (ASCE, 2010). While the inapplicability of ASCE 19-10 to the failed socket design is recognized, it was found that the effective design factor in this application fell short of the 2.2 specified in that standard and even those specified in international standards (Ali *et al.*, 2021). The ASCE standard also states the minimum breaking strength of cables shall always be at least twice the maximum cable design loads, including the envelope of loading combinations of cable self-weight, structure dead load, cable pre-stress forces, and live load and environmental load combinations. Consequently, given the negative structural margins and insufficient factor of safety, insufficient design criterion was identified as significant contributor to the failure event.

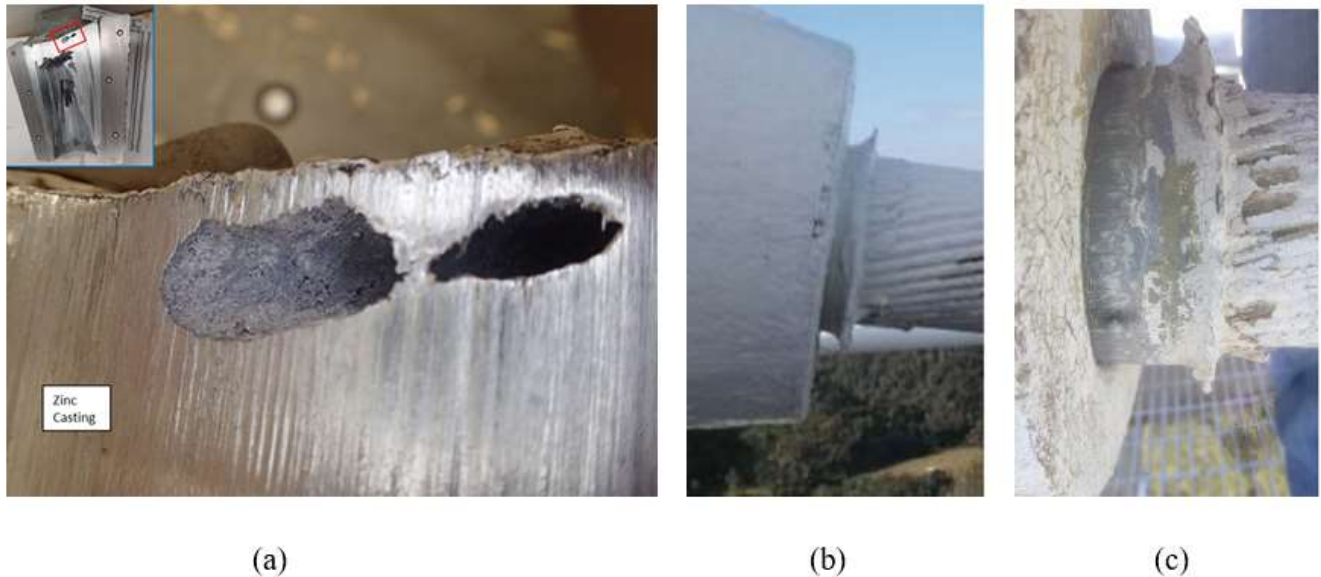
Inspection limitations prevent the ability to characterize defects within the zinc casting of a particular build, thus preventing the qualification test from accounting for worst-case build conditions without some other destructive process. Inspection criteria were not traceable to the qualification program, despite easily observable and measurable zinc extrusion at the socket joint base. In-service inspections conducted over the socket life showed evidence of zinc extrusion and moisture intrusion/corrosion. Records and socket failure analysis showed that corrosion mitigations were employed, and that the zinc extruded progressively between 2003 (0.5 inch) and 2019 (1 3/8 inches). Although no pass/fail criteria were known to exist, AASHTO M277-06 states that seating extrusion should be less than one-sixth of the cable diameter, or less

than 0.6 inch for the Auxiliary M4N cable that failed (Figure 6). The inspection process did not couple the qualification/design process to a pass/fail criterion to trigger a replacement.

Figure 6: (a) Close-up view of a single gas bubble in zinc casting; (b) 2003 photo of aux M4N showing ~0.5-inch zinc seating extrusion; (c) 2019 photo showing ~1 3/8-inches extrusion. (WJE, 2021)

1. Socket joint constituents should be verified to have positive structural margins for strength, fatigue, and creep failure modes for the service life of the socket for all design load combinations.
2. Periodic visual inspection of socket joints should include pass/fail criteria for zinc extrusion tied to a structural qualification test program that verifies the creep failure mode.

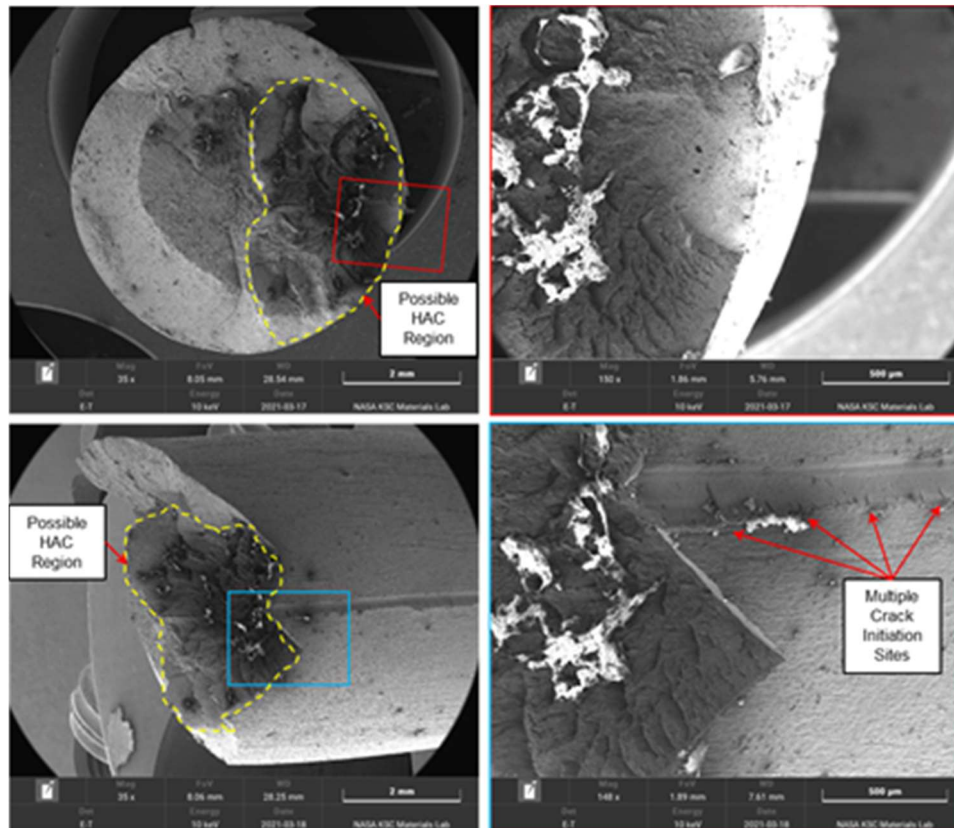
Wires: Independent mechanical testing of excised/recovered wire material from the Aux M4N socket showed conforming dimensions and mechanical properties. Failure analysis of the socket verified that the cross section met drawing and had the correct number of wires. At least two wires had surface defects (Figure 7) that likely contributed to wire fractures. The negative structural margins in the outer wires likely deteriorated further for those wires with surface defects, as these act as stress risers.

Figure 7: Scanning Electron Microscopy (SEM) images of surface defect found on a wire.

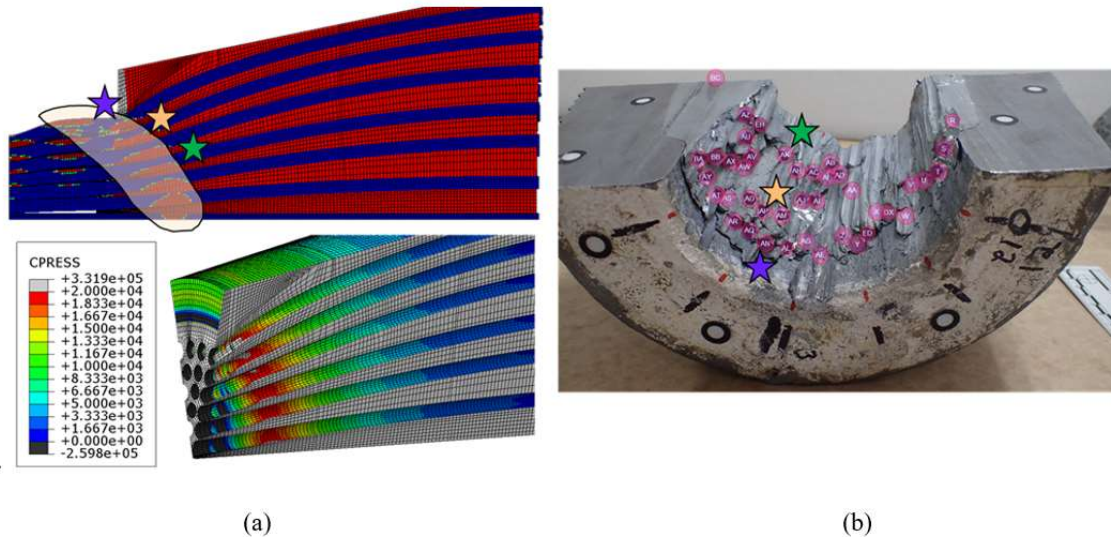
The highest stresses were not predicted to be planar from wire to wire, rather the failure surface followed the surface of a rough spheroid, matching the stepped pattern of wire fracture locations within the socket seen from forensic examination (Figure 8). The outer wires were predicted to fail closer to the socket base cable outlet region, while the inner wires failed slightly inboard to the socket, as seen in the forensic evidence. The stress field suggested that the wires failed adjacent to the greatest confining pressure within the zinc. The zinc plastic flow and the shape of the socket create a region of confining pressure in the shape of a half spheroid, which causes the highest wire stresses adjacent to the boundary of the highest confining pressure. The red output, showing interface contact pressure (“CPRESS”) in Figure 8, reflects the area of

highest confining pressure at the zinc/wire interface, which would squeeze the individual wires and suggest the fracture location to be ahead of this region. Regions of colored stars show the different "steps" of failure in the socket. Note that the yellow shading in the top left figure in Figure 8 and the red high stress zones in the lower left figure match the shape of the failure surfaces in the right figure. Model predictions were qualitatively consistent with the observed wire failure modes from the Aux M4N socket. Forensics identified that most wires failed in cup-cone fracture, although a select number of outer wires failed in shear. Analysis shows that the inner wires are under significant confining pressure, thus increasing elongation capability and resulting in a "ductile" cup-cone failure mode.

Figure 8: Stress distribution and failure mode: (a) highest stresses were not predicted to be planar; (b) failure surface followed a spheroid shape, matching stepped patterns seen in forensic evidence.

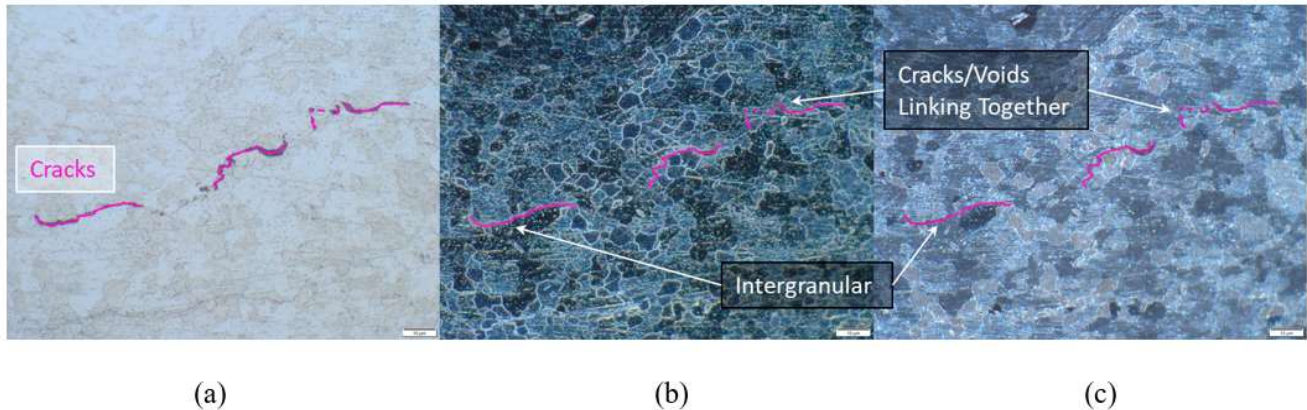
Cumulative Damage: Creep was found to be a major contributor to the failure for the following reasons: (1) Forensic analysis showed clear evidence of creep within the zinc (Figure 9). Zinc microstructure nearest the cable/zinc boundary was fully recrystallized with a predominance of grain boundaries aligned 45° to the shear stress, as expected for creep in pure zinc at ambient temperatures. The zinc nearest the socket base, adjacent to the cable/zinc boundary, was determined to be in the late secondary or tertiary stage of creep. Small, non-connected cracks are present within the fully recrystallized grain region near the cable/zinc boundary (Figure 9), running parallel with the cable-end section. These cracks are either from the tertiary stage or cavitation/voids that were squeezed closed due to continued confining pressure imposed by the cable tension and socket wall. High-magnification image of non-connected cracks in different illuminations after tint etching showed predominantly intergranular cracks, which are associated with slower creep mechanisms. Zinc microstructure nearest the socket casing was partially recrystallized with evidence of highly strained zinc (e.g., twinning / slip bands). (2) Loads analysis also supports a higher percentage of dead loads compared to transient loads. (3) Finite element analysis predicted high stresses within the zinc caused by sustained loading, and as the zinc crept the outer wire stresses were predicted

to increase. The negative structural margins further deteriorated over time due to the creep setting within the zinc, until wire and zinc failure occurred.

Figure 9: Intergranular cracks present adjacent to cable/zinc slug boundary as seen in (a) brightfield, (b) dark field, and (c) cross-polarized illumination. Klemm's 1 Reagent tint etch at 500X magnification.
