# The Structural Strengthening of a Masonry Heritage Shop House using Glass Fibre Based Materials

**Abstract.** *A two-storey masonry pre-war shop house in Taiping, Malaysia was badly affected by construction being undertaken at an adjacent lot. The building was in a serious state of disrepair and on the verge of collapse at the time of the investigation and temporary propping and a stoppage of adjacent works had to be imposed. For the remedial intervention a rapid approach was critical with materials and methodologies selected to incur minimum additional impacts on the building in terms of physical works and with flexibility on site. Several innovative techniques developed for the structural intervention of masonry buildings was considered. In this case the masonry wall cracks were repaired by a stitching method using the glass fiber rod maperod g which was considered a suitable material due to the compatibility of modulus of elasticity (40,800N/mm<sup>2</sup>) to the lime mortar, having good tensile strength of 760 N/mm<sup>2</sup> to help bridge the cracks in case of further movement and is also corrosion resistant and will remain protected in future even though it is embedded

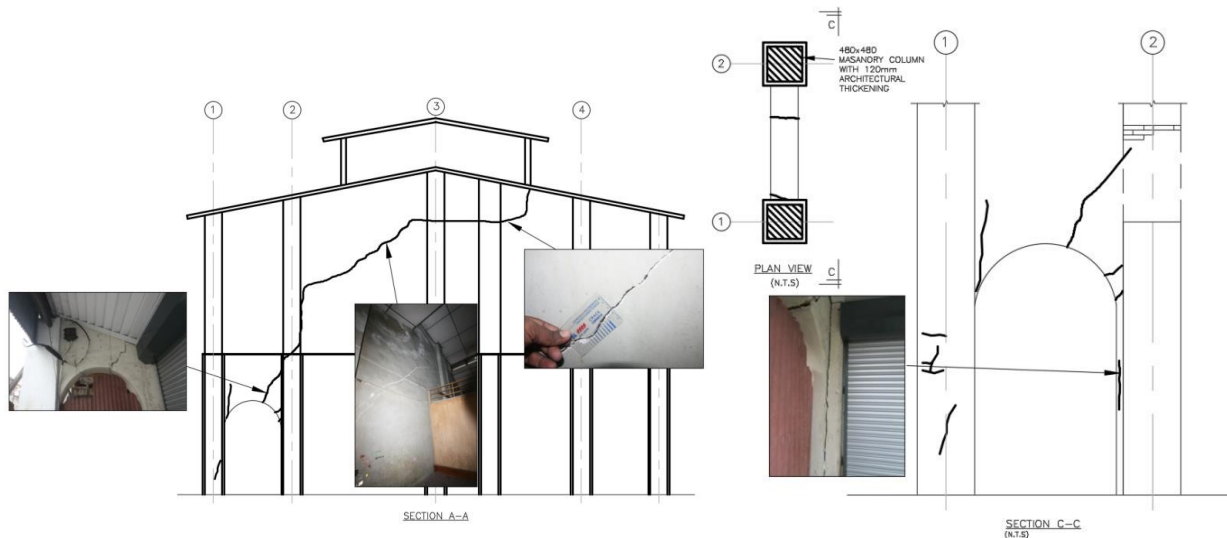
There was considerable evidence of settlement of the columns in gridline A/1-3 as shown in Figure 2. This led to uneven loads on the masonry columns causing the characteristic structural cracking of the Arch, where cracks of up to 50 mm in width were noted. A closer examination of the party wall from the adjacent shop house confirmed that the structural cracking extended to this wall along Gridline A2- A5 where cracks of up to 30 mm were noted. In general the party wall away from the new development was structurally intact. An immediate intervention was proposed to structurally reinstate the front Arch, the common party wall along gridline A and other settlement and cracking points. It was noted that the building was not loaded with the full complement of live loads which can be expected. The cracking on the walls and the Corridor Arch were clearly to do with settlement and vibration loads associated with the adjacent construction, rendering the building unsafe to use at the time of the investigation. There was also a considerable amount of water ingress into the building particular at gridline A-B/5-7 and also at the building corners at gridline A1 and A5 which had not been a problem previously. Based on the visual survey the key defects noted are summarised in Table1.

**Figure 2.** A Record of the defects at the Main Arch at the Shop House Front and at the Party Wall.

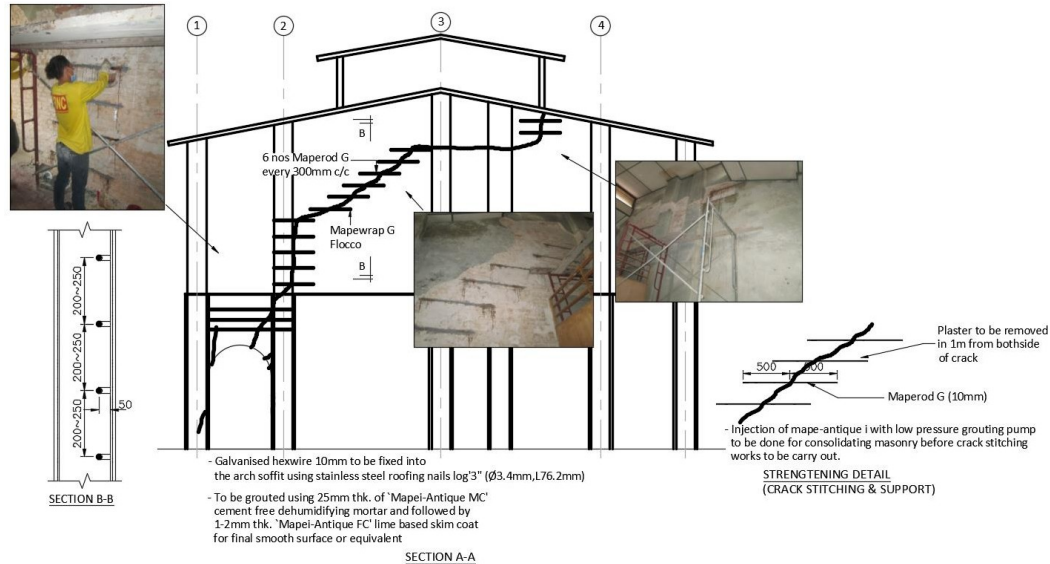
**Figure 3.** Significant Cracking of the Arch and Party Wall and the proposed approach to crack repair.

- f) The Arch and wall cracks were repaired by a stitching method using Maperod G a glass fibre rod which is inert within the matrix but providing structural strength.

- g) Mapewrap G Fiocco was used allowing stitching to be performed at one-side with minimum impact to the overall wall with the anchors planted deep into the masonry wall to provide the full anchorage.

In this case the stitching could only be performed at one-side and for this reason Mapewrap G Fiocco was selected as an appropriate method. Mapewrap G Fiocco is made into an L-shaped anchor using epoxy impregnator Mapewrap 31 SP and is bonded at both ends of the Maperod G.

The anchor is planted deep into the masonry wall, ie approximately to a depth of 140mm to provide the full anchorage. To structurally bond the Maperod G and Mapewrap Fiocco to the masonry wall, epoxy adhesive Adesilex PG2 TG was selected. Epoxy has high durability and good mechanical properties in terms of compressive, flexural, tensile and shear strength.

To enhance the bonding to the masonry wall, all contact surfaces of the masonry were primed with Mapewrap Primer 1 SP to consolidate the porous surface and eliminate dust. The crack lines were reinforced at every 4-5 brick intervals and inserted into the pointing layer for a minimal impact on the existing masonry wall. The full extent of the repairs is illustrated in Figure 3.

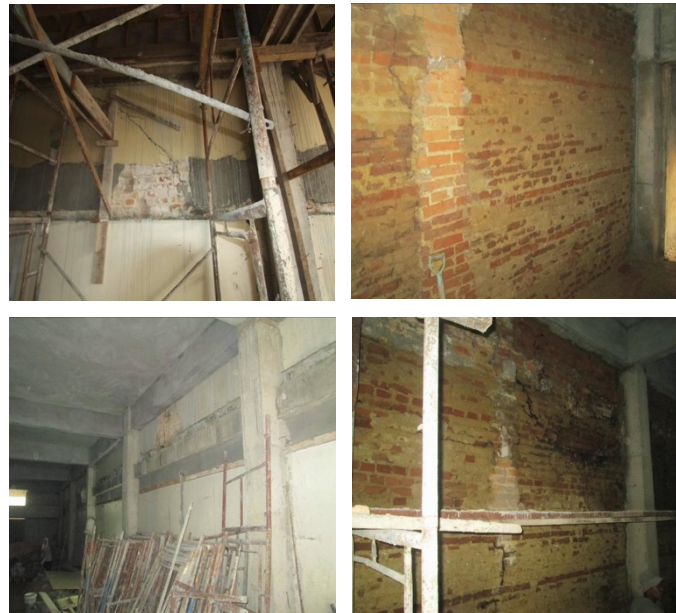
**Figure 4.** Additional Illustrations of the Remedial works.

The remedial work was carried out by a specialist contractor and the repair materials were supplied by Mapei. The works were carried out successfully and the shop house was reinstated to its original condition within 3 weeks (see Figure 4).
