DAMAGES PATTERNS IN HISTORICAL TEMPLES OF PUEBLA, MORELOS AND OAXACA AFTER SEPTEMBER 2017 MEXICO EARTHQUAKES

MARCOS M. CHÁVEZ^{1*}, FERNANDO PEÑA¹, NATALIA GARCÍA² AND
DANIEL DURÁN¹

Keywords: Stone Masonry, Damage Assessment, Architectural Heritage Buildings, Seismic Behavior

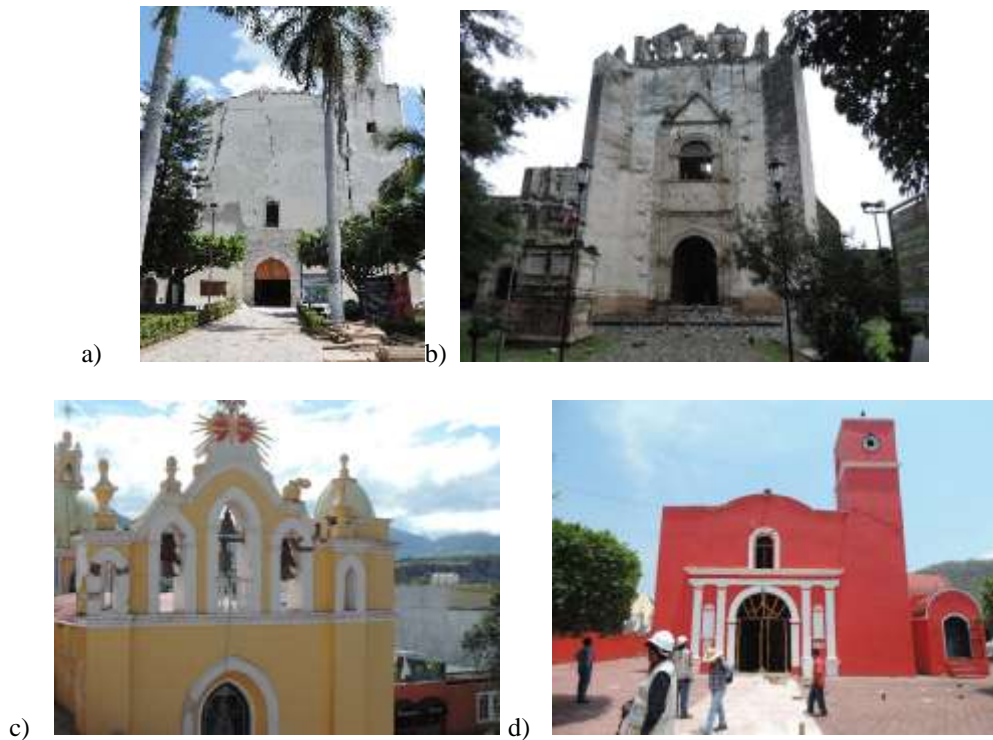
Some examples are showed in figure 2. The façade of Tlaquiltenango temple, in Morelos, present a separation between the façade and sidewalls; as well as, a diagonal crack in the middle of this element (Fig. 2a). In Tlayacapan, some diagonal cracks were located over the façade, near to the door and windows. The bell gable showed a partial collapse due to the out of plane behavior of this element (Fig. 2b). A similar behavior was observed in the *Sagrario* temple, in Huajuapán de León, Oaxaca (Fig. 2c). The façade of Chila de la Sal chapel showed some cracks between the side walls, in the middle, and the towers (Fig. 2d).

Figure 2: Damages patterns in façades: a) Tlaquiltenango, Morelos; b) Tlayacapan, Morelos; c) Huajuapán de León, Oaxaca and d) Chila de la Sal, Puebla

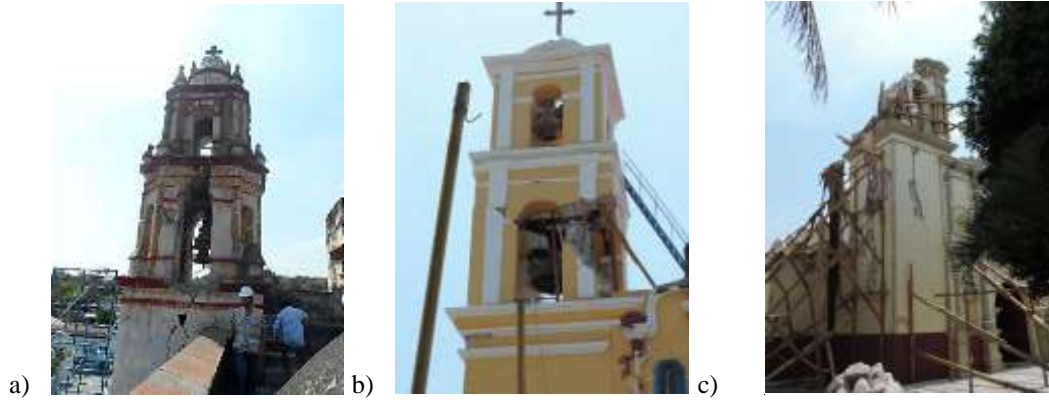
The towers were the structural element that more damages presented in temples located, mainly, in Puebla and Morelos. In San Andrés de la Cal chapel, Morelos, the arches of the lower body of the bell tower collapsed and horizontal cracks appeared in the upper and base of the pilasters (Fig. 3a). Similar behavior was observed in the pilasters of the bell towers of Santa Ana Jolalpan (Fig. 3b) and Pilcaya, (Fig. 3c) Puebla.

Figure 3: Damages patterns in bell towers: a) San Andrés de la Cal, Morelos; b) Santa Ana Jolalpan, Puebla
c) Pilcaya, Puebla

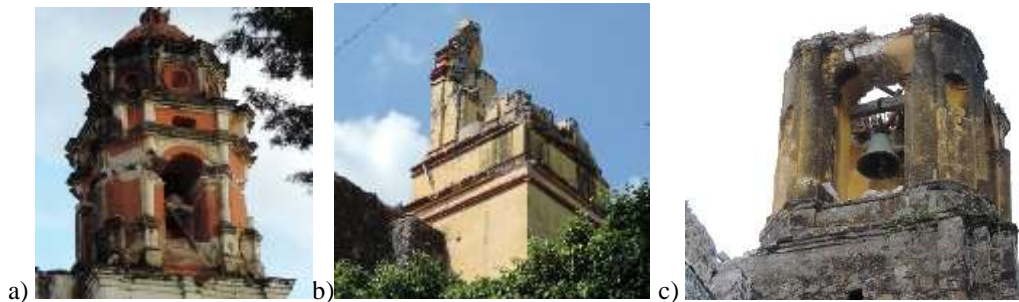
The temples Hueyapan, Jiutepec and Ocuituco located into the *Ruta de los Conventos*, in Morelos, they have only a one bell tower. In all cases, this element presented a different level of damage, from only cracks until partial or total collapse (Fig. 4). Hueyapan tower shown cracks upper and the base of the pilasters of the first body of the belfry. This is because the upper body, being more rigid and smaller, worked mainly as a rigid body with a considerable mass, where the seismic shear was concentrated (Fig. 4a). The temples of Jiutepec and Ocuituco presented collapses of the bell towers, while the main walls of the facades had slight damage, which was concentrated in the opening of the window of the choir (Figs. 4b and 4c).

Figure 4: Damage to facades of temples in Morelos: a) Hueyapan; b) Jiutepec; c) Ocuituco

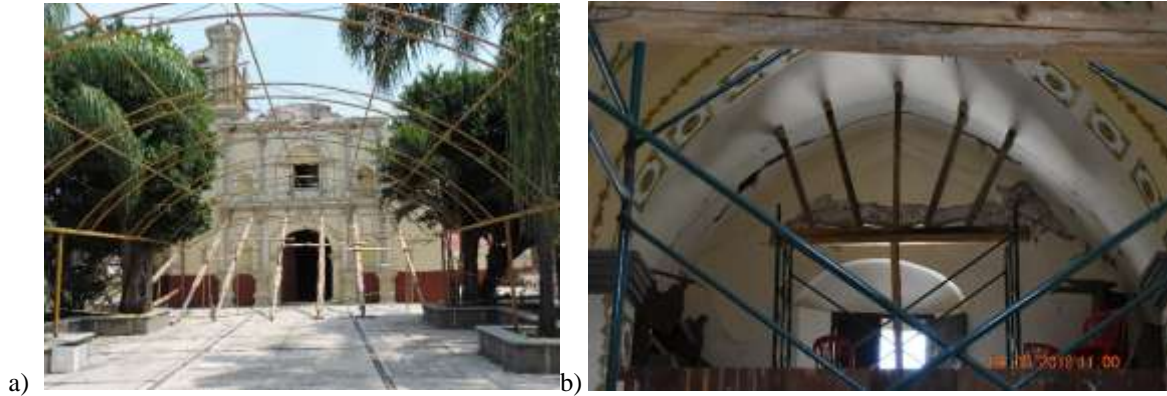
Although most of the temples in Mexico have a vaulted roof, as stone or brick masonry, some façades were damaged due to presence of the out of plane behavior. For example, in Pilcaya (Fig. 5), the facade was separated from the vault because of a deficient anchoring of the roof to the facade wall. Likewise, the frontispiece collapsed due to movement out of plane. In Tlayacapan (Fig. 6) vertical cracking are shown between the façade and the side walls of the nave, due to an out-of-plane behavior.

Figure 5: Temple of Pilcaya, Puebla: a) turning of the frontispiece; b) separation of the facade from the body of the nave

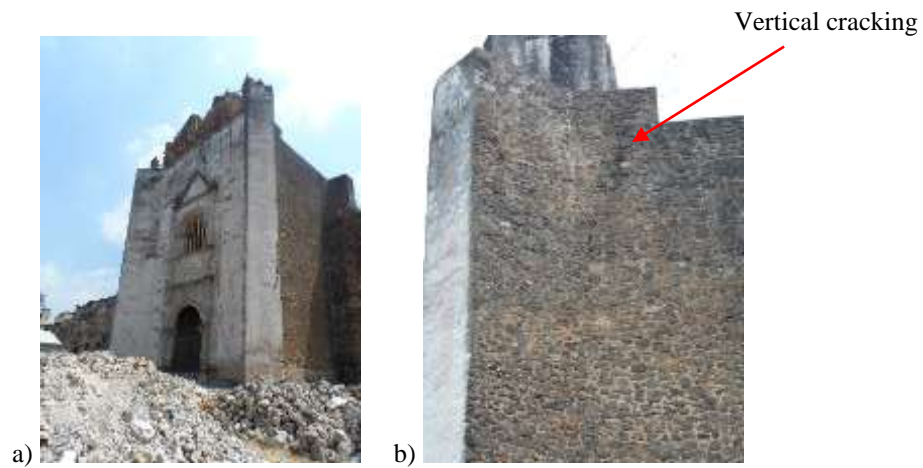
Figure 6: Facade of the Tlayacapan temple, Morelos: a) General view; b) Vertical cracking between the facade and the wall of the nave

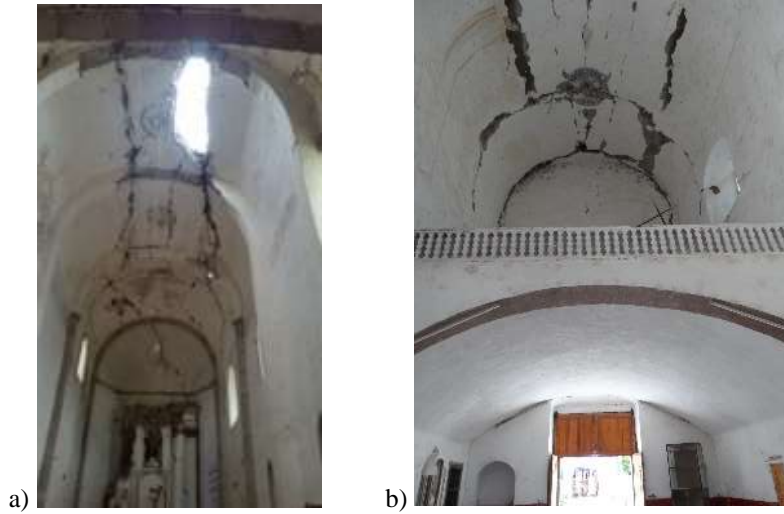
The roofing system of this kind of temples is mainly made by domes and vaults. The most common are the barrel vaults without or with lunettes. Many cases of damages in this system was observed, from longitudinal and transversal cracks until partial or total collapses. Figure 7 shows the typical cracking of continuous barrel vaults, where longitudinal cracks are present along the vault. Usually a crack appears at the top of the vault, in the intrados and extrados, ridding the fillings that commonly cover the kidneys of the vault in the extrados (Fig. 7). In some cases, the cracks were large enough to cause the collapse of the vault and arches.

Figure 7: Damage in vaults: a) Tlayacapan, Morelos and; b) Tlaquiltenango, Morelos

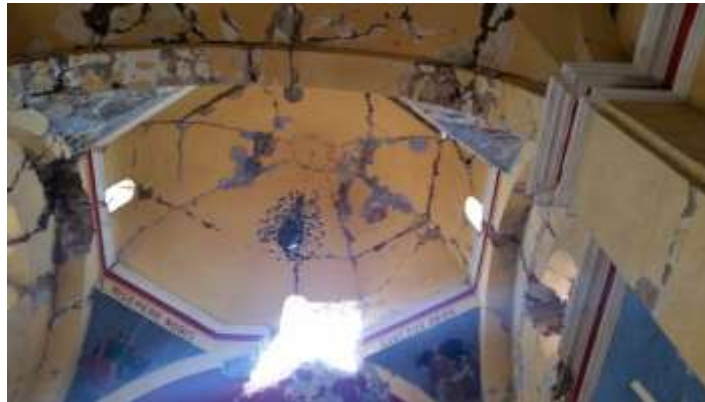
About of the domes, typical damages were observed: radial cracks at the base of the dome and meridians on the body of the dome (Fig. 8). In some cases, the damages were located only in the drums. In others, the dome collapsed and the drum remained standing, apparently undamaged (Fig. 9).

Figure 8: Radial and meridian cracks in the dome of the Jiutepec temple, Morelos

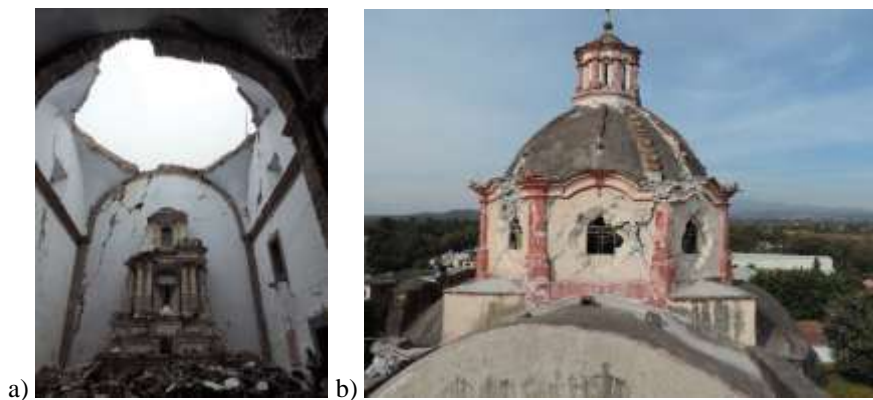
Figure 9: Damage to the main dome in temples in Morelos: a) Totolapan (sail vault); b) Zacualpan

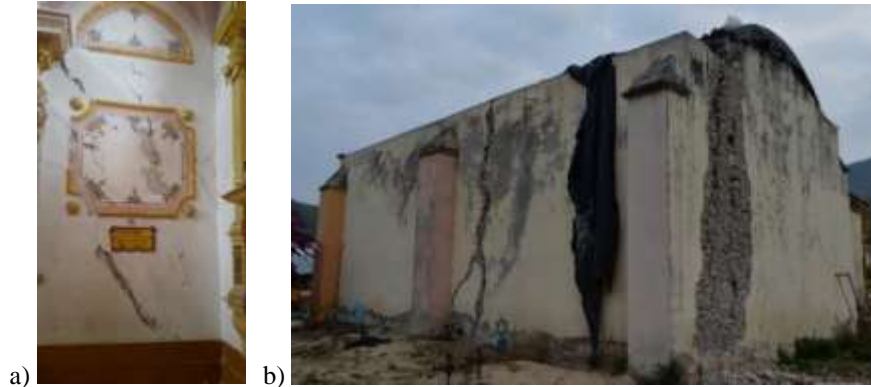
The temples are massive structures. The weight of their structural elements contributes to the stability. The walls usually are robust and can hardly collapse. However, damage may occur mainly by shear forces that the masonry cannot resist as shown in figure 10.

Figure 10: Damage in side walls: a) El Calvario temple, Huajuapán, Oaxaca; b) Ayoxutla, Puebla

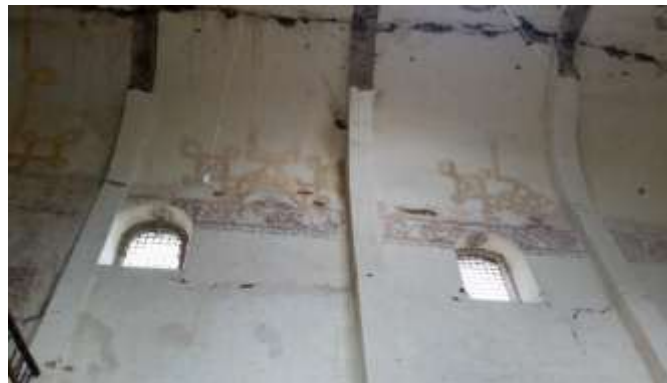
In some cases, the side walls have horizontal cracks that cross the thickness of the wall and generally are located below the windows (Fig. 11). This type of cracking is due to bending moments outside the plane of the wall; which occur mainly in churches that have other bodies attached to the side wall, such as convents, chapels or parish offices. These attached bodies function as struts on the side walls.

Figure 11: Horizontal wall cracks in the temple of Tlayacapan, Morelos

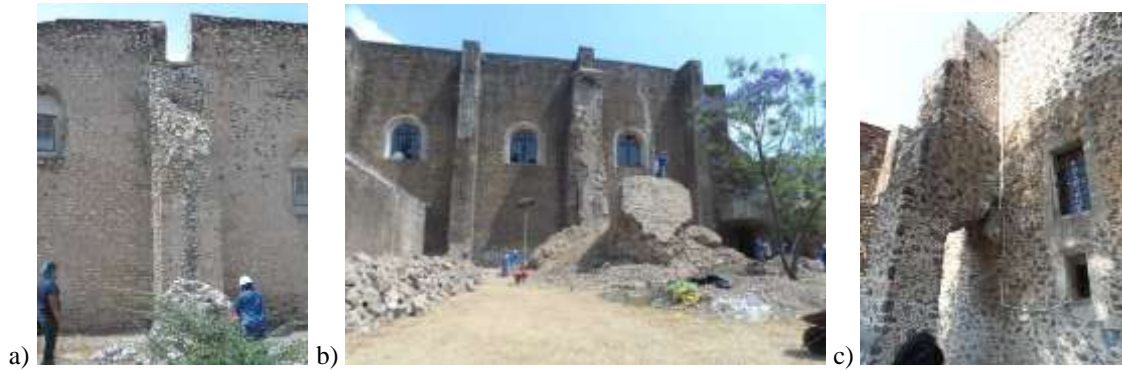
Buttresses with added sections at different stages of construction collapsed by separating mainly in areas with old cracks that had been repaired in previous works. In flying buttresses, shear cracks occurred even when their arches had been bricked up, in addition to the separation of the walls (Fig. 12).

Figure 12: Typical damage to butresses in Morelos: a) Tlayecac; b) Tlayacapan and c) Totolapan

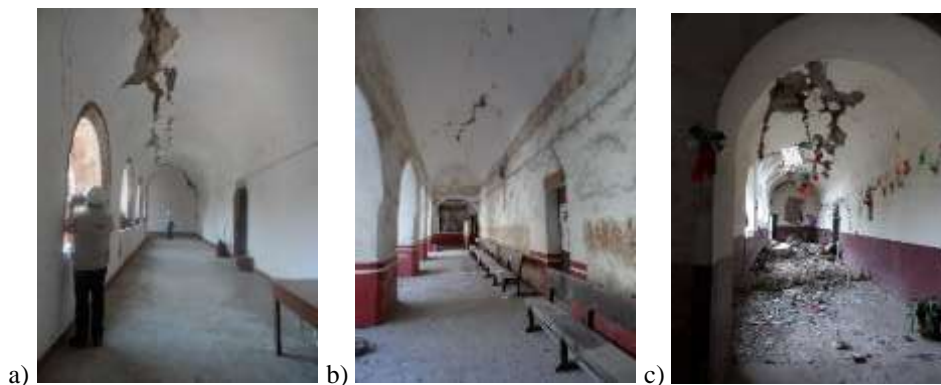
The barrel vaults in the corridors showed longitudinal cracks, located at the top and in the kidneys of the roof; in a few cases they were located in the bases of the vault, as in the Totolapan convent (Fig. 13a). These cracks are located frequently next to the cloister, because in this side, the structural elements are insufficient to contain the thrust of the vault, compared to the opposite side, that contain the walls of the rooms, which are more rigid (Figs. 13a and 13b).

Figure 13: Typical damages in Morelos convents: a) Ocuituco; b) Jiutepec; c) Totolapan

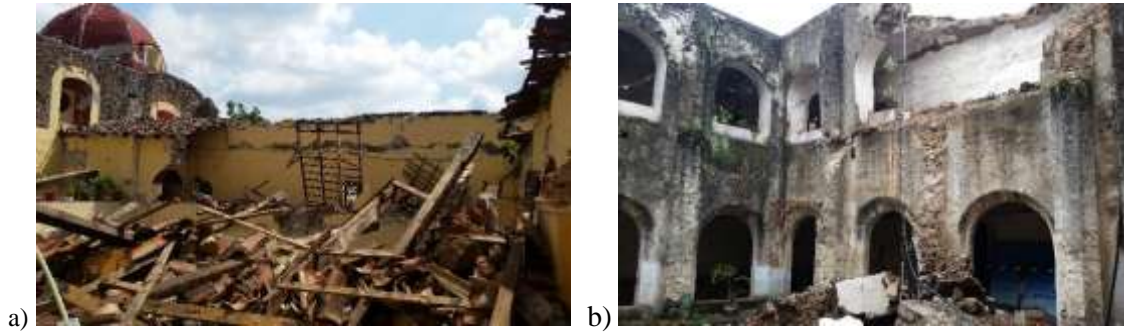
In some convents, the arches of the upper cloister collapse because they have an important opening and the poor quality of the material building. In particular, the convents of Jiutepec and Totolapan, located in Morelos, were the most affected. In the first, the roof of the high cloister was formed by wooden and tiles, with thickness arcades and without butresses (Fig. 14a). In Totolapan, the damage was associated to the poor quality of the masonry, maybe for a lack of maintenance. The low cohesion between the mortar and the stone induce the crumbling of the masonry, which caused the collapse of the buttressed arch and the barrel vault in the gallery of the high cloister, due to movement out of plane (Figure 14b).

Figure 14: Damage to the upper cloister of Morelos convents: a) Juitepec; b) Totolapan

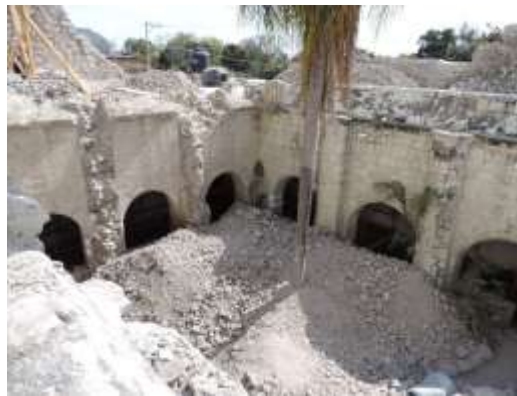
The convent of Jantetelco presented severe damage due to the low resistance of the masonry used for its construction; since it is made mostly of large pebbles and a low quality mortar, causing an inadequate adherence between the mortar and the stone as well as for the poor interlocking between the stones. Due to this, when the action of the earthquake induced high levels of stresses on the convent, the masonry crumbling. Figure 15 shows the cloister with debris of the masonry.

Figure 15: Damage to the cloister of the convent of Jantetelco, Morelos

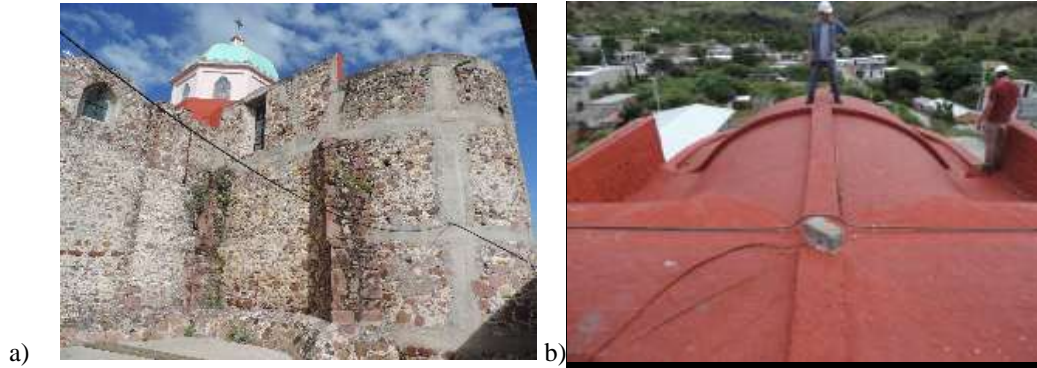
In Oaxaca are located some temples intervened with massive reinforced concrete elements, because they were severely damaged for previous earthquakes. Figure 17 shows two cases: Santiago Cacaloxtepc and San Andrés Dinicuiti, both with reinforced concrete elements embedded in the walls and the vault (Figure 16 and 17). In San Andrés Dinicuiti, the original vault was replaced totally by a reinforced concrete slab (Figure 17b). In both temples, not damages by the earthquake of the September 19 were detected.

Figure 16: Temple of Santiago Cacaloxtepc reinforced with concrete element: a) walls and b) vault

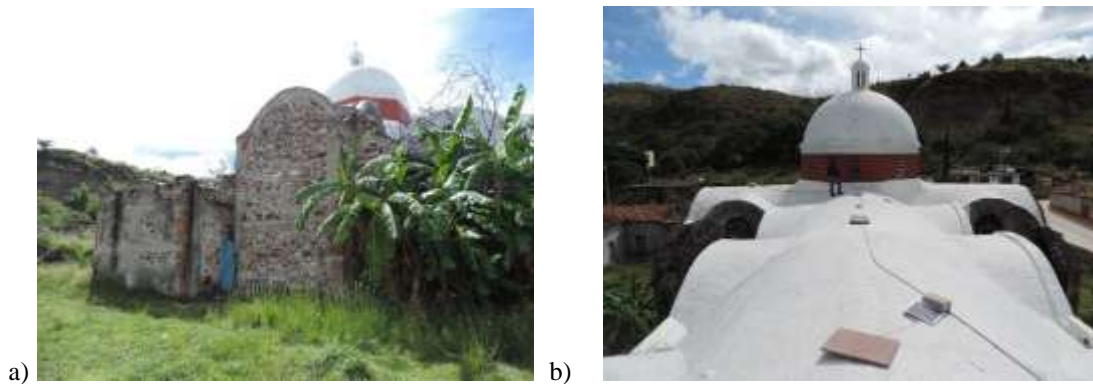
Figure 17: Temples of San Andrés Dinicuiti reinforced with concrete elements: a) walls and b) vault

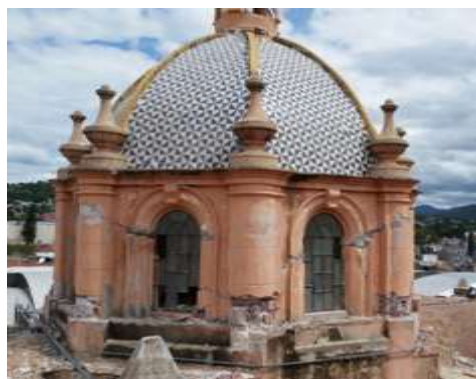
Other cases were found where only the interventions of reinforcement were applied locally in specific structural element, without intervening adjacent elements. Causing that the damages were transferred to weakest regions that probably before the intervention had not been damages. For example, Figure 18 shows the damage in the drum of the Huajuapán Cathedral. In this case, the dome was rebuilt previously with reinforced concrete. Another example is when reinforced concrete or steel elements are incorporated as structural reinforcement. However, due to incompatibility of materials or an inadequate anchorage with around structural elements, some damages were produced as show in Figure 19.

Figure 18: Damage in the dome of Huajuapán Cathedral, Oaxaca due to interventions before to the 2017 earthquakes

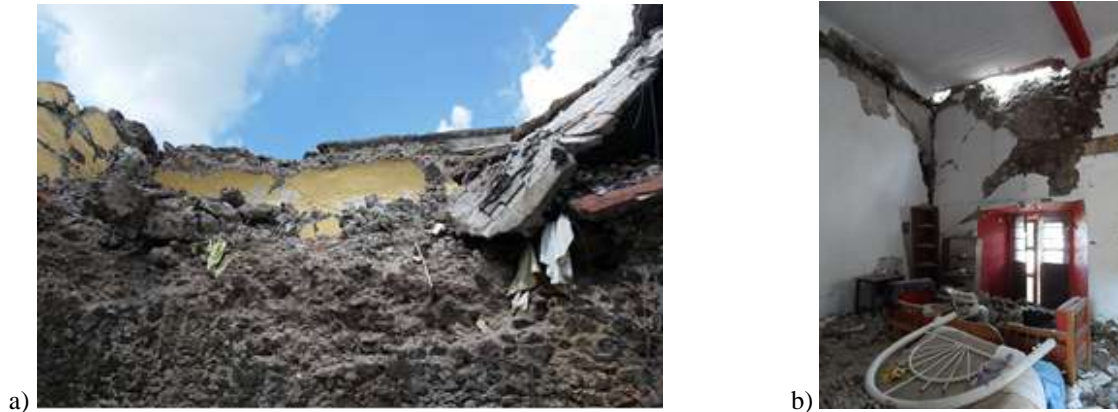
Figure 19: Wall collapses due to interventions with concrete slabs in the convent of Jiutepec, Morelos: a) Slab supported directly on the wall; b) Beams supported on the walls
