THE MODERN IMPOSSIBILITY OF MAKING ART LIKE THAT OF THE PAST. INTERVENTION PROPOSAL FOR THE TEMPLE OF SAN JUAN BAUTISTA, TOCHIMILICO, PUEBLA, MEXICO.

M. ELISA VERA LUNA¹

¹Universidad Popular Autónoma del Estado de Puebla (UPAEP)
Facultad de Arquitectura
e-mail: marthaelisa.vera@upaep.mx, www.upaep.mx

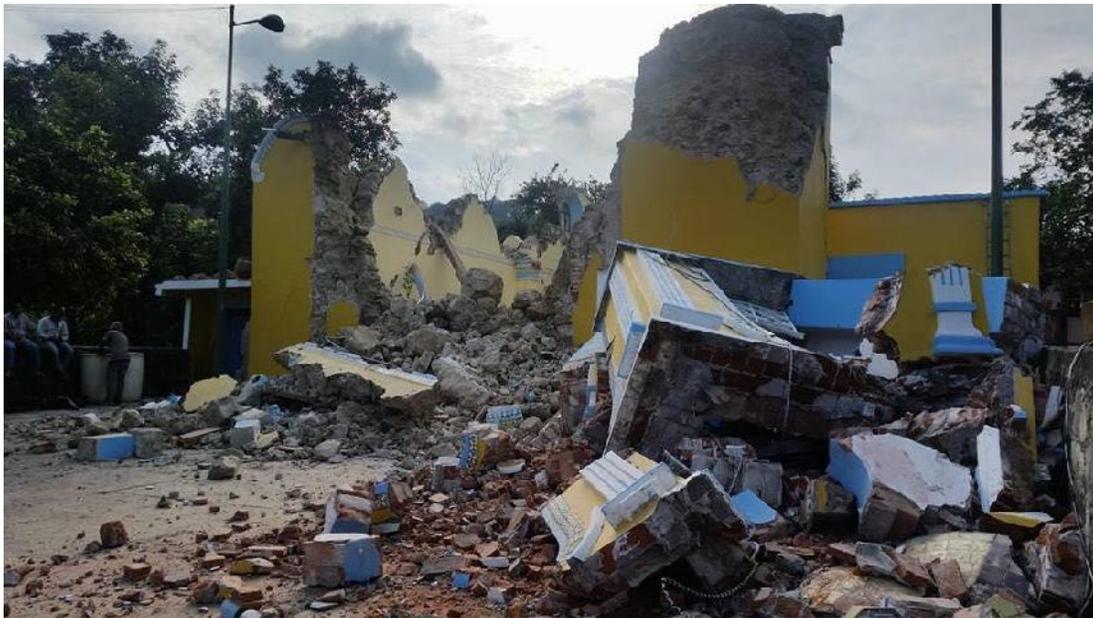
The temple of Saint John the Baptist was one of the most affected buildings by the earthquake of September 19th, 2017. Only 30% of the total structure stood after the quake. The amount of damage sparked controversy over the restoration procedures fit for this particular case.

During the quake and due to its slender shape, the bell tower suffered a displacement which led to its collapse. The tower collapse also collapsed the temple's façade. The addition of rooms to the sides of the temple, warehouses on the left and sacristy on the right, strengthened the bases of the walls around the altar. Hence, these walls moved at a different frequency than the first body of the nave, provoking the dismantling of the rest arches, the band and causing the collapse of the vaults. The main wall suffered a vertical fracture, several cracks on the topmost area and loss of material. The buttresses gave way; they cracked in the middle and lost their binding with the main structure.

Figure2. San Juan Bautista after 19 September earthquake.

When considering the restoration criteria of Villagrán, the current condition of the materials, the state of the damage and the capacity of the structure to support the structural weight, we propose the consolidation of the ruin by freeing all the elements which could present a health hazard and rehabilitating the space with an independent architectural intervention with state of the art systems whilst keeping the proportions and original shapes.

To consolidate the wall's stumps, we plan to inject slip, a fluid mixture of clay, in the joints, and patching up the cracks when needed. The crowning of the walls, up to the original heights, will be built with mud bricks and plastered with earth mortar. For the roof, we will craft a timber framework covered with clay roof tiles. Such framework will be composed of certified timber, kiln-dried, treated with sealers, flame-retardants, and anti-xylophages. The proposed system consists of a gabled roof with two side-skirts and ridge pitched between 30° y 40° and covered with flat clay roof tiles. To support the roof we propose an internal metallic structure detached from the temple walls so that it can also recreate the geometrical shapes of the arches and groin vaults to facilitate the reading of original elements that are still standing. We propose to build the façade according to the documentation to keep the identity of the temple and to rebuild the
