## DOCUMENTATION AND STRUCTURAL APPRAISAL OF THE MEDIIEVAL MANOR OF POTAMIA, CYPRUS: AN INTERDISCIPLINARY APPROACH

**Keywords:** Historical Structure, Masonry, Monitoring, Non-Destructive Inspection

**Abstract.** *This paper aims to present, via a case study, an interdisciplinary approach towards the comprehensive analysis of historic constructions. The case study monument examined is the Medieval Manor of Potamia in Cyprus. The work hereby presented was based on a collaboration between scientists from the fields of archeology, architecture, materials science/conservation and structural engineering. A thorough review of historical sources was initially carried out in order to obtain data concerning the history and construction development of the Manor. Extensive field work was undertaken to study the architectural typology and construction detailing of the structures and to explicitly map the various agents of pathology. For the characterization of the historic fabric, masonry materials were sampled and studied at the laboratory. The accumulated data facilitated the development of a Finite Element (FE) model, which was used to numerically assess the structure's seismic response.*

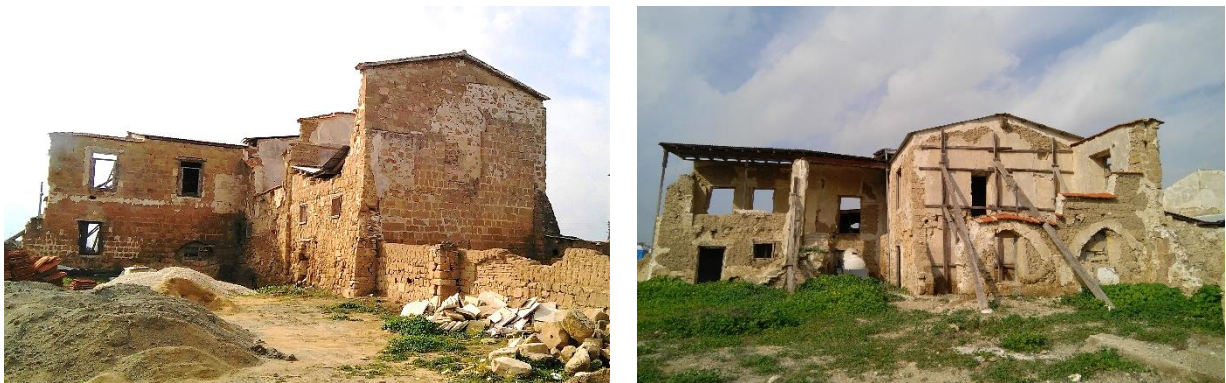
**Figure 2:** Photographs of the east part of the Potamia Manor showing stone masonry structures facing towards the north (left) and adobe constructions attached to stone structures at the south (right).

vaulted room of unknown use exists. This is considered to be the only medieval structure surviving to its original height. Towards the south, adobe constructions were attached to the pre-existing stone structures. Many sections of the east part, including most of the roof and floor structures, and large segments of the walls at the upper floor, have collapsed.

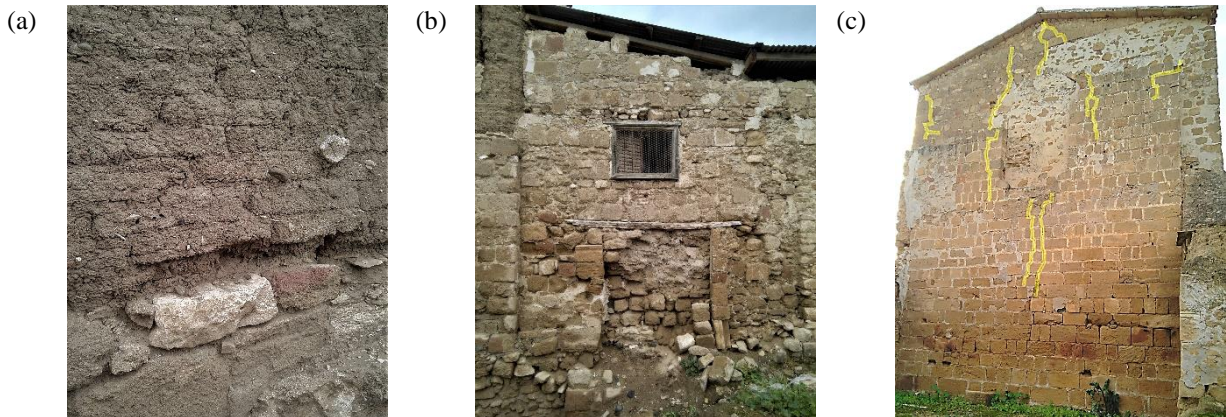
It was noted that the main agents of pathology are associated with the action of water, and especially salt crystallization. The absence of waterproofing courses at the foundation level has resulted to capillary rise of ground water. The high moisture contents recorded 70-200 cm from the ground indicate the presence of a capillary rise front at this level, which is in line with the sharp front theory [10] and field observations reported elsewhere [11] [12]. The loss of roofing protection in large parts of the complex has left many building components exposed to the climatic conditions. Unobstructed water runoff and penetration of moisture at the top of the walls have contributed to material deterioration. In many areas, moisture infiltration, combined with thermal distress, have caused the detachment of render and plaster materials from the substrate, leaving the masonry surfaces exposed to the weather.

Adobe materials exhibit severe weathering due to the susceptibility of unfired earth to moisture-driven disintegration [13] [14]. Surface erosion characterized by loss of cohesion of the soil matrix was recorded on most earthen walls. Deterioration of adobes induced by rising damp has led to the formation of continuous horizontal fissures along the boundary between the walls' stone base and the adobe masonry, where the evaporation front is located (Figure 3a). Moisture-driven damage on stone walls is more noticeable at the sections affected by rising damp. At these areas, the jointing mortar has weathered away to a depth of 5-15 cm from the face of the masonry, while many stone blocks have suffered spalling and have become rather friable (Figure 3b). Biodegradation of masonry materials by lichens/mosses, as well as mechanical damage caused by vegetation growing next to or within the mass of the walls occur. Many of the remaining timber members were found to be in rather poor state, showing signs of insect infestation and/or fungal decay.

In terms of structural damage, the major issues identified are partial collapse of masonry sections, cracking (Figure 3c), loss of interaction among interconnected members and deformation of wall elements (i.e. bulging, loss of verticality). Measured crack widths were in many cases  $\geq 10$  mm, while the presence of through-cracks indicating separation among

orthogonal walls was recorded. Structural damage has been caused by the joint action of several factors, including seismic loading, climatic conditions, defects associated with original construction methods/materials, incompatible/ineffective interventions and application of excessive loads on the structure due to changes in building use. The lack of adequate connection between parts of the monument constructed at different building phases and the inherent absence of stiff floor and roof diaphragms have also affected the structural response.

**Figure 3:** (a) Undercutting and surface erosion of adobe masonry. (b) Deterioration of stone masonry materials due to rising dump. (c) Marking of crack locations on the stone masonry wall of the north elevation.

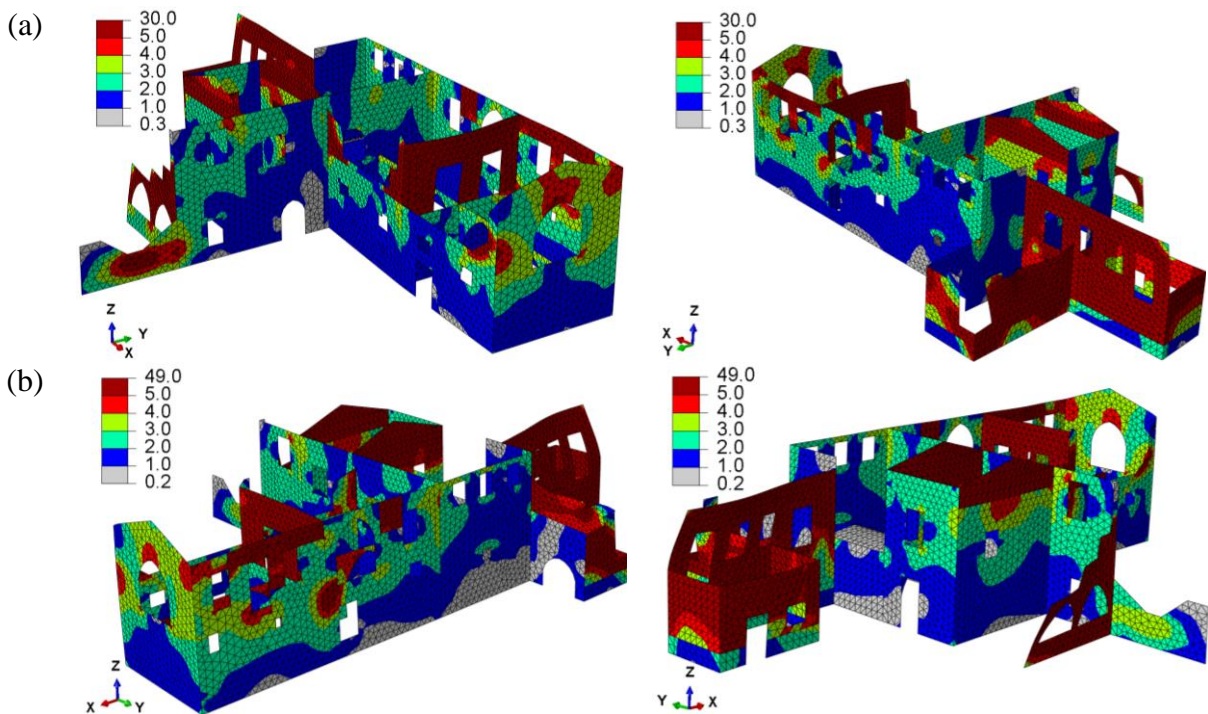
Figure 5 presents contour diagrams of damage variable  $R$  over deformed FE meshes for load combinations corresponding to different directions of the principal seismic component. Good correlation between numerically predicted damage and recorded cracking is observed at

many of the stone walls (e.g. compare the crack pattern of the north elevation wall shown in Figure 3c with the corresponding areas exhibiting  $R > 5$  in Figure 5). This provides a useful indication regarding the validity of the computational model. Analyses show widespread damage due to exceedance of allowable stress state. For all load combinations examined  $> 60\%$  of the total surface area of the shell elements develop stresses outside the failure envelopes defined. According to Asteris [24], this can be interpreted as the structure reaching the near collapse limit state.

The computed deformation distribution indicates that the walls which sustain out-of-plane seismic loading are susceptible to overturning. This failure mode appears to be critical for the walls and parapets of the upper floor and for certain free-standing wall sections at the ground floor level. It is evident that adobe constructions are the most vulnerable parts of the monument. The low modulus of earth masonry results to the development of high deformations at these sections. In addition, the poor mechanical properties of adobe are not adequate for resisting the significant demands imposed by seismic action, particularly at wall sections which are not effectively restrained against lateral motion. Overall, spatial discontinuity of the load-bearing system due to partial collapse of sections and variation of the stiffness and mass distribution within the walls negatively affect global seismic response.

**Figure 5:** Isoparametric views of the structure under study showing deformed FE meshes (deformation scale  $\times 20$ ) with contour diagrams of damage variable  $R$  for load combinations (a)  $G + E_x + 0.3E_y$  and (b)  $G - 0.3E_x - E_y$ .
