Observations of Moisture Damages in Historic and Modern Wooden Constructions

Stephan Ott and Patrik Aondio

Abstract. *With the introduction of new building products made of planar glued board lamellas, the CLT, the restriction of load-bearing structures to linear and thus additively used load-bearing members was abolished. As a result, new, technically determined boundary conditions for moisture management in the interior of buildings have arisen. Due to the emergence of massive, planar wall and floor components as in concrete construction, the integration of building services technology in timber construction must now take place differently than was traditionally the case. In addition, it can be observed that the damage to building components is increasing, the detection of moisture damage is becoming more difficult and, ultimately, the consequences and risks are not yet foreseeable. The study focuses on the cause-effect relationship of increased water input and uses selected examples to reveal the problem of moisture exposure in the interior of buildings with planar load-bearing structures, the damage mechanisms and direct consequences set in motion. This paper shows the necess

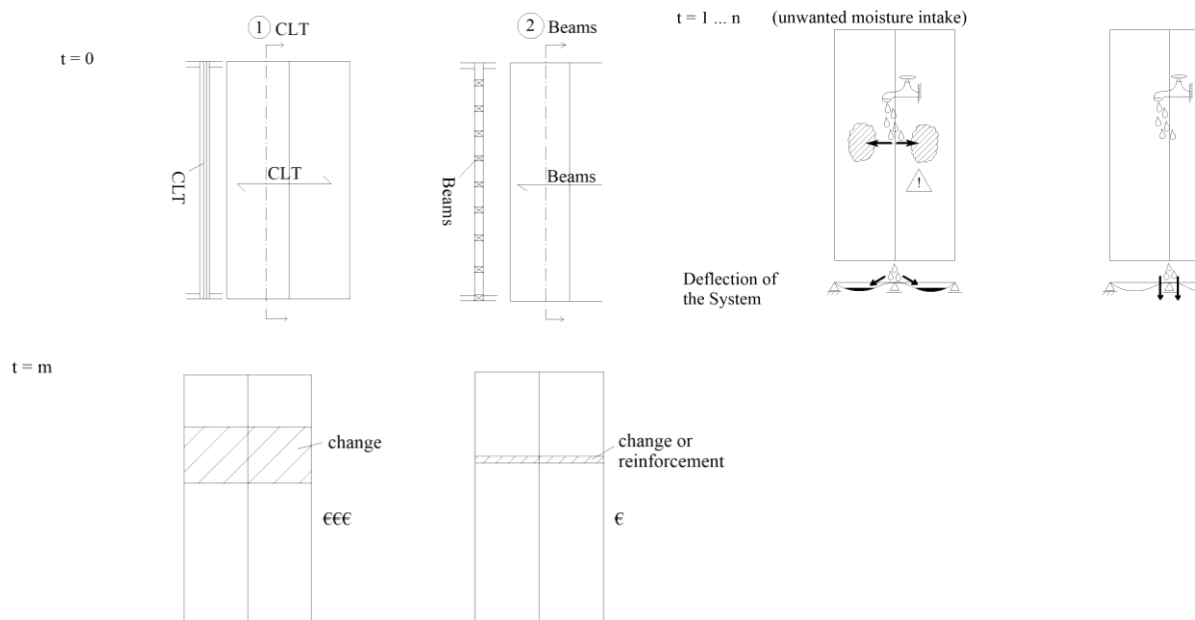
Figure 2. Timber floor systems 2-axial (left column) versus 1-axial during assembly $t = 0$, $t = 1 \dots n$ with moisture intake and finally $t = m$ with possible repair scenarios.

If damage to the load-bearing structure is known, it must be repaired. In the case of the beam floor, the repair of damaged beams is relatively simple. In the simplest case, the damaged beams can be removed and replaced. Alternatively there are possibilities of lateral reinforcement by additional beams, construction materials or steel. As there is still space between the beams, this can be used for repair purposes. This is different for *CLT* constructions. Since the construction space is already completely occupied, *CLT* cannot simply be renovated or reinforced on the existing level. If a *CLT* floor cannot simply be replaced, complex constructions are often required to carry out the renovation. This is also reflected in the repair costs.

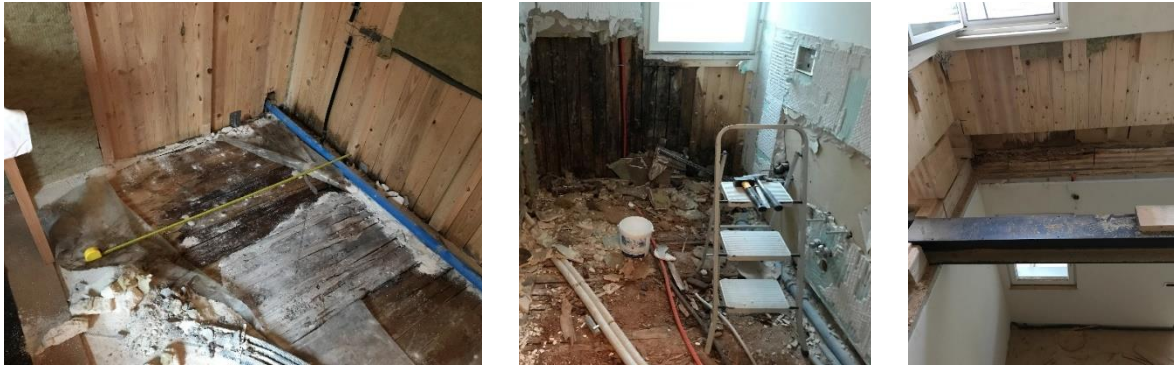
Moisture damage is one of the most frequent types of damage in residential buildings. These are often caused by leaking pipes or design faults. In beam floor, the escaping water often migrates through the construction level and escapes at the underside and thus becomes visible quite quickly. Furthermore, the water inlet and outlet areas of beam floors are usually close to each other. If water is exposed to a closed surface such as *CLT*, the water moves to the deepest point of the structure where it collects, see Figure 2. Since the surface is usually closed and the water cannot pass unhindered through the construction level, it sometimes remains lying there for a long time and searches its way downwards along paths that are sometimes difficult to follow. Thus the place of the moisture entry and the place of the exit may be far apart. Furthermore, it can take a very long time until such moisture damage is detected. As an example the *CLT* floor of a hotel is shown here, where a damaged water connection was not found over 8 years, see Figure 3. From the once 220 mm thick *CLT* floor 100 mm have been decomposed by wood-destroying fungi. The floor structures originally did not suggest any damage, as the top of the floor and the underside of the floor were dry. In addition, the location of the maximum damage was several meters away from the cause of the damage (leaky water connection). Due to the very low construction height, the renovation was very costly. Auxiliary steel structures have to be used to replace the damaged *CLT* elements with new ones and to support the roof structure above.

Figure 3. Pictures of damaged CLT slab and wall elements in hotel room.
