Thermal segregation of asphalt material in road repair

Juliana Byzyka^{*}, Mujib Rahman, Denis Albert Chamberlain

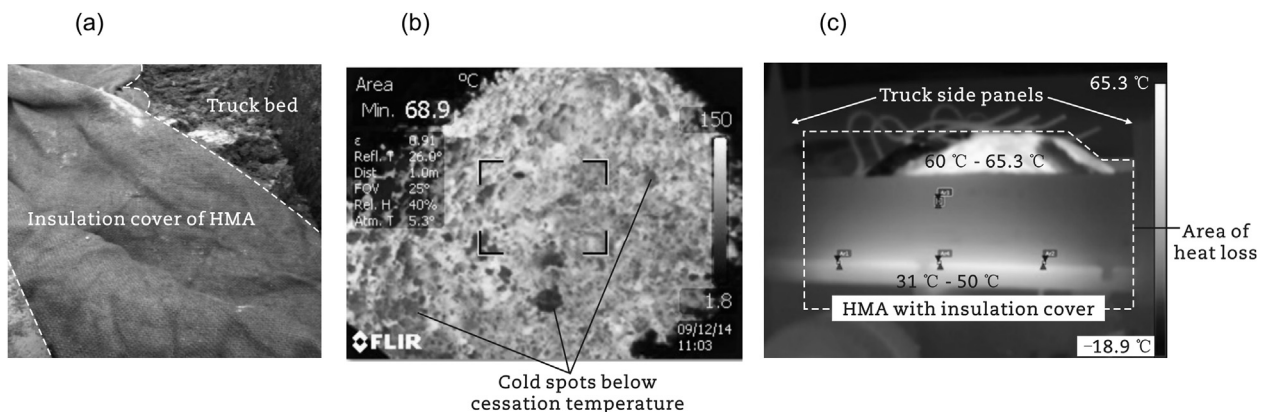
During transportation, the HMA was covered only with a thin insulation sheet (Fig. 2(a)). Two thermal images were taken immediately after the HMA was loaded onto the truck. At this point, thermal segregation had begun to develop, this shown as black areas on Fig. 2(b). The temperatures of the asphalt mat at this stage varied between 69 °C and 150 °C, indicating cold spots throughout the asphalt mat. Further, heat loss occurred through the panels of the truck and the cover sheet (Fig. 2(c)). The dark areas on the periphery of both thermal images are the surroundings to the HMA containment and not the material itself.

Fig. 2 – Asphalt collection at the production plant for repair sites 1–5. (a) Insulation cover of HMA. (b) Asphalt mat temperatures after collection. (c) Insulation cover temperatures.

production facility. Improper insulation of the hot-fill material and long travel time, in combination with low ambient temperatures, impacted on the asphalt mix temperature causing significant temperature losses through the panels of the truck and the cover sheet (Fig. 2). Table 2 and Fig. 3 present the overall transportation time and temperature drop versus time respectively of the asphalt from the production plant to each repair site.

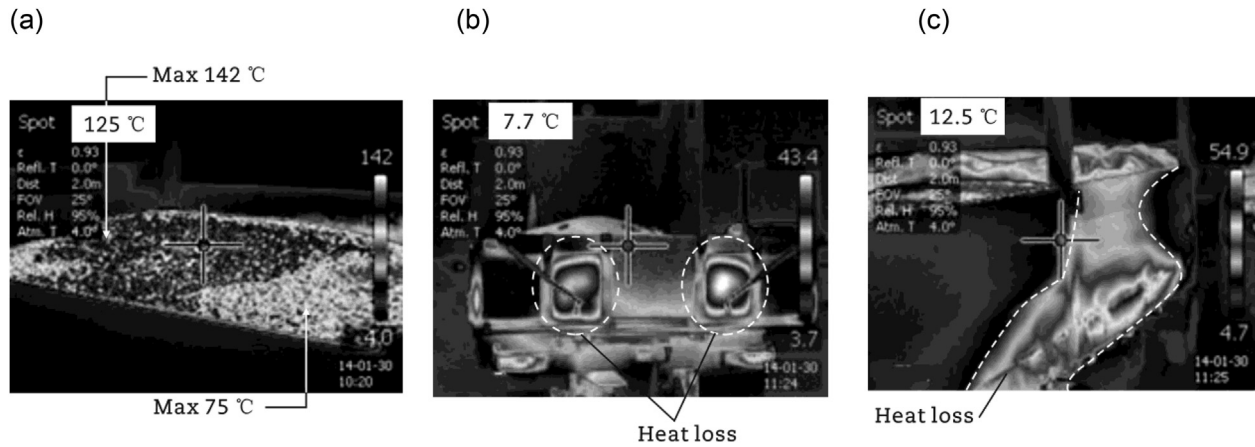
Contractor B was monitored during their patch repair activity on repair site 6, between the production facility and this. The transportation process of Contractor B is similar to that of Contractor A. A tail gate dump track type was used to transport the HMA. When the asphalt was loaded onto the track it was covered by an insulation sheet. The prevailing ambient temperature was approximately 4 °C. Three thermal images of the asphalt were taken immediately after loading the HMA onto the truck, these are all shown in Fig. 4.

The crew travelled approximately 2 h to reach the repair site. This caused a temperature drop of 42 °C compared to the initial maximum temperature of 142 °C.

Fig. 4 – Asphalt collection at the production plant for repair site 6. (a) Temperature variation of HMA after collection. (b) Heat loss from the back of the truck. (c) Heat loss alongside the vehicle.

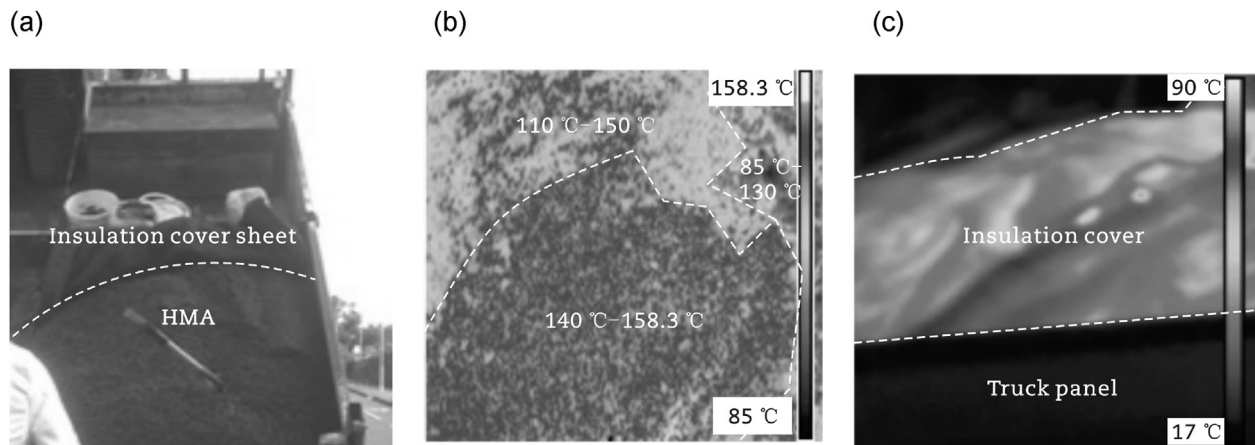
The maximum temperature of asphalt, when gathered from the production plant at day 1, was approximately 158.3 °C (Fig. 5(b)). Thermal segregation had started to develop as observed with Contractors A and B. Heat loss from the truck panels and insulation cover was also observed, shown in Fig. 5(c). At day 2, the maximum temperature measured on the mat of the HMA was 138.5 °C with cold spots also seen throughout the asphalt mat as per all the repairs previously discussed Fig. 6(b). Further, Table 3 and Fig. 7 demonstrate transportation time and temperatures of the mix upon arrival at repair sites.

Fig. 5 – Asphalt collection at the production plant during the first day of repairs for sites 7–8. (a) Transportation truck with HMA. (b) Asphalt mat temperatures after collection. (c) Insulation cover temperatures.

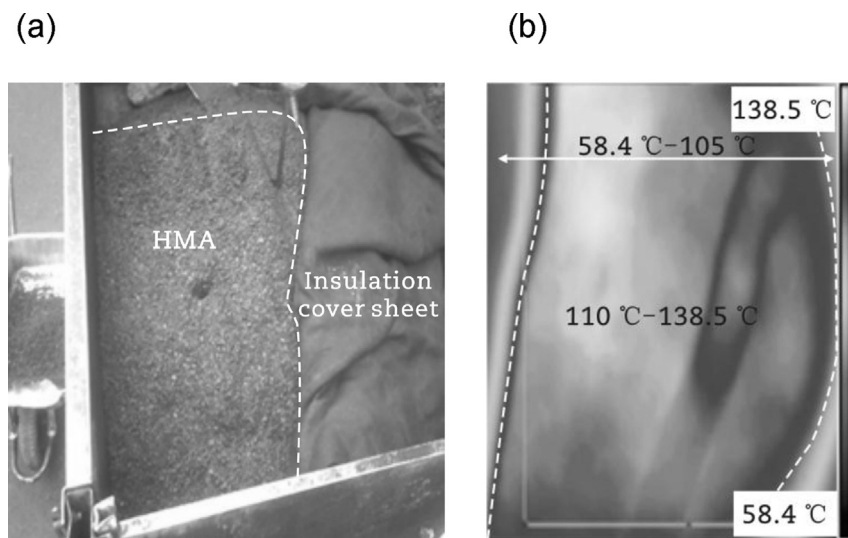
Fig. 6 – Asphalt collection at the production plant during the second day of repairs for sites 9–10. (a) Transportation truck with HMA and insulation cover. (b) Asphalt mat temperatures after collection.

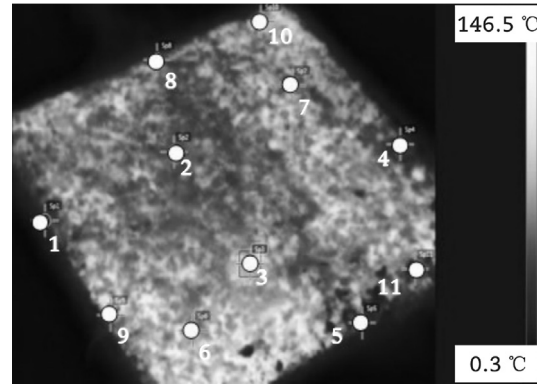
Fig. 8 – Temperature variation of patch repair on paving site 1 after compaction—thermal image 1.

For Contractor A, Figs. 8 and 9 were taken after compaction of the HMA at repair site 1. Fig. 8 presents eleven points taken randomly on the mat. The maximum temperature of the compacted hot fill mix surface was 146.5 °C. The point temperature measurements show cold spots throughout the whole surface of the repair (Fig. 8 and Table 4) that had reached and decreased below cessation temperature indicating the areas that are most likely to prematurely fail. These were also expected to have affected the effectiveness of the compaction.

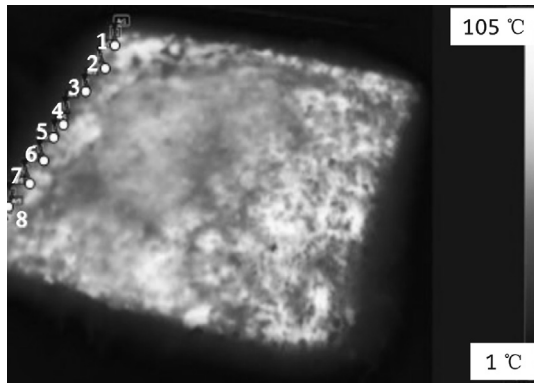
Fig. 9 shows temperature variations between the host pavement and the new hot-fill material. Eight points were chosen from the edge of the patch repair. All showed temperatures are below the cessation temperature (Table 5), indicating low strength interface bonding, prone to water ingress and premature failure under traffic loading.

Fig. 9 – Temperature variation of patch repair on paving site 1 after compaction—thermal image 2.

No.	Maximum (°C)	Minimum (°C)	Average (°C)
Point 1	43.2	27.8	35.5
Point 2	57.9	49.7	53.8
Point 3	51.1	48.7	49.9
Point 4	42.8	33.3	38.1
Point 5	53.5	44.9	49.2
Point 6	50.0	40.3	45.2
Point 7	48.4	39.9	44.2
Point 8	44.8	33.6	39.2

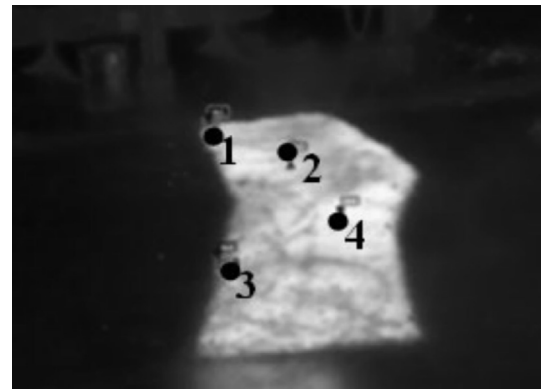
Fig. 10 represents temperature measurements at repair site 2. Four random points were selected to understand the variation in temperature. For each point, seven measurements were collected at different times. Points 1 and 3 were taken on the edges of the mat, and points 2 and 4 were in the middle area of the mat. The measurements

showed that different locations of the mat exhibit different repair quality. This means that the points with low temperature are expected to have been poorly compacted creating areas of future premature failure. The points located on the edges (points 1 and 3) had lower temperatures than those located in the middle of the mat (points 2 and 4). The temperature reduced, after 21 min reaching a temperature difference of 56.4 °C for point 1 from the first thermal image shot, 30.6 °C for point 2, 53.3 °C for point 3, and 32.9 °C for point 4 (Table 6). This means that the average percentage of temperature reduction on the edges was approximately 50% and it was approximately 29% in the middle. Consequently, the edges of the repair appear to have a temperature difference of approximately 28% from the middle of the mat, indicating low interface bonding between the host pavement and the hot-fill material which may lead to premature failure of the repair at its edges.

Fig. 10 – Thermal image of patch repair immediately after compaction on paving site 2.

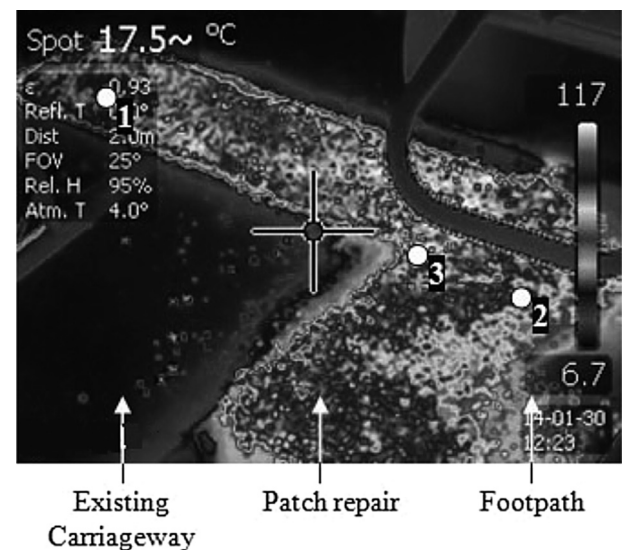
image gives an indication of the overall temperature variation of the mix immediately after compaction. Three points (Points 1, 2 and 3) were studied in more detail. Point 1 was situated away from the kerb line and drainage area. Point 2 was located near the kerb line and within the drainage area and, finally, Point 3 was located at the edge between the new and old reinstatement. Further, due to the position of the repair water was flowing through the patch constantly. Eight temperature recordings were collected for each point all these displayed in Table 7. All points had an initial temperature of approximately 100 °C. This is a 42 °C drop from the initial temperature of 142 °C when the HMA was loaded onto the truck.

The results indicate that, in a period of 5 min, the temperature for points 1, 2 and 3 dropped to approximately 33%, 65%, and 71%, respectively. The highest drop is for points 2 and 3 which are located at the edges of the repair. Similar results were observed for the repair examples of Contractor A,

Fig. 11 – Thermal image of patch repair immediately after compaction on repair site 6.

indicating a similar weak point of the executed repairs. Usually, the areas of the repair with a temperature less than the cessation temperature tend to have lower density and cause failure of the patch repair.

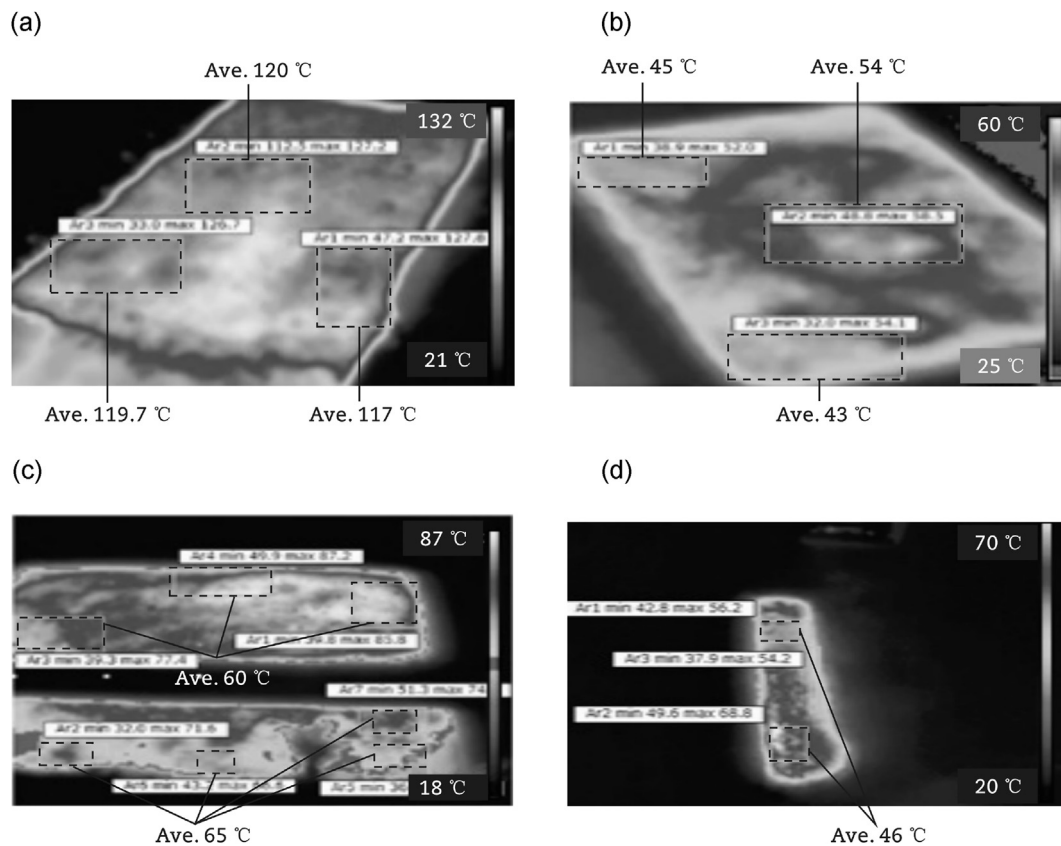
In contrast with the other two contractors, temperatures during these repairs were measured on areas and not on specific points. Fig. 12 demonstrates four thermal images for each repair site with temperature variations immediately after compaction. All four repairs had cold spots throughout

the repair area with the lowest temperatures being located at the interface between the host pavements and the new hot-fill material.

Fig. 12 – Thermal images of patch repairs immediately after compaction. (a) Repair site 7. (b) Repair site 8. (c) Repair site 9. (d) Repair site 10.

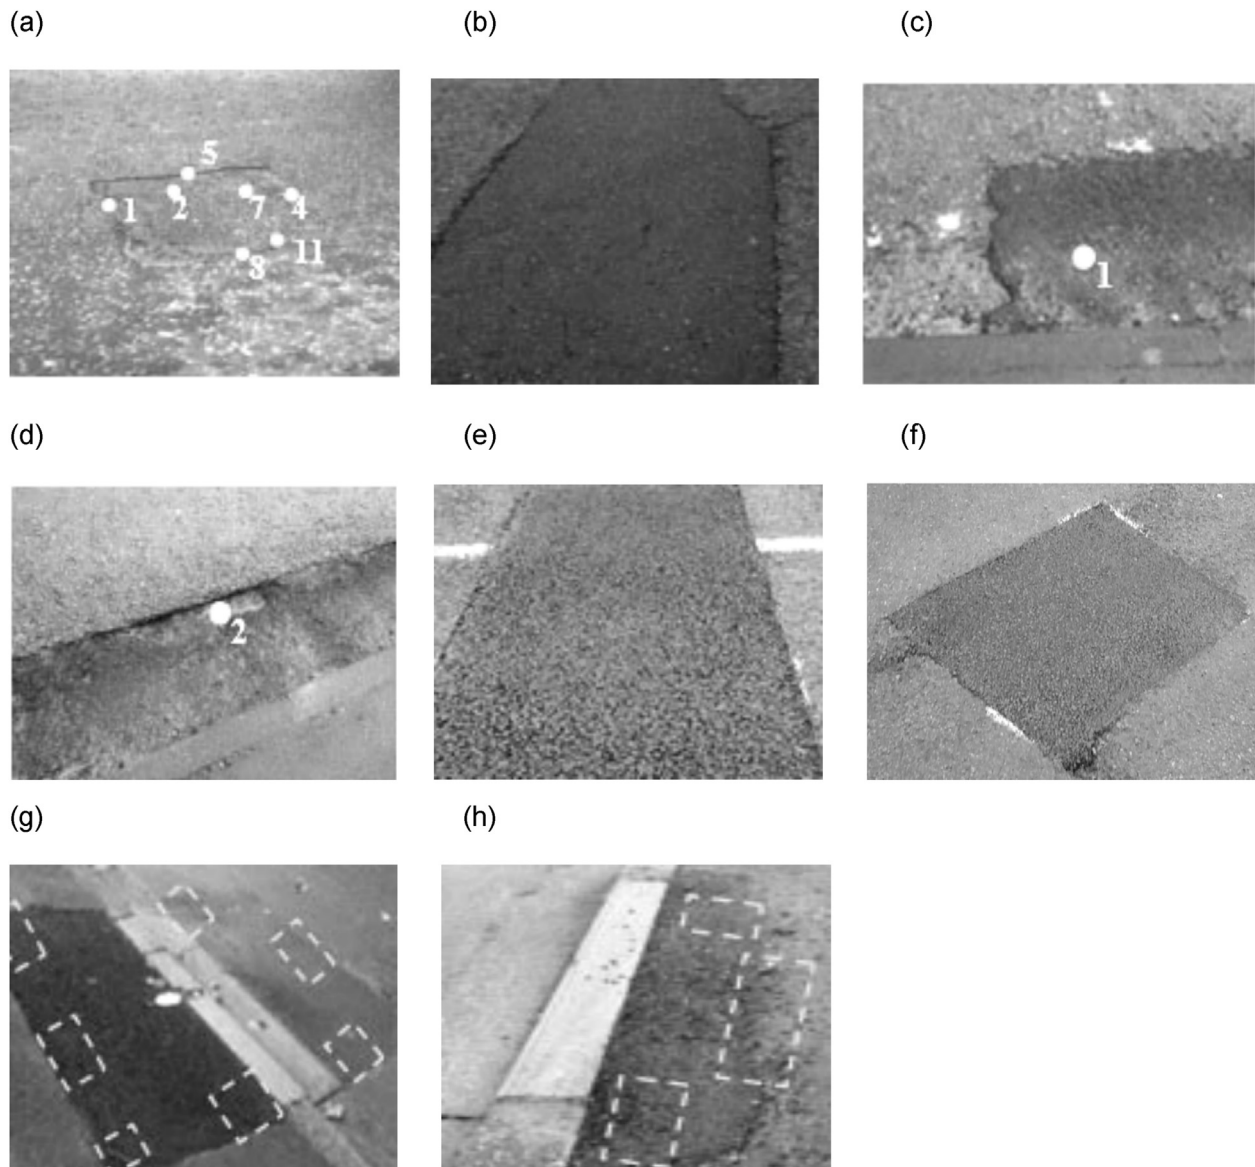
All the repaired sites were revisited three months after completion of the repair work. Fig. 13 presents the condition of most of the repairs. The main points of failure were observed along the edges of the reinstatement. Repair site 1 showed also evidence of settlement. Whereas, on repair

sites 6 and 7–10 the patch material had started to fall away. Images (a), (c), (d), (g), and (h) of Fig. 13 demonstrate examples of the points and places where excessive low temperatures were observed after the compaction of the hot-fill material.

Fig. 13 – Patch repair sites after three months of completion. (a) Repair site 1. (b) Repair site 2. (c) and (d) Repair site 6. (e) Repair site 7. (f) Repair site 8. (g) Repair site 9. (h) Repair site 10.

To offset the described effects, it would be necessary to plan a days repair work, taking into account the cooling characteristics of the transported repair asphalt relative to ambient temperature, distance and probably travelling time between sites, host pavement temperatures at each site relative to arrival time and anticipated repair time at each site. Without these considerations, there is a risk of repair temperatures below cessation temperature. It would be advantageous to heat the pothole excavation but this must be in a controlled manner.
