## STRUCTURAL RESTORATION AND RE-USE OF THE HISTORIC COAL MINE TOWER

**Abstract.** The coal mine is located in the town of Labin, Istria peninsula, Croatia. Restoration of the tower is a part of the project that includes thorough restoration and re-use of the Labin mining complex for cultural, tourist and educational purposes. The tower was built in 1938 by Italian authorities as part of the pre-war campaign. It is a 32.5 m high steel structure that once enveloped the elevator to a 200 m deep mine shaft. The structure is a built up Vierendeel truss with four columns / chords connected with horizontal moment resistant beams. Two large steel inclined struts were resisting elevator rope forces connected to the elevator machine building. The mine was shut down in 1988. The assessment of the tower consisted of geometry measurement, cross-section shape determination, steel quality determination, condition of members and connections (rivets and bolts), protective coating condition and underground supports condition. Two samples were taken to laboratory to determine the steel grade with tensile yield test. Structural model with existing members has also been analysed. Different loads were

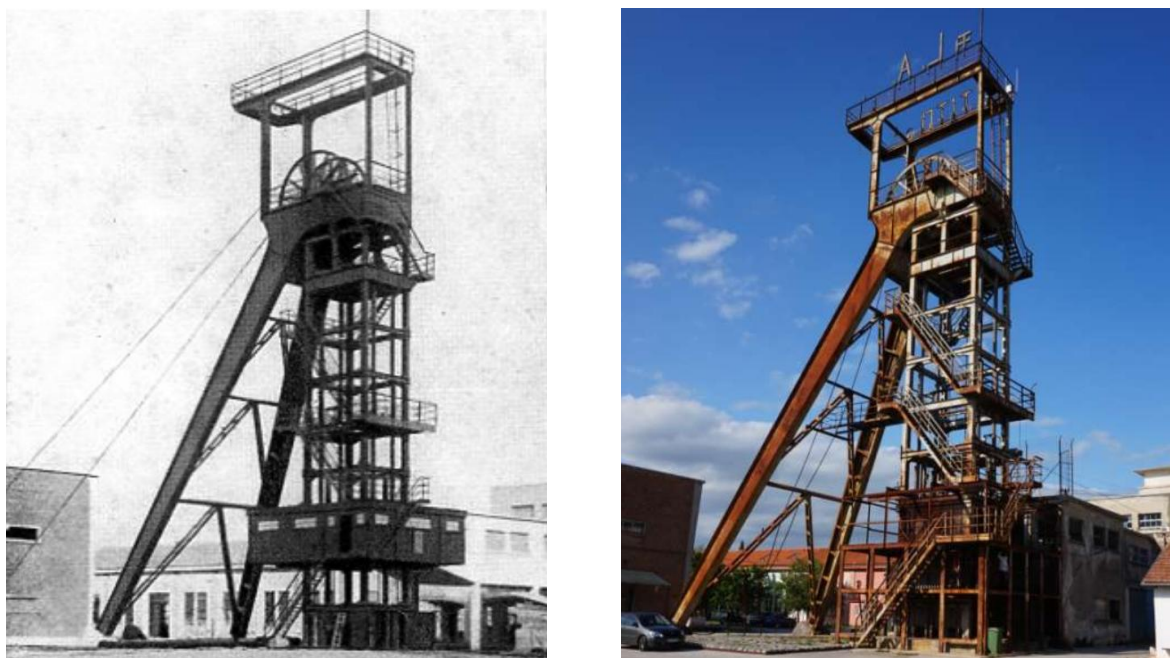
**Figure 2:** Mine tower and the connecting bridge, as originally built - photo taken in 1942. on the left, mine tower nearly 30 years after shutting down – photo taken in 2015. on the right

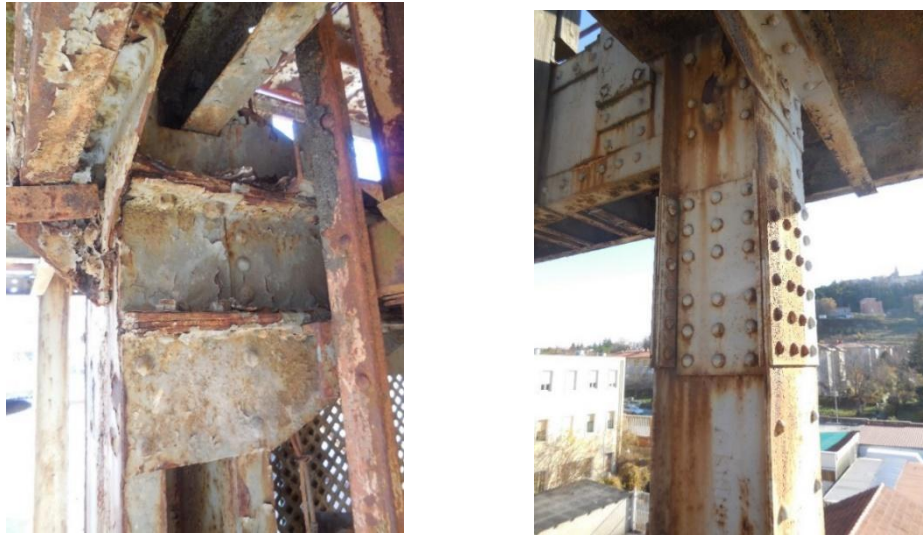
Thorough visual inspection of the tower structure was conducted. Comprehensive photographic documentation was produced for every tower level together with the series of evaluations determining coating conditions elaborated below. Thickness of the protective coating was measured with PCE- CT 28 instrument. Measurements were carried out on five bearing elements partially corroded and they have shown mean value of protective coating thickness of 107.8  $\mu\text{m}$ . The results were taken with reserve given that instrument measured thickness of the coating along with corrosion byproducts. Together with measuring coating thickness, cross hatch adhesion test was conducted with Elcometer 107 cross hatch cutter. Results showed that structure elements above level +11.70 m fall into class 2 and elements below into class 4 determined by ISO 2409 standard. Furthermore, evaluation of the degradation of the coating was made according to standards HRN EN ISO 4628-(2-6).

It was concluded that the underground support structure and the lower part of the structure were in extremely deteriorated condition. Therefore, these sections were selected for complete or partial replacement. Members of the upper part of the structure were selected for restoration of the protective coating and minimal repair actions.

**Figure 4:** Coating condition – lower part of the structure on the left; upper part of the structure on the right

Future corrosion protection, as well as existing anticorrosive coating condition was one of the main concerns at the time of the inspection. Due to the condition of the coating, especially in the lower part of the structure, sand blasting to Sa2<sup>1/2</sup> according to EN ISO 12 944 was proposed. Execution and supervision of the protective coating was done according to EN ISO 12944-1-8:1999. Atmospheric corrodibility category was determined as C5 very high (80-200 µm for a year of exposure). Anticorrosive protection coating was proposed as a combination of two component priming coat with high zinc share (80 µm NDFT), epoxy based intermediate coats (80 µm NDFT) and polyurethane topcoat (80 µm NDFT). Overall nominal dry film thickness was designed as 240 µm.

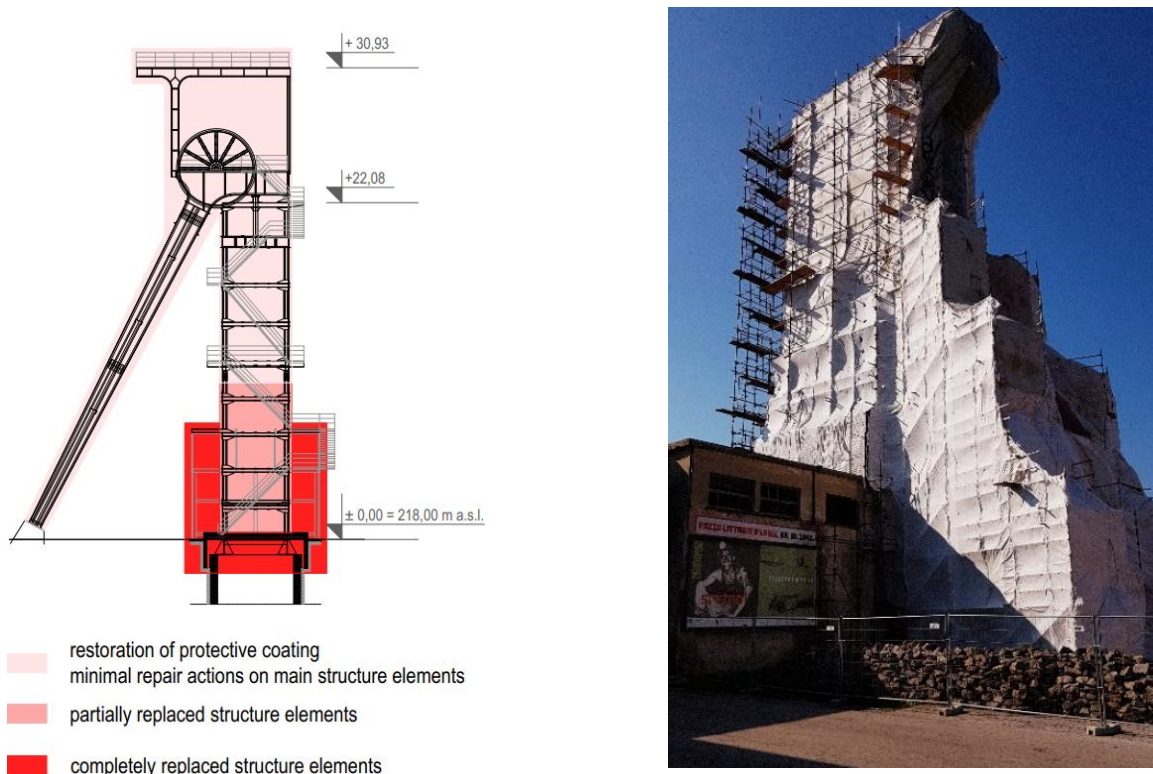
**Figure 5:** Structure defects and repair actions classification on the left; tower during sandblasting of the upper part of the structure on the right

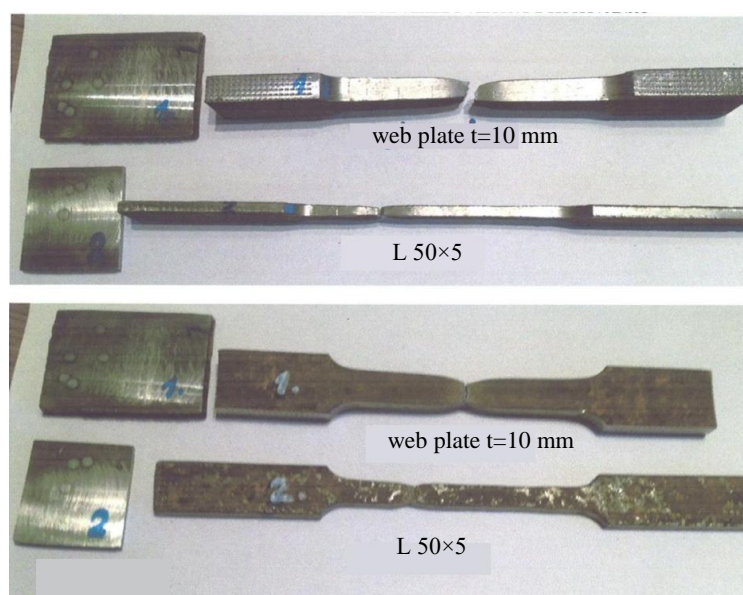
In addition to the on-field inspection, tensile test and chemical analysis in laboratory were conducted. The specimens were taken from the field into laboratory for analysis. Although specimens satisfy tensile test for hot rolled type of steel S235 in line with EN 10025:2002, toughness not being tested, chemical analysis has shown that the concentration of impurities is higher than allowed - concentration of P, S and Cu, respectively. Taking the results of chemical analysis into account together with age of structure, built in 1938., specimens fall into St33 type of steel according to DIN 17100, unkilld steel. The aforementioned type of steel matched S185 type of steel according to HRN EN 10025 with remark that lesser welding capability should be taken into account when choosing welding technology. Therefore, only bolted connections were used.

**Figure 6:** Specimens for chemical analysis on the left and tensile test specimens on the right

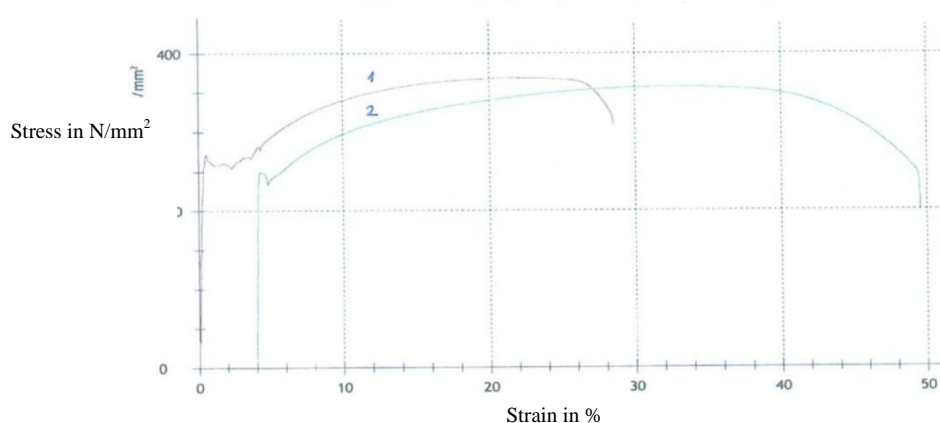
**Figure 7:** Stress- strain diagram for tested specimens

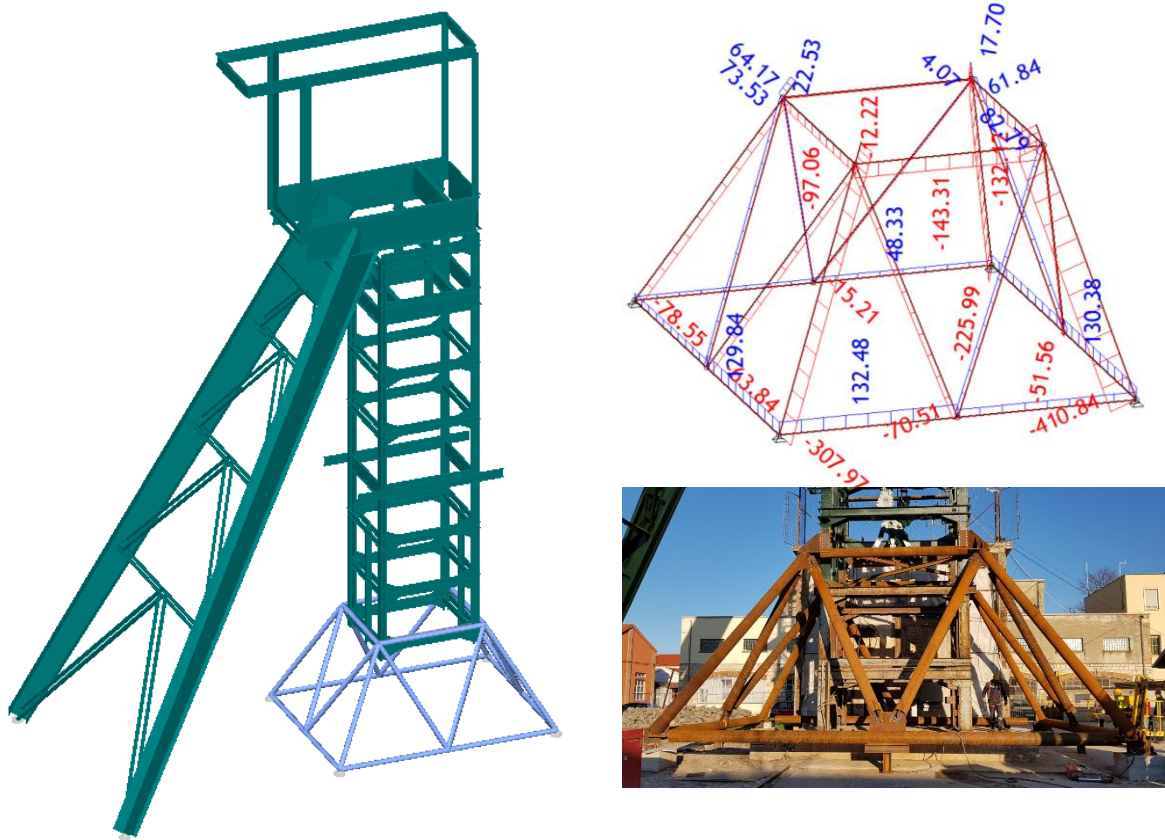
**Figure 8:** Temporary support structure model on the left; diagrams of longitudinal forces on temporary truss structure on the top right and the same structure constructed on the site on the bottom right

As part of the reconstruction, temporary support structure was designed. Neighbouring structure and existing roads around the site also determined the final outline of the temporary structure. Steel space truss in the form of truncated pyramid was chosen as the optimal structure for given purpose. Truss elements were bolted with circular hollow sections 273.1x10.0mm.

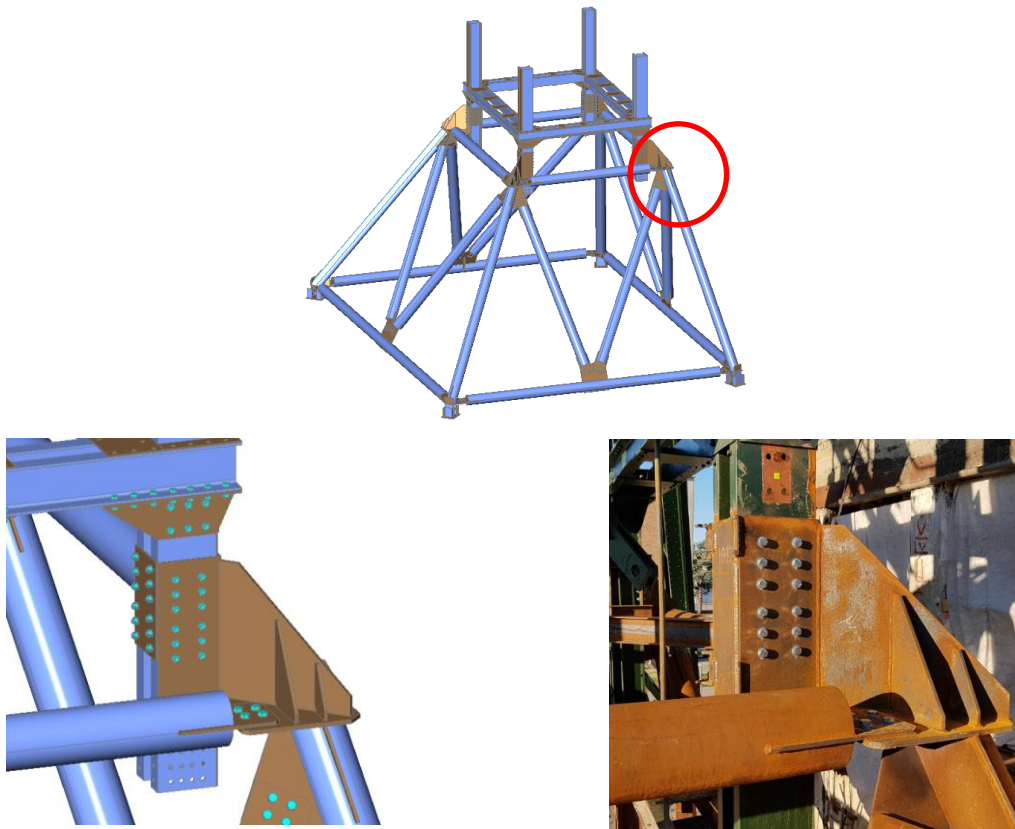
**Figure 9:** Isometric view of the temporary support structure model in Bentley Prosteel software in the top centre, model of the connection detail of the existing tower structure and temporary support structure on the left, and constructed on-site on the right

Transfer of the gravitational and horizontal loads from tower to temporary structure was enabled via bolted connection. Forces between two structures were transmitted through 24 M24 bolts and 20 mm thick plate with side stiffeners into the members of the temporary truss structure.

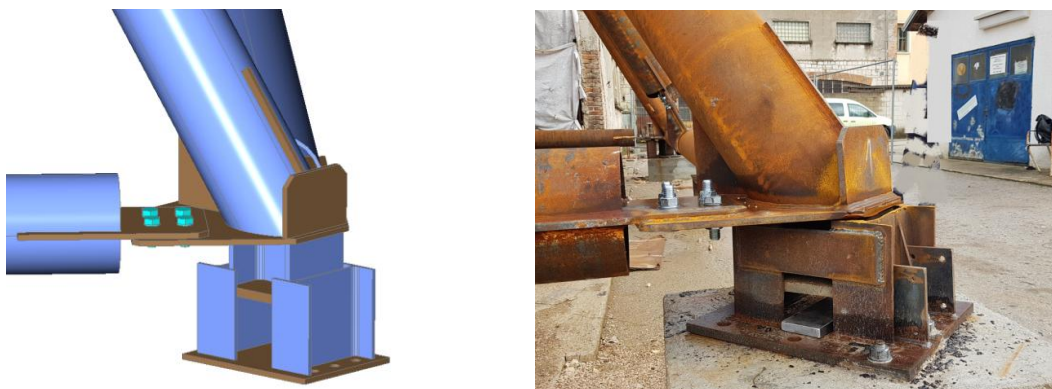
**Figure 10:** Software design of the steel bearing connection on the left and constructed on-site in the right

Hydraulic pump was installed in the steel bearing connection. Pumps enabled lifting, load releasing and lowering of the structure as well as its accurate positioning. In the course of the design of the temporary structure it was important to properly assign boundary conditions of the supports. Three out of four bearings were designed as movable in horizontal directions while fourth bearing was fixed so the forces in members of the truss could be correctly triggered.
