# RESTORATION OF THE QUEEN VICTORIA MARKET SHEDS E-F AND J-M, MELBOURNE, AUSTRALIA

JUSTIN C. HETTINGA<sup>1\*</sup>

**Abstract.** *This paper discusses the investigations, analysis, and proposed strengthening to Sheds E-F and J-M of the Queen Victoria Market in Melbourne, Australia. The sheds were visually inspected and measured, a point cloud survey was carried out, wind tunnel testing determined design pressures, and timber samples determined species, grade and extent of deterioration. Strengthening designs were in accordance with the Burra Charter – The Australia ICOMOS Charter for Places of Cultural Significance 2013.*

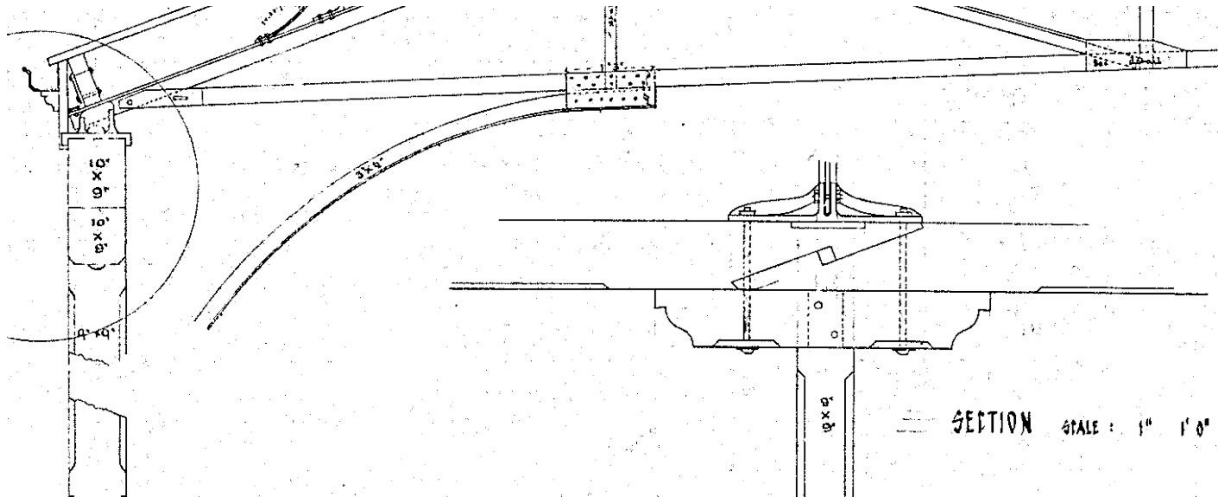
**Figure 6:** Shed E knee bracing and post to beam connection detail for Sheds E and F

In the north-south direction of Shed E, knee-bracing on every second truss provides lateral stability. Shed F has timber framed infill walls between tenancies and therefore does not have knee-bracing. In the east-west direction of both sheds, portal frame action was achieved from the bolts and haunch at the beam-column connection, shown in Figure 6.

The lateral capacity of the sheds in the east-west direction was found to be insufficient as the bending moments in the connections exceeded their design strength. To rectify this, a modification to the connection using steel angles and through bolts was designed, as shown in Figure 8.

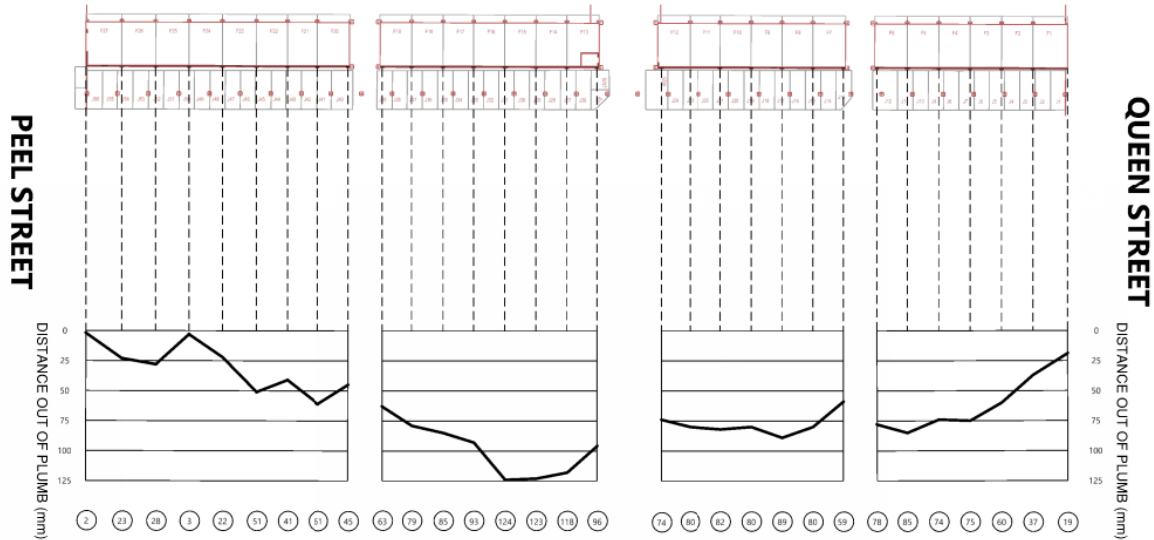
Figure 9: Survey results for the masonry wall at back of Shed F [6]

The masonry wall at the back of Shed F was visibly out of plumb and leaning towards the south, which was confirmed by the point cloud survey. Monthly surveys were undertaken over a six-month period, which determined that no further movement was occurring. Figure 9 shows the survey results for lateral displacement of the top of the wall.

Non-linear push-over analysis determined that the back wall of Shed F required strengthening to comply with NCC requirements in locations where it was out of plumb by more than 90mm. The concession from the building surveyor to reduce compliance to 80% for structural adequacy removed the need for strengthening to the wall. However, the design originally proposed is described below.

Buttresses on the south side of the masonry wall were designed so that the wall would bear on them in an earthquake. The buttresses would be on the exterior of Shed F to avoid interfering with the tenancies and have shallow pad footings extending partially above ground to avoid interfering with graves. The buttress to wall interface was detailed with rubber bearing pads such that the wall could lean against the buttresses without any physical attachment between them, making the proposed intervention entirely reversible.

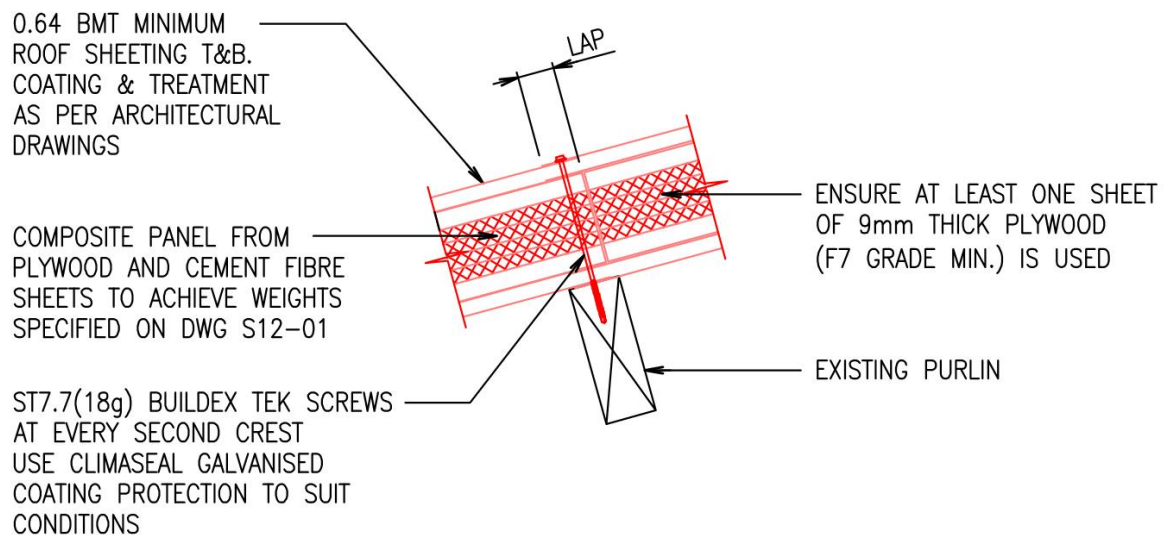
**Figure 10:** Replacement roof sheeting detail at purlins

The trusses were found to be structurally inadequate under the wind uplift design case, as the uplift pressures were enough to put the bottom chords of the trusses into compression. As the bottom chords were tension-only flat-plate members, they did not have any appreciable compression capacity.

The metal roof sheeting requires replacement as it has reached the end of its design life and was deemed to be unrepairable by the heritage consultant. By adding layers of plywood and fibre cement sheet between two layers of metal sheeting, the new panels add weight onto the trusses to prevent compression from occurring in the truss bottom chords in a wind uplift event.

Other than the roof sheeting, there were no other lateral stability elements in the plane of the roof. The replacement roof sheeting build-up was therefore designed as a diaphragm. In Australia, steel cladding systems are commonly made from thin high strength steel, and steel design codes do not currently provide guidelines for the design of crest-fixed steel roof or wall claddings. [7] As the steel roof sheeting is being custom-made for this project, it was designed and specified using *CAN/CSA-S136-01 North American Specification for the Design of Cold-Formed Steel Structural Members*. The crest-fixing of the composite roof decking panel to the purlins resulted in the screw being placed in bending, which was accounted for in the design. A detail of the roof build-up at the metal deck splice location is shown in Figure 10.

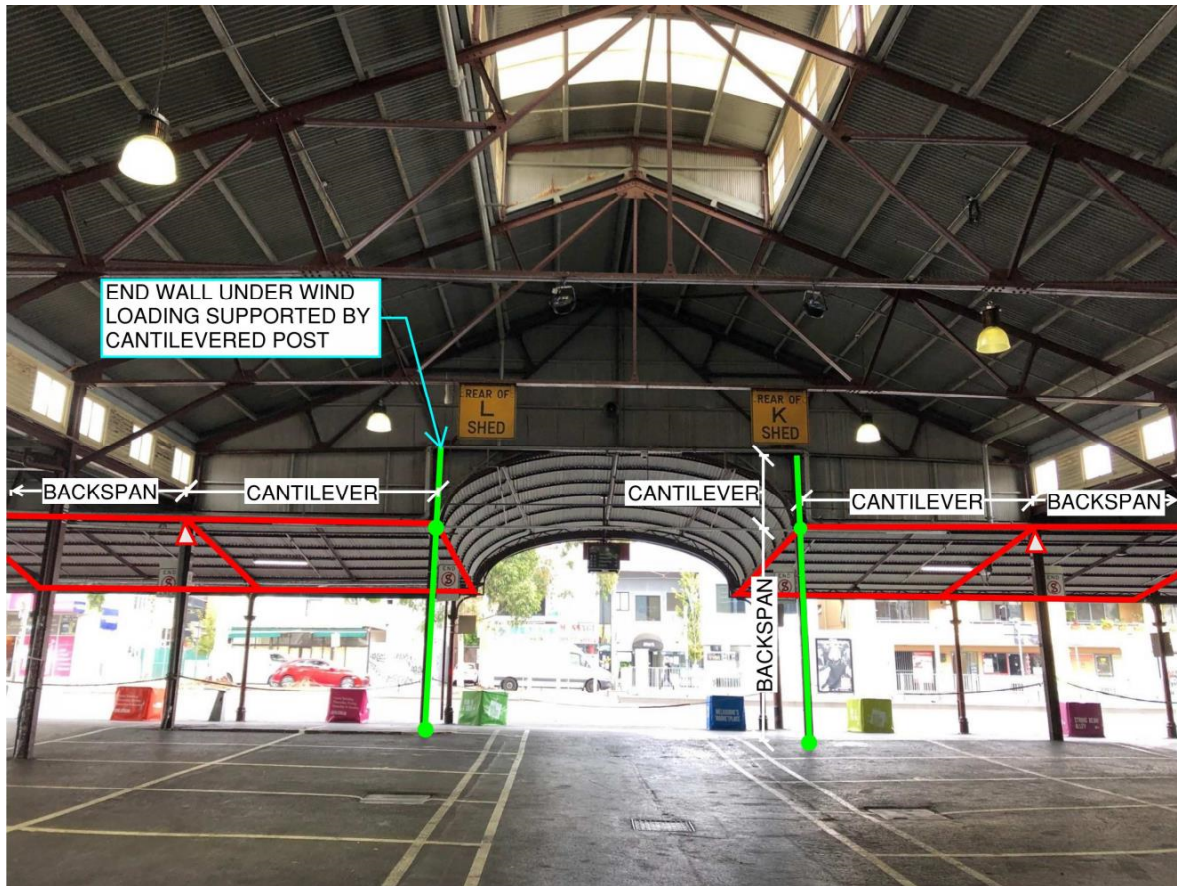
Figure 11: West end of Sheds K and L

Lightweight sheeting encloses the ends of Sheds K and L between the top of the end truss and canopy roof. To verify structural capacity of this partial end wall under wind load, including preventing out of plane buckling of the truss, the columns were checked as cantilevering off the canopy roof diaphragm as shown in Figure 11, and found to be sufficient.
