## INSPECTION, DIAGNOSIS AND MODELLING OF AZURARA CHURCH IN THE NORTH OF PORTUGAL

ESTEFANÍA A. CHAVES MORENO<sup>1\*</sup>, ELLEN T. KEY<sup>1</sup>, AMRUTA UPLEKAR<sup>1</sup>,  
OMAR PINO ACUÑA<sup>1</sup>, GRAÇA VASCONCELOS<sup>1</sup>, JAVIER ORTEGA<sup>1</sup>, ELISA  
POLETTI<sup>1</sup>

<sup>1</sup>University of Minho

**Abstract.** *Santa Maria de Azurara church is a XVI century church in Portugal, classified as a national monument since 1910. The building shows not only the influence of the Manueline architectural style (Portuguese late Gothic style), but also Baroque and Mannerism styles. Presently, the church presents some structural and non-structural problems, so an inspection and diagnosis of the main building pathologies was carried out. This process was assisted by non-destructive testing (NDT) techniques which included sonic tests, ground penetrating radar (GPR) and Schmidt hammer for masonry elements and Pilodyn and ultrasonic pulse velocity for the timber elements. In addition, scanning electron microscope and x-ray diffraction analysis were used for mortar and stone characterization. Furthermore, dynamic identification tests were performed. Numerical analysis

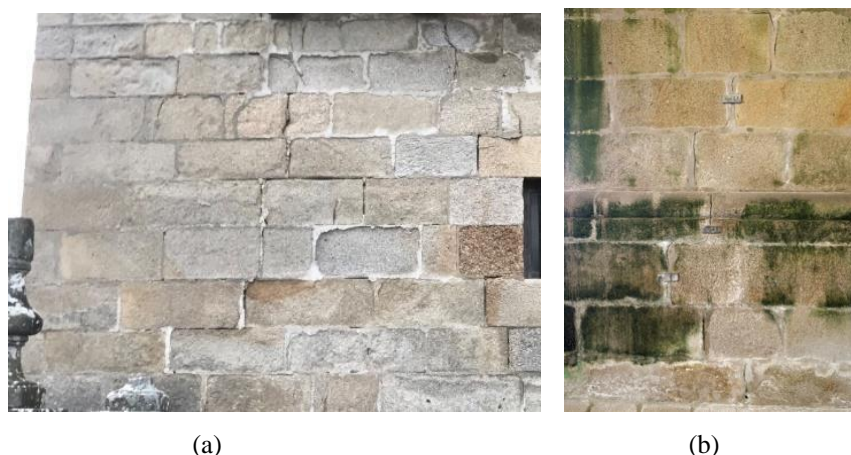
The most prevalent appearance of cracks is on the bell tower. Major cracks can be seen on the exterior part of its western facade, under the balcony projection. Also, a major crack is noted on the internal facade which was measured and marked previously in the year 1985 (Figure 2). The crack meter placed there has detected movement since that date.

**Figure 2:** Cracks under the balcony of the tower in (a) external west facade and (b) internal east facade.

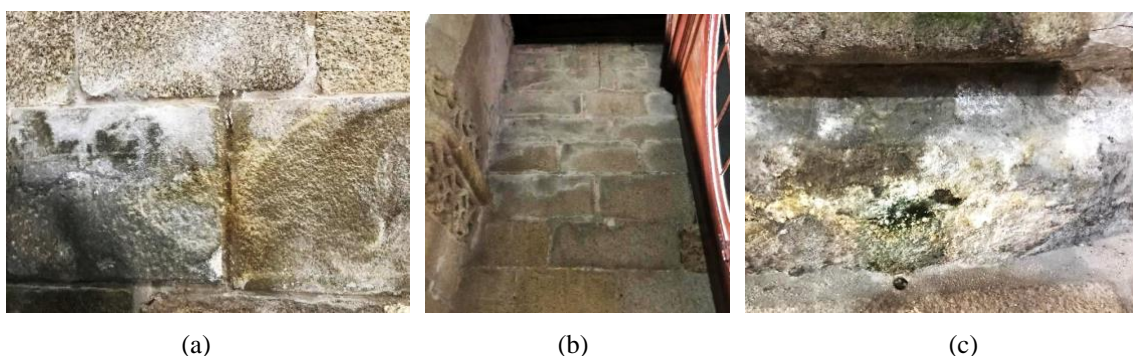
Staining and soiling were present on the exterior walls. Moist areas could be seen in the interior. Efflorescence was densely observed on the lower areas of the internal surface of the walls (Figure 3(a)). It was also observed in areas close to the roof and all the column bases (Figure 3(b),(c)). Clearly, the existing drainage system is not sufficient. The problems in the rainwater system in the roof are the cause of this pathology in the upper part of the walls.

**Figure 3:** Efflorescence damage observed in (a) internal wall, (b) areas close to the roof and (c) column bases

The overall state of conservation of the church is good. No major structural deficiencies were observed. Recommendations include repointing in areas of lost mortar, cleaning of efflorescence and staining, replacing rotted wood, applying a chemical anti-termite barrier in walls and altars, improving ventilation, installing a stormwater drainage system, and performing continued monitoring and maintenance.

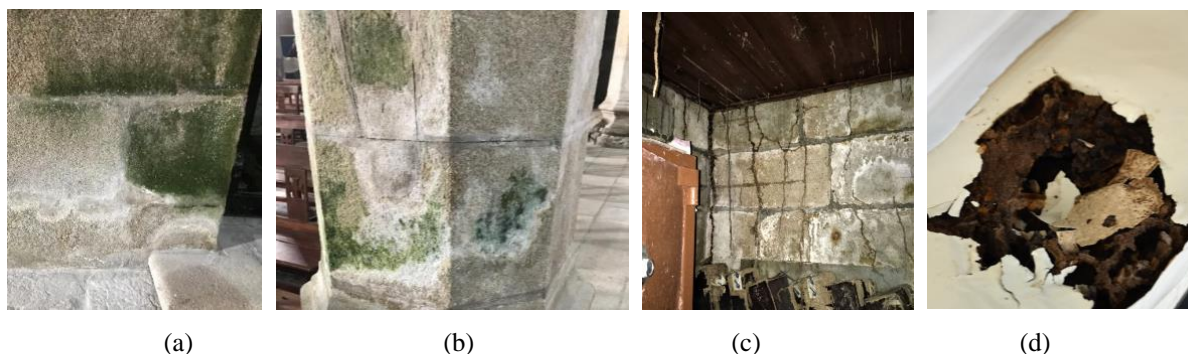
Plants and lichen were observed on the external facades due to inaccessibility, lack of cleanliness and maintenance. Widespread growth of algae can be seen in the interior walls and columns (Figure 4(a),(b)). Algae generally constitute superficial films. However, in the church interior they seem to be growing within the stone rather than on the surface.

The timber altars and roof are heavily infested with termites, wood boring beetles and rot (Figure 4(c),(d)). Termites have infiltrated all of the altars; the small room behind the main altar is the most infested. Trails can be found throughout the building, including in masonry. Holes created by wood boring beetles can mostly be seen on decorative parts of the altars.

**Figure 4:** Algae observed on (a) interior walls and (b) column base; (c) termite infestation behind altar; (d) rot in altar

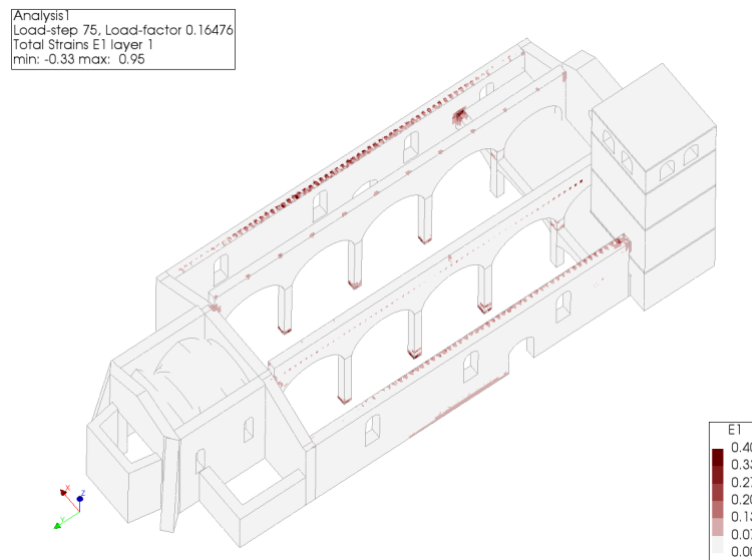
The strain graphs for the pushover in X shows concentrations in the base of the columns and in the connection of the arch of the choir with the lateral wall, see Figure 9. To a lesser extent, strain also appears in the base of the longitudinal walls.

**Figure 9:** Maximum principal strains E1, x-direction

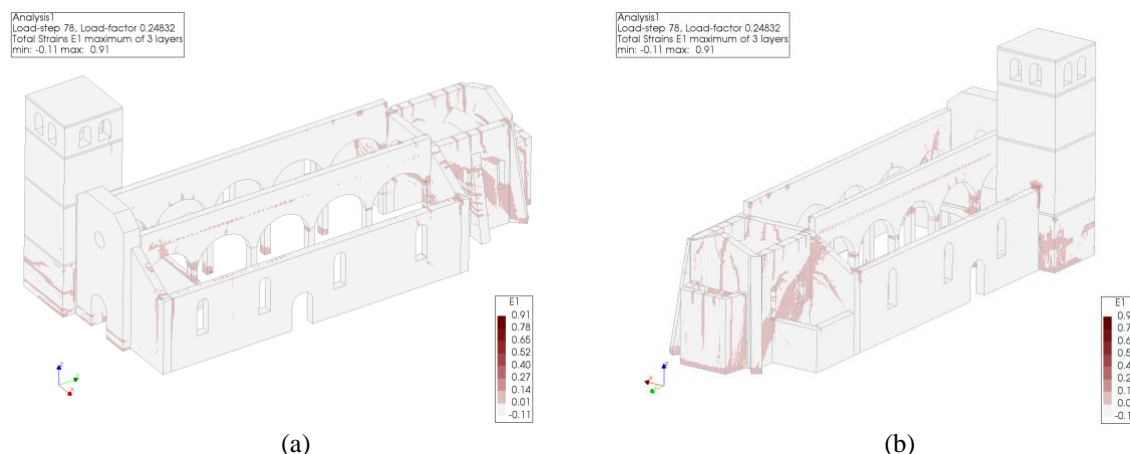
A different pattern is obtained from the pushover analysis in the y-direction. In this case the strain concentration is located at the base of the tower and the main façade in the shape of horizontal lines (Figure 10(a)), as well as in the connection of the tower with the church walls and in the body of the altar, where the strain pattern is diagonal in the lateral walls and vertical in the wall perpendicular to the force (Figure 10(b)). This diagonal concentration indicates shear failure may happen in the chancel under high loading in the y-direction. Maximum strain values are located in the connection of the arches of the choir with the longitudinal walls.

**Figure 10:** Maximum principal strains E1, y-direction (a) front view; (b) rear view
