# TYPOLOGICAL CLASSIFICATION AND OBSERVED DAMAGE PATTERNS OF MASONRY CHURCHES AFTER THE 2016 CENTRAL ITALY EARTHQUAKE

G. CIANCHINO<sup>1</sup>, G. DE MATTEIS<sup>2</sup> AND G. BRANDO<sup>1\*</sup>

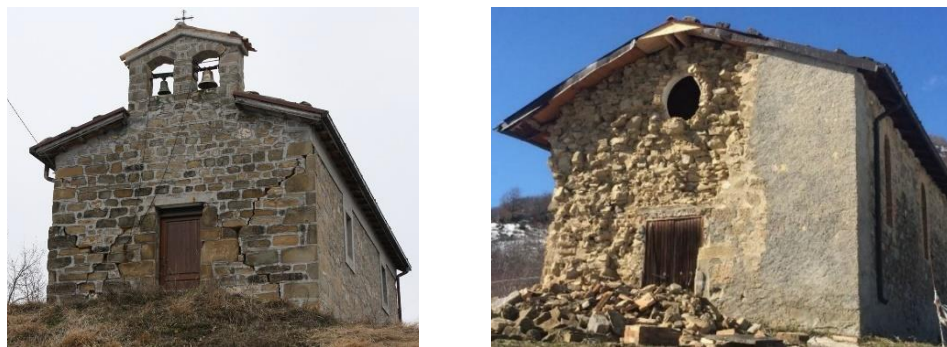
With reference to failure mechanisms of the facade macro-element [11], the 26% of the churches presented damage  $D_0$ , the 17% damage  $D_1$ , the 28% damage  $D_2$ , the 14% damage  $D_3$ , the 7% damage  $D_4$  and the remaining 3% damage  $D_5$ . An example of this type of mechanism was found in the Church of Santa Giusta in Cortino (TE), which has very serious cracks in the facade plan to which damage  $D_4$  has been attributed (Figure 8a).

Many of the out-of-plane mechanisms occurred in the presence of poor masonry. This is the case of the church of San Michele in Valle Castellana (TE), which showed a collapse of a portion of the facade. The poor wall quality and the absence of transverse connections contributed to the delamination of the external material (Figure 8b).

**Figure 8:** a) Santa Giusta church in Cortino (TE); b) San Michele church in Valle Castellana (TE)

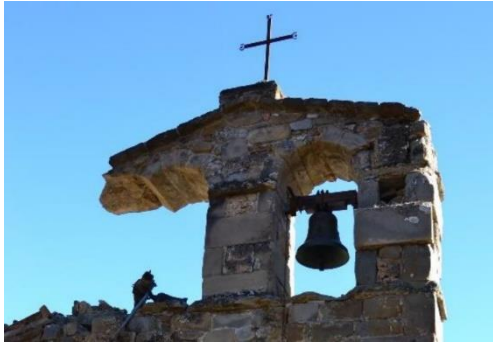
It is important to note that more than half of the bell towers or gables resulted seriously damaged. These are slender elements, which often do not present any type of anti-seismic devices. Therefore important damages and, in some cases, collapses have been observed. An example is the bell gable of the church of San Paolo in Cortino (TE), where a partial collapse

was found (Figure 9).

**Figure 9:** The damaged bell gable of San Paolo a Cortino (TE)
