FATIGUE ASSESSMENT OF OLD RIVETED RAILWAY BRIDGES: LABORATORY TESTING OF A REAL BRIDGE

JOSÉ M. ADAM*, PEDRO A. CALDERÓN¹, MANUEL BUITRAGO¹, ELISA
BERTOLESI¹, JUAN J. MORAGUES¹, SALVADOR IVORRA², BENJAMÍN
TORRES²

Abstract. *The bridge over the Quisi Ravine in Alicante Province (Spain), built between 1913 and 1915, consists of six 22-22-42-42-22-22 m long steel Pratt truss spans, the lateral spans being isostatic and the central spans continuous. All the joints between the steel elements are riveted. As the bridge has been carrying railway traffic for more than 100 years, its condition needed to be assessed before carrying out the necessary repairs-reinforcement to extend its service life. One of the most interesting tasks on the bridge involved a study of its fatigue behaviour to estimate its remaining useful life. Only a few kilometres away there happened to be another bridge with identical geometry over the Ferrandet Ravine, which had recently been dismantled and taken out of service and had carried the same railway traffic as the one over the Quisi Ravine. Advantage was therefore taken of this unique opportunity to test one of its isostatic spans in order to extrapolate the res

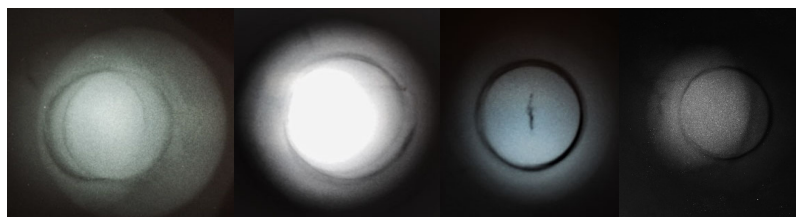
Specimens extracted from different profiles and plates were analysed. Parameters such as yield stress, ultimate stress, elongation, absorbed energy or the chemical composition were determined. A total of 160 gamma ray scans were carried out on different elements, following EN ISO 5579. Although in general the joints were found to be in good condition, a number of small cracks were found in different components. Figure 3 shows some examples of flaws in scanned rivets.

Figure 3. Gamma scans of rivets.

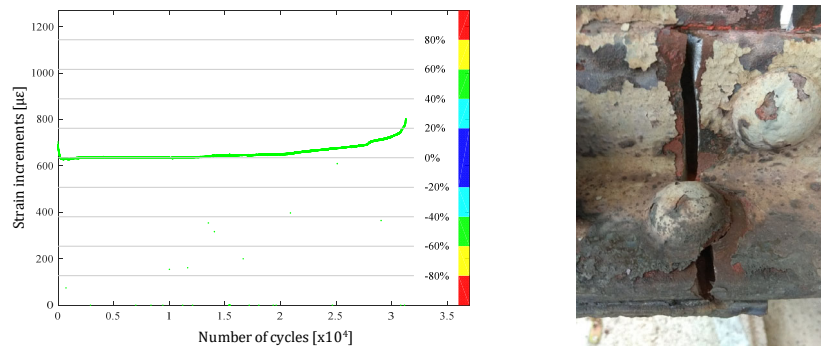
Figure 9 gives an example of the readings from a strain gauge in a short period of time and Figure 10 shows the evolution of the deformation increment measured in each cycle from the start until failure (cycle 31377). The element failed at normal stresses in cycle 31377. Figure 10 shows the fatigue crack that started at the bottom of the element (zone in tension) and propagated to the top of the beam element.

Figure 10. Strain increment evolution of SG_2 (left) and fatigue crack at the end of the test (right).

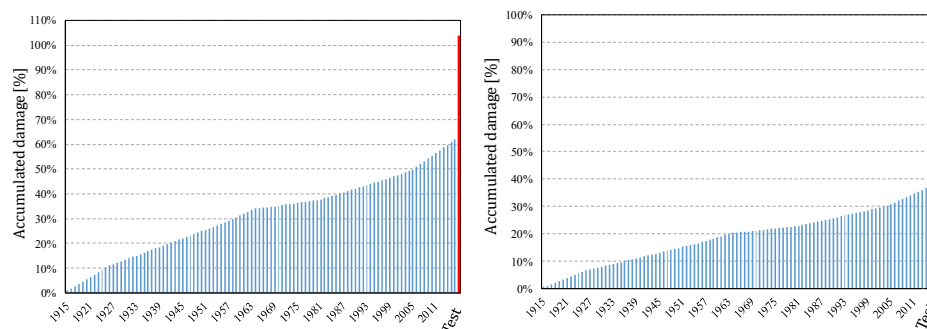
Adopting the damage accumulation method laid down in different codes, (e.g. EC-3 Part 1-9 [5] or EAE [6]), the detail category to which the failed element belonged could be obtained by considering 100% total accumulated damage at the end of the test as follows:

- Fully loaded trains: detail category 71.
- Empty trains: detail category 63.

Figure 11 gives a summary of these calculations. It can be seen that the accumulated damage was 100% in both cases.

Figure 11. Hypothesis of fully loaded trains (left) and empty trains (right).

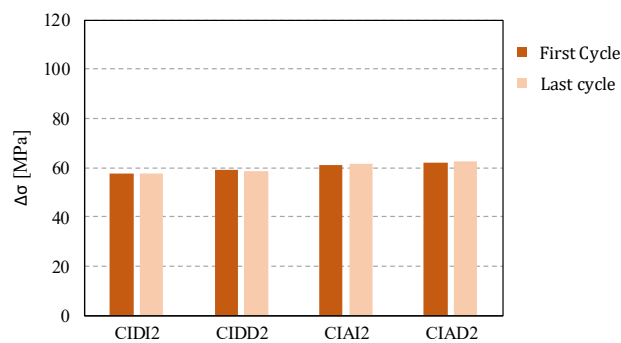
Figure 17 shows an example of the strain increments in four strain gauges in the last cycle of the test. It can be seen that the structural behaviour at the beginning and end is almost identical.

Figure 17. Example of stress increment measurements in 4 strain gauges in the first and last cycle.

The tests revealed clearly elastic linear behaviour with no apparent damage, based on:

- Stresses clearly lower than the yield stress in the different elements.
- Similar deformation and stress patterns were found in the first and last cycle. Variations were less than 5% in all cases and below 2.5% in 85% of cases.
- Similar deflections and horizontal displacements were found during the entire test and all were below 3%.

The dynamic test gave a variation of 8.40Hz at the start and 8.05Hz in the first mode of vibration in the structure at the end of the cycle, which implies a frequency reduction of 4.2% and shows a slight increase in the bridge flexibility. Together with the variations obtained by the deformation and displacement sensors, this value shows the minimum variation in the general bridge behaviour after the intense fatigue test it had been subjected to. There were no signs of failure or weakness in any of the elements.

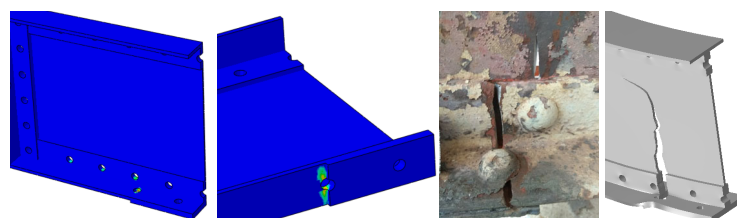
Computational simulations and analytical studies were used to evaluate and reinforce the conclusions reached up to this point. The analytical studies were by means of fracture mechanics and confirmed that the fracture of the elements in the local load sharing system would occur at the same or even slightly higher number of cycles than in the experimental tests and those calculated by applying the expressions in EC-3[5]. This confirmed that the bridge would have a remaining service life of 10.7 years, the same as that calculated from the experimental tests.

Similar results were also obtained from the computational models. For example, the numerical prediction found that cracks would begin to appear after 7530 cycles (experimentally, between 10,000 and 15,000) with similar propagation patterns to those obtained experimentally (see Figure 18).

Figure 18. Computational models for triggering cracks (left) and predicting the cracking pattern (right).

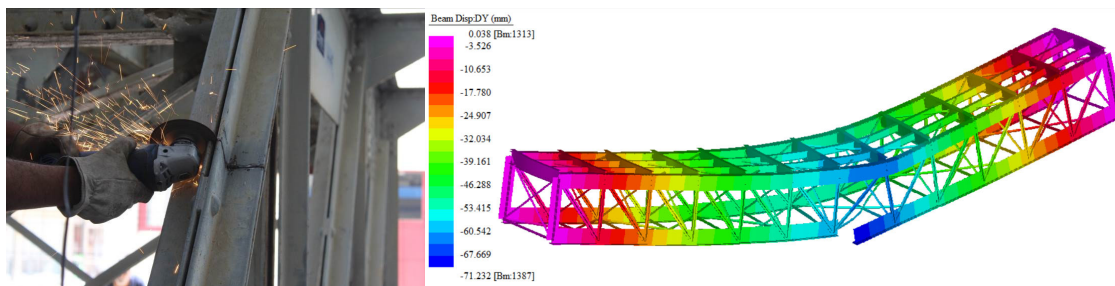
The study was in two parts: experimental and numerical (see Figure 19). In the first, two of the most critical diagonals were cut at different damage levels, while the second simulated the failure of a critical element under tensile loads. Both methods were aimed at studying the alternative load paths and robustness of the structure.

Figure 19. Experimental (left) and numerical (right) study of the influence of different levels of damage on the behaviour of the structure.

The results showed that the structure, normally considered as an isostatic structure working solely under axial stresses, had a certain redundancy and was able to withstand this type of failure, activating for this purpose some of the alternative load paths with high bending stresses at the joints.

- Real time monitoring, considering the crucial elements that could trigger a failure of the structure and develop a fatigue crack.
- Periodical inspections.
- Limitation to a lighter type of train than others.
- Limited number of trains per day.
