STANDARD GRAVITY AND WIND LOAD ANALYSIS ON 103 YEARS OLD UNREINFORCED MASONRY BUILDING

Finite element modelling and analysis has been performed on 103-years old unreinforced masonry Senate hall building (SHB), Allahabad University, India. It is an Indo-Saracenic style of architecture which was built in 1915. An in-situ survey is conducted to know the present condition of the SHB. The major and minor cracks are visible, and construction material has deteriorated at various part of the SHB. The old documents, reports, on-site measurement, and photographs are used to gather the historical data and prepared the accurate model of the SHB on Ansys workbench (ANSYS 14.0) tool. Macro and homogenisation approach has used in the modelling of the SHB. The standard gravity and wind load analysis is performed with a fixed boundary condition on its based of SHB. In gravity analysis, maximum stress (5.69MPa) has been observed at the connections of the ground floor and maximum deformation (7.8mm) on the crown of the arch of the first-floor. The maximum stress and deformation 14.286MPa and 12.491mm have been observed under live load analysis. Further, the maximum stress and deformation obtained un

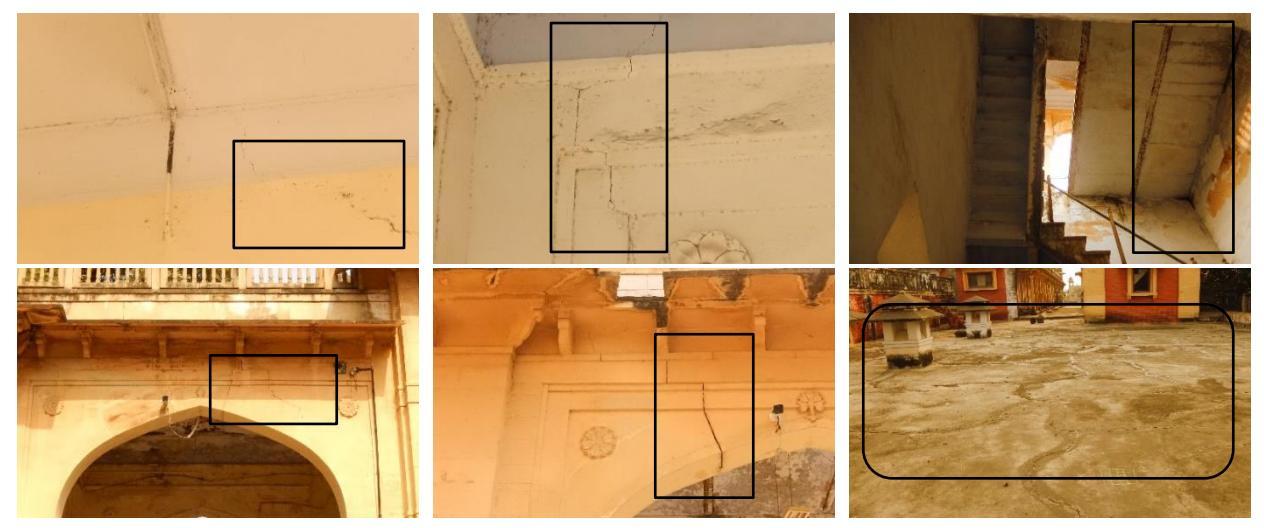
Figure 3: Major cracks (5mm-15mm) visible in the building

Fig.3 shows the deteriorated portion of the structural element in the rectangular black box. Most of the damages and failures are visible in the towers and boundary wall. The decorating element of the building is a failure in north, south and east entrance porches. The entrance of MH and EH of the building is visible major cracks on the ground floor, and first-floor level are closed from brick walls on both side entrance of the portions. Internal side plaster is deteriorated on the stairs and domes due to the effect of seepage, moisture, atmospheric variations. The Central hall bricks wall on the second floor is also deteriorated, and there is a major crack in the octagonal stone columns.

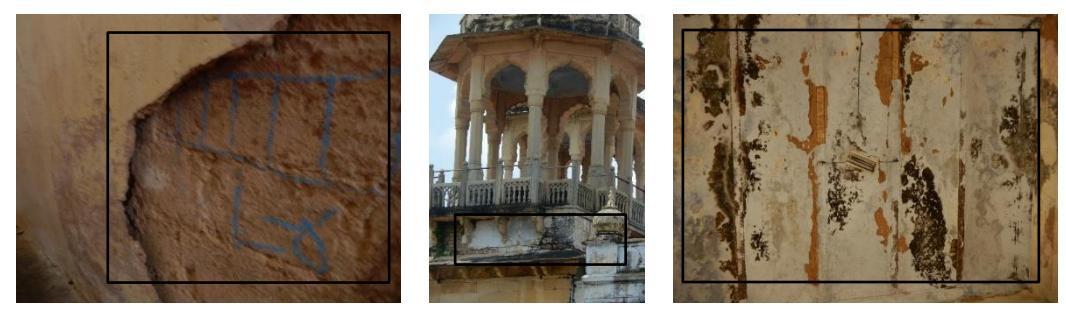
Figure 4: Material deteriorated on different structural components of the SHB

The major cracks are visible in the stone arches and columns of the SHB (Fig. 4). The administration restricts the access of the second-floor portion of the SHB due to damages roof. The meeting hall roof is covered with approximate 2.5mm thick tar-coal coating layer. The front and back verandah of the second-floor level is covered with approximately 2.5-inch thick concrete plaster, but this concrete plaster is not compatible with the old material and it is spalling out. The small plants are visible between the joints of the walls and roofs of the second-floor level.

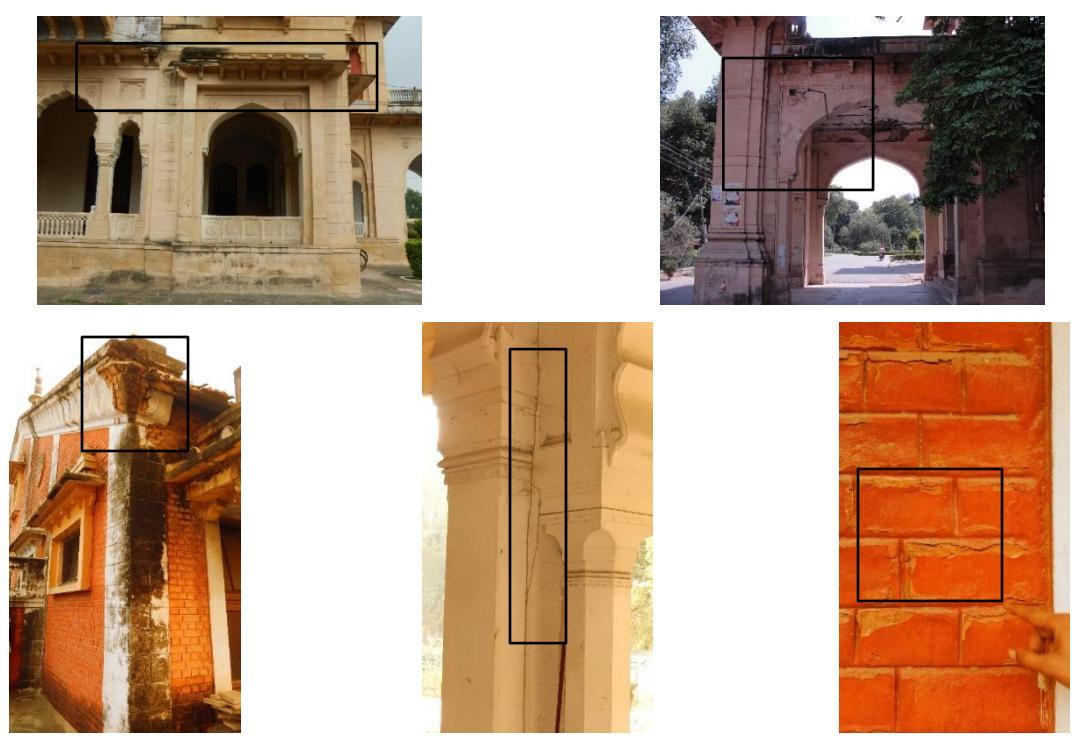
Figure 5: Material deterioration of the SHB

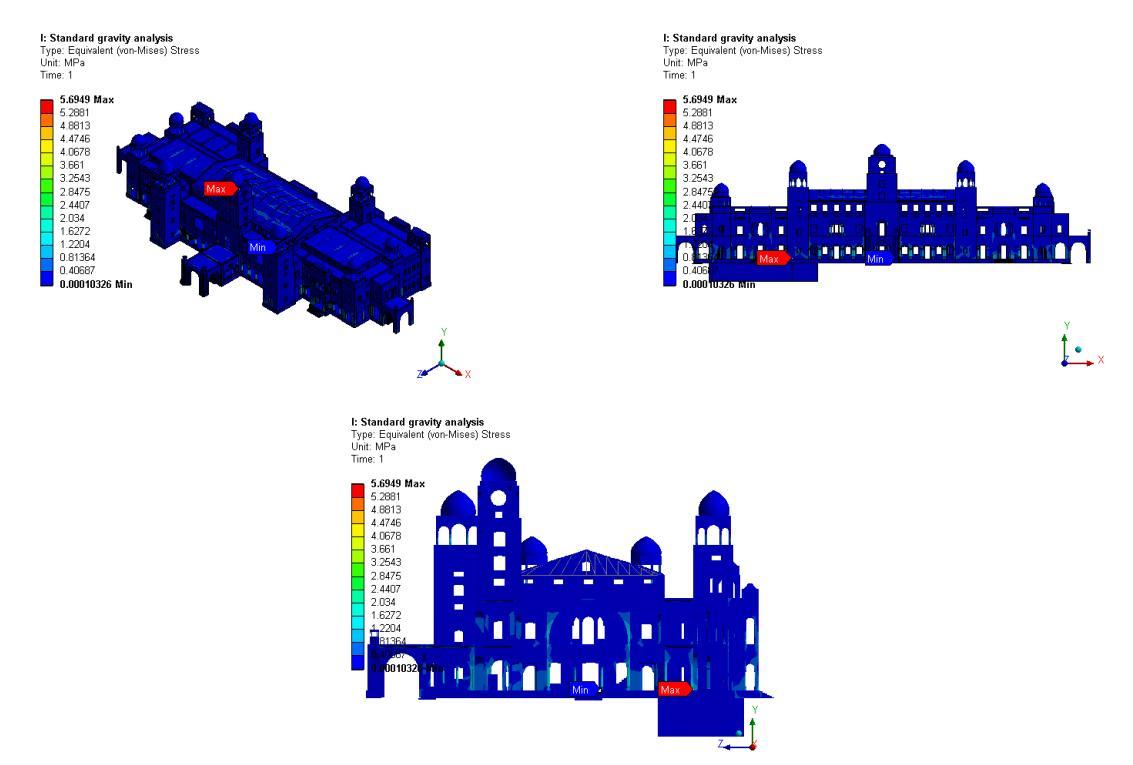
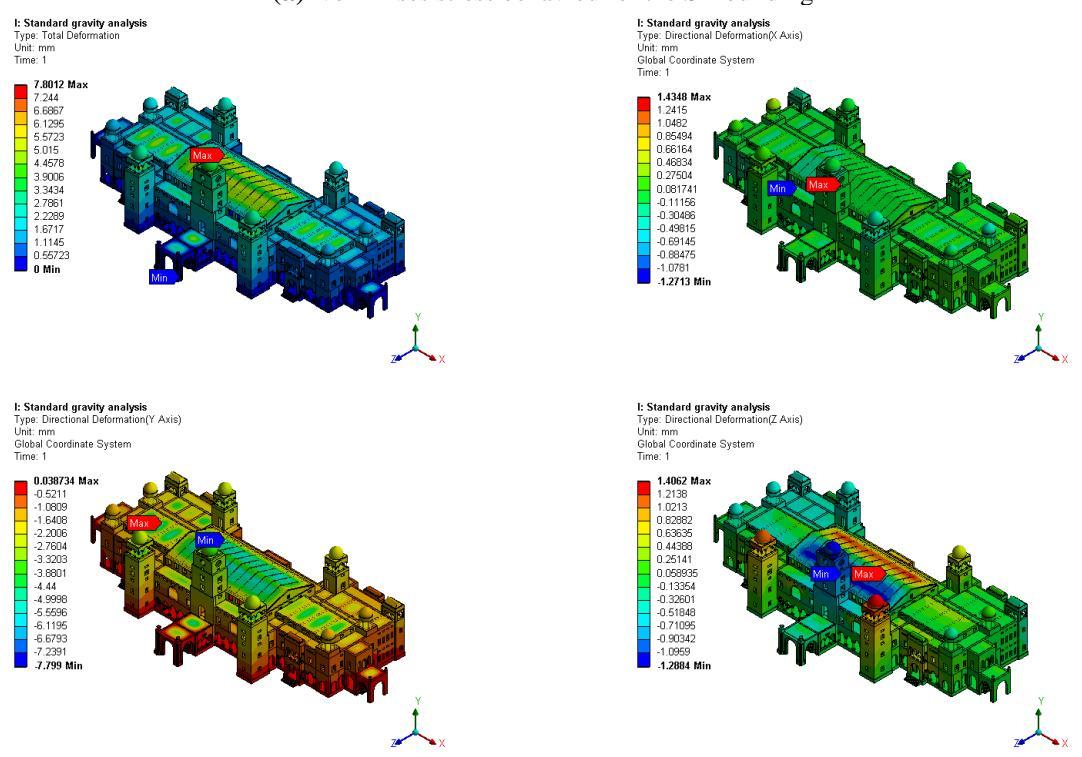
Fig. 7 shows the stress and deformation response to gravity load analysis. The maximum stress of 5.69MPa is observed on the connection between the back verandah wall and the ground floor of the stair tower. The stress is negligible on the ground floor masonry walls, and this may be due to its thickness that provides a large area to transfer the building load. The brick masonry walls of the central hall and side halls on the ground floor perform better than the stone masonry walls. The observed stress on the internal portion of stone arches, columns and facades of the meeting and examination hall are in the range of 1.62MPa to 2.03MPa and it is shown in Fig. 7a. The major stress has affected the connection between wall to wall, wall to the roof, roof to the tower of the building from the ground floor to the second floor. The maximum deformation of 7.80mm is observed at the second-floor of south facade wall of the central hall. The directional deformation of the building is observed approximately similar to 1.4mm, but vertical directional deformation of 0.03mm is observed at first-floor wall of the meeting hall. The overall deformation response of the SHB is shown in Fig. 7b. The deformation of the clock tower and side stair tower is observed in the range of 3.9mm to 4.45mm from the third floor to sixth-floor level.

(b) Deformation behaviour of the SH building Figure 7: von Mises stress and deformation behaviour during gravity analysis

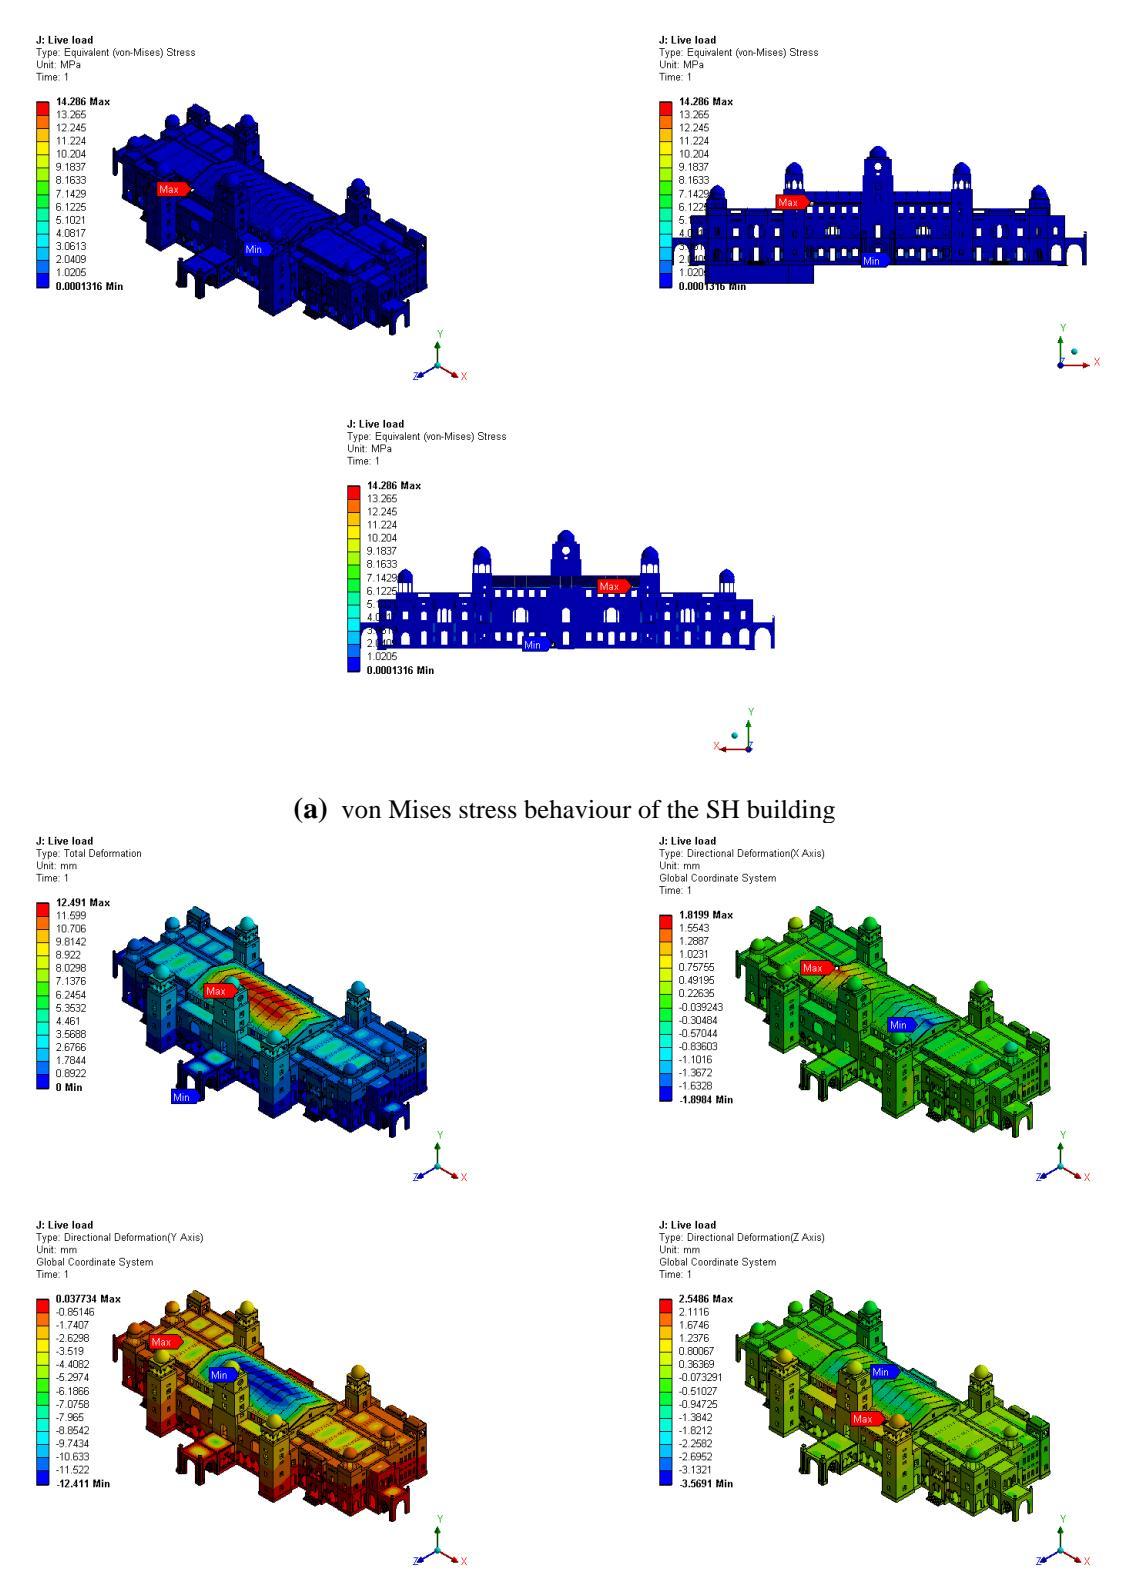
Fig. 8 shows the stress and deformation response of the SHB due to live load. The maximum stress 14.28MPa has been observed on the openings of the window and connections between wall and roof joint of the second-floor level. The in-situ survey of the SHB shows the major cracks and damages on the stone columns, arches and walls on the position of critical stresses. The stresses on stone arches of the meeting hall and examination hall are observed in the range of 5.1MPa to 6.1MPa, respectively. The maximum deformation of 12.49mm has observed on the floor of second-floor and at the roof of the central hall in the building. The truss sections are designed from I-section; the access of these portions is restricted.

(b) Deformation behaviour of the SH building Figure 8: von Mises stress and deformation behaviour during live load analysis

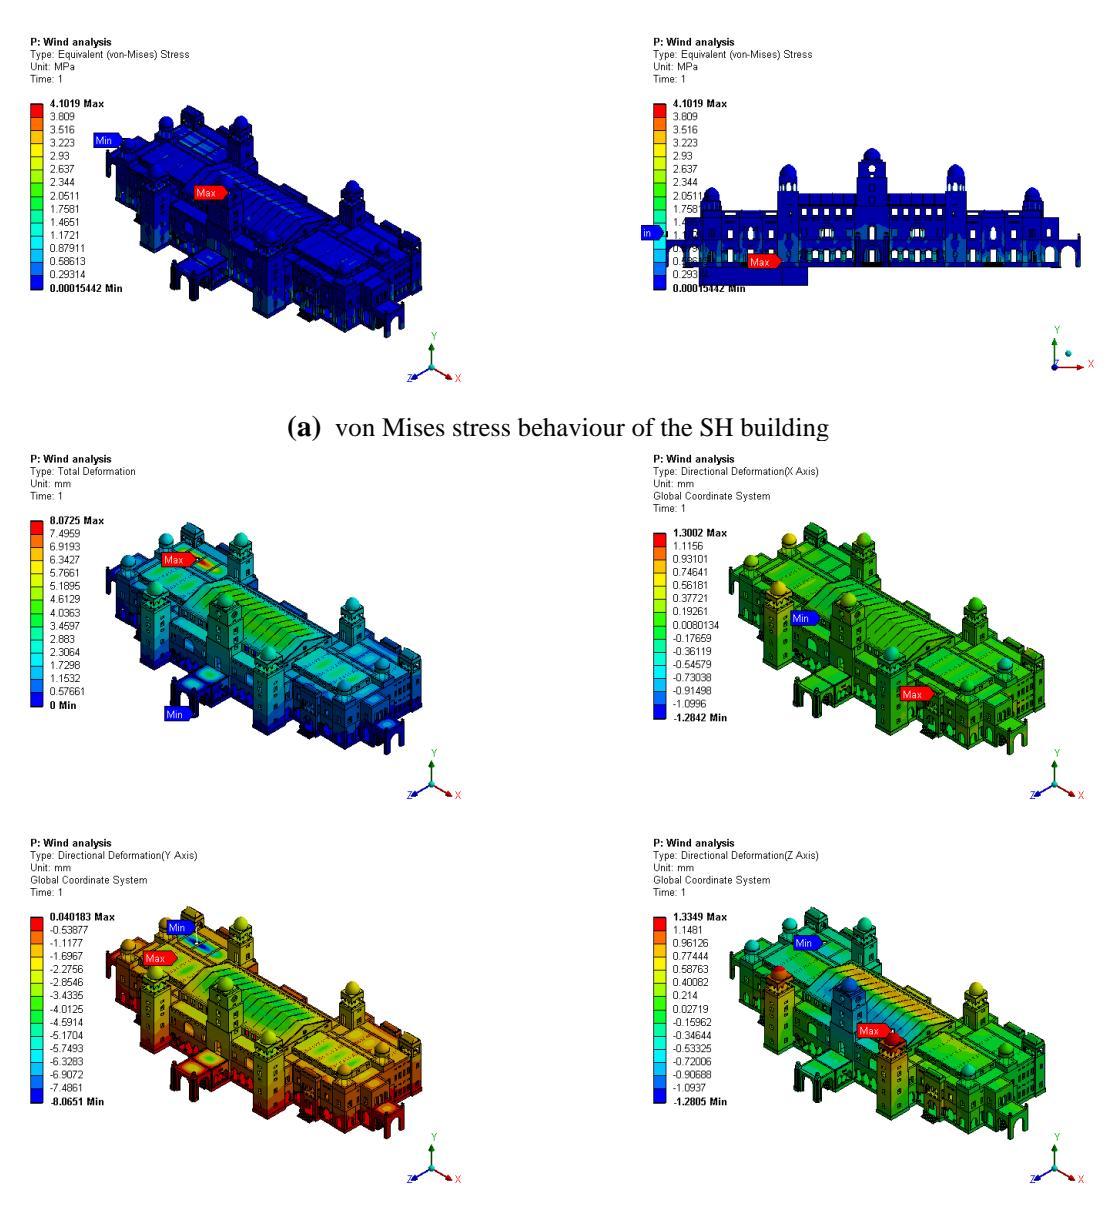
Further, to know the stress generated through the lateral load; wind analysis has been performed on the SHB building. The maximum stress of 4.10MPa is observed on the wall of the ground floor level between the central hall and examination hall verandah. The stress range on the octagonal columns, domes, tile roof, the balcony from 0.87MPa to 1.17MPa. Front corner tower has observed the stress 1.75MPa to 2.05MPa at the ground and first-floor level. The maximum deflection 8.07mm is observed on the verandah (backside) of the second-floor. The longitudinal and transverse direction deformation is estimated as 1.30mm and 1.33mm, respectively. The vertical directional deformation 0.04mm of the building has observed as negligible at the second-floor level.

(b) Deformation behaviour of the SH building Figure 9: von Mises stress and deformation behaviour during wind analysis
