Holism vs. Sustainability in Construction

Tomasz Szkuta

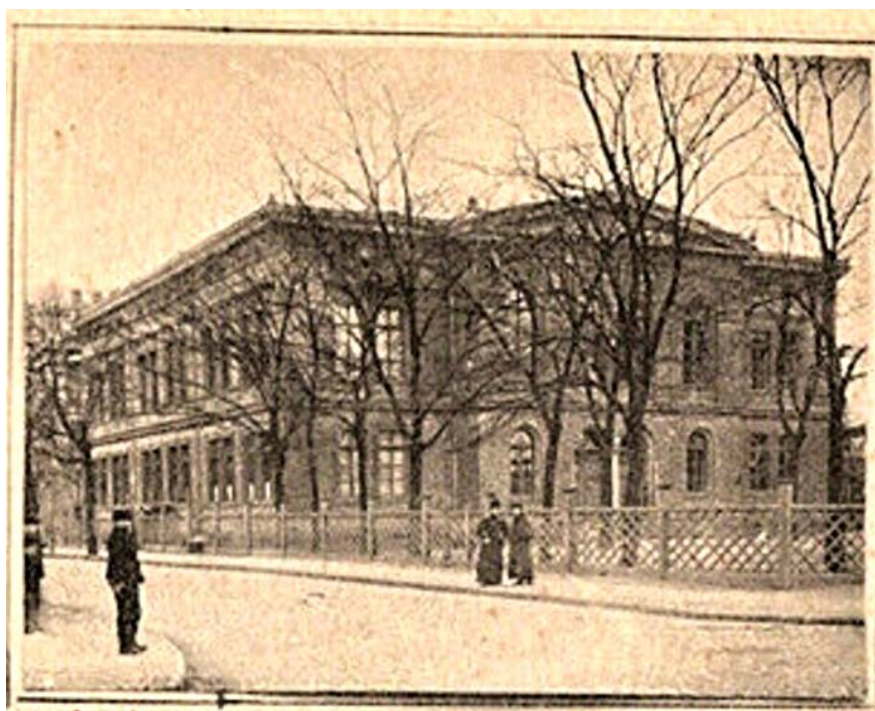
Fig. 1 Photo from around 1900

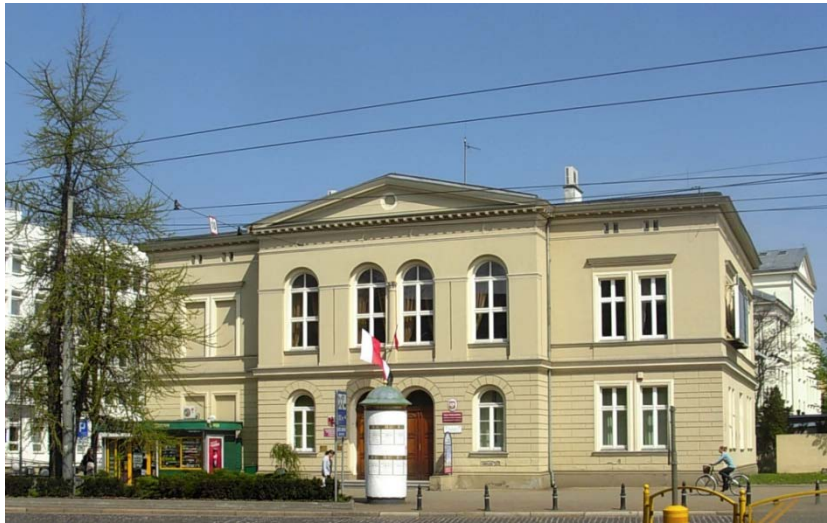
Fig. 2 Current state of the building 2023

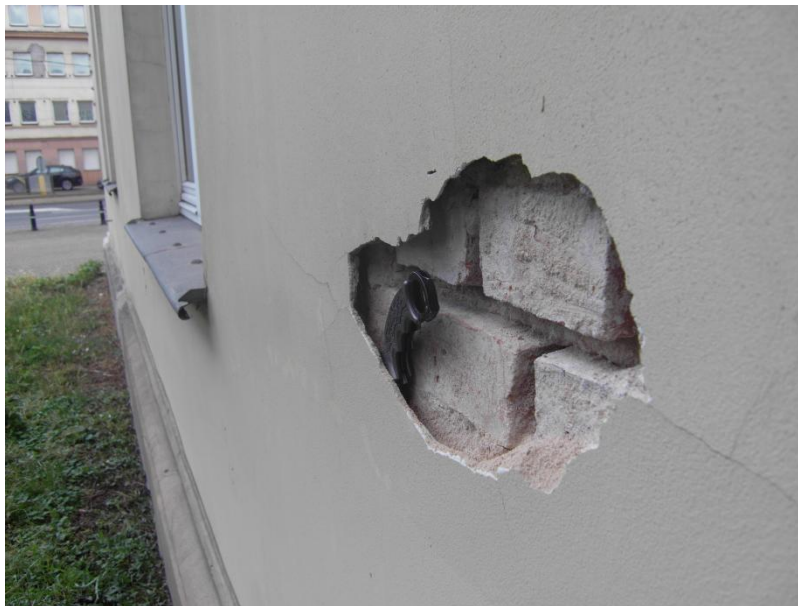
Fig. 3 Plaster on an exterior wall 15 years after renovation. It shows the complete destruction of the lime mortar covered by a too-tight and too-strong repair system from one of the leading companies in the local market

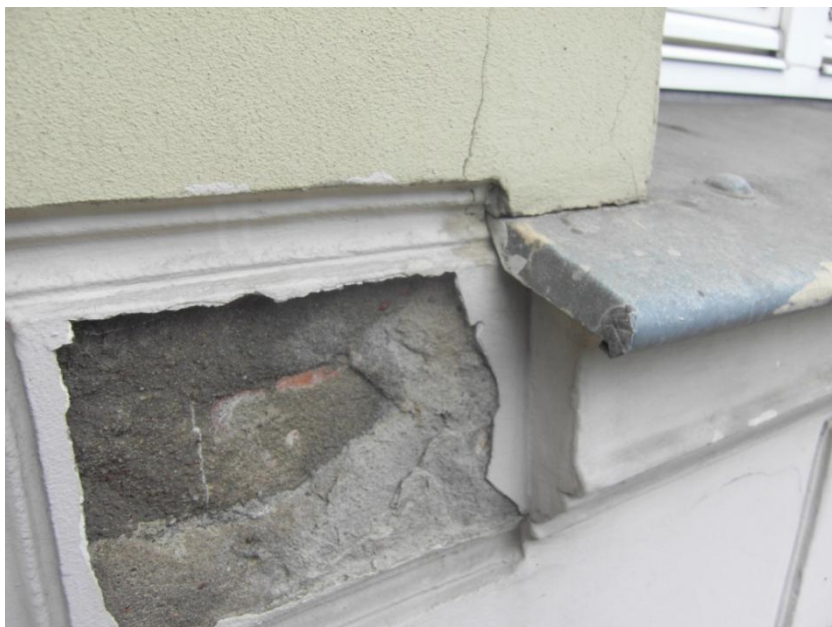
Fig. 4 Plaster on exterior wall j/w. Shows lack of knowledge and skills at the stages of technical evaluation, design and execution. Unacceptable underlayment of cement render on brick wall in lime mortar

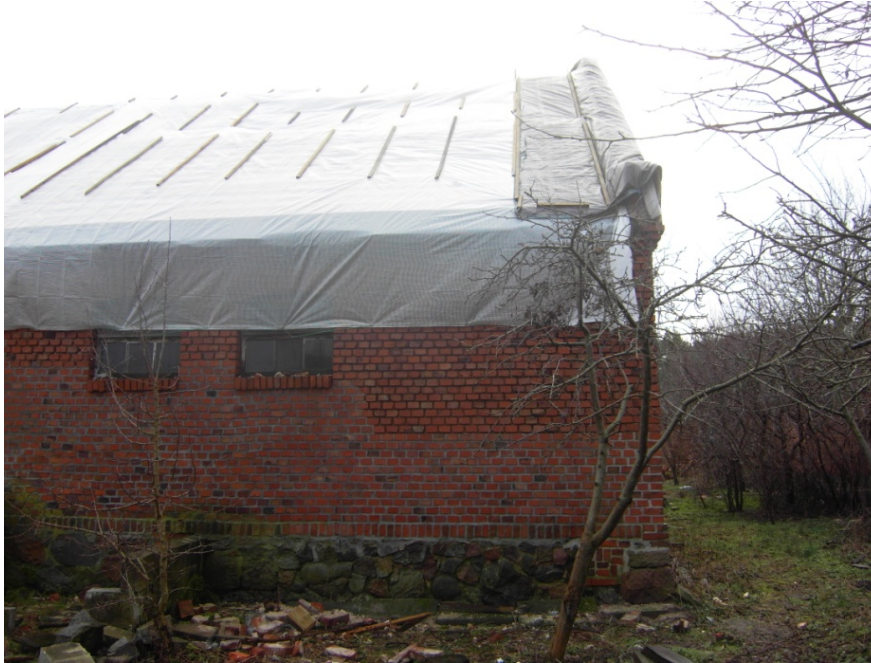
Fig. 5 The north wall of the outbuilding section with partial improper restoration with cement-lime mortar of the brick wall and cement of the stone plinth

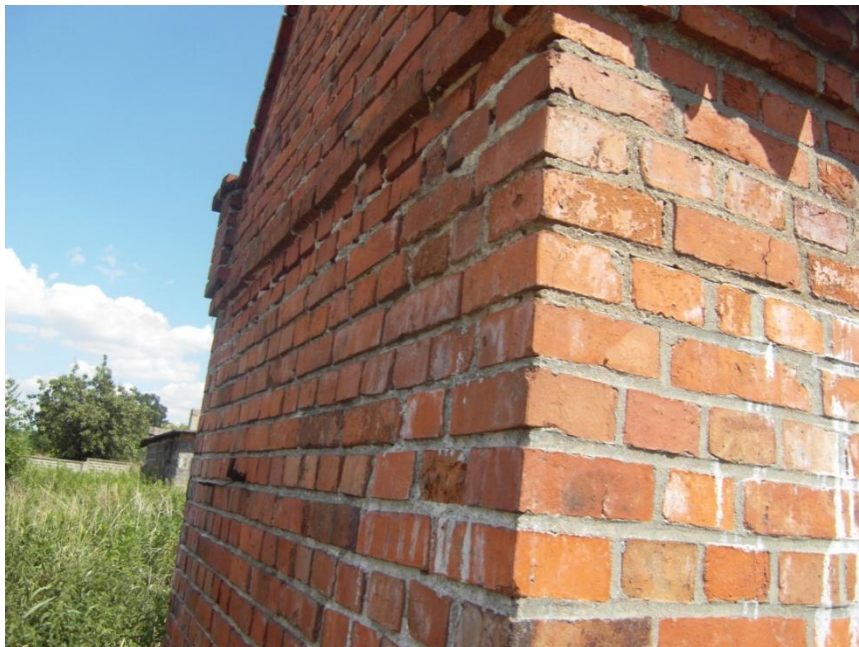
Fig. 6 The southwest corner of the farm section showing the good condition of the brick improperly jointed with cement-lime mortar. Still without damage caused by improperly applied material

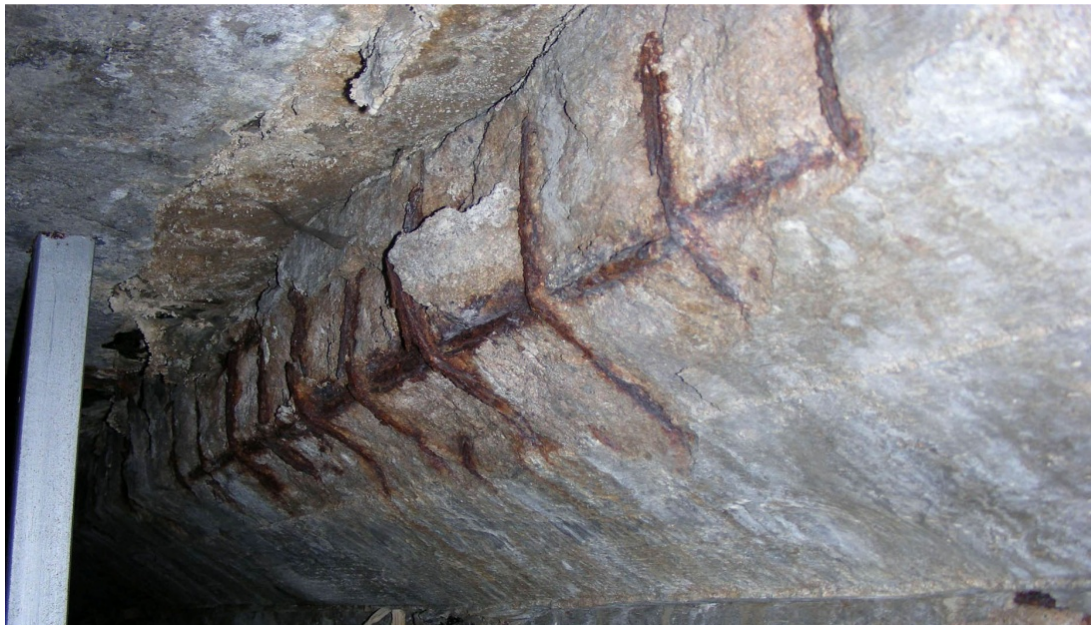
Fig. 7 Condition of the pool basin. Complete destruction of reinforcement, effect of carbonation of concrete

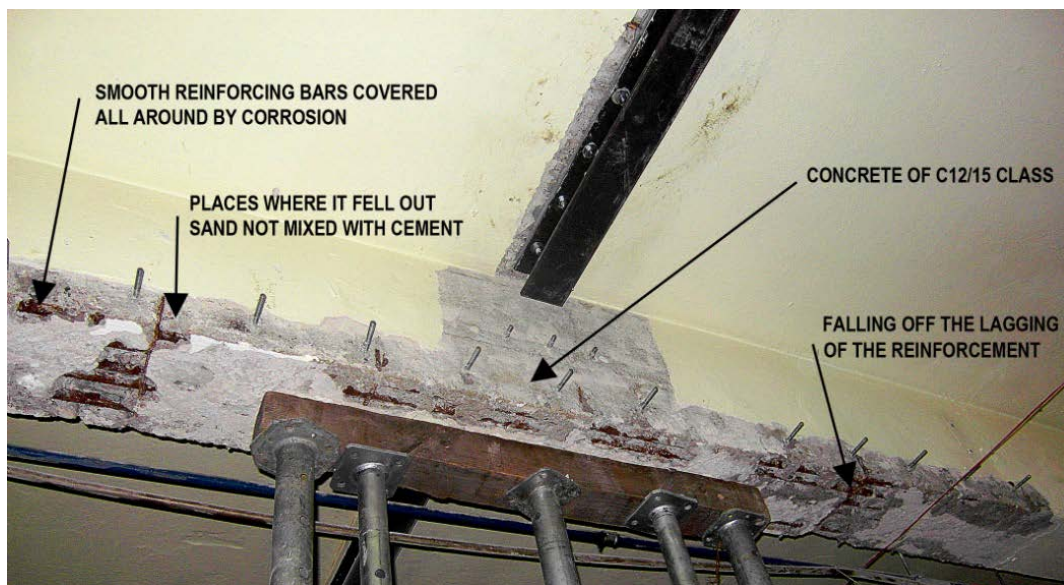
Fig. 8 Shown is an uncovered reinforced concrete beam in a structurally unsafe condition
